Release Notification and Corrective Action

Name of Company	Lime Rock Resources	Contact	Michael Barrett
Address	1111 Bagby Street Suite 4600, Houston, TX 77002	Telephone No.	575-623-8424 505-353-2644
Facility Name	Staley State A #4	Facility Type	Oil Well

Describe Area Affected and Cleanup Action Taken.
Release site was remediated to applicable NMOCD standards, please see Basin Consulting *Remediation Summary and Site Closure Request*.

Based on the analytical results of the confirmation soil samples, Basin recommends Lime Rock provide the NMOCD Artesia District Office a copy of this *Remediation Summary and Site Closure Request* and request the NMOCD grant site closure to the Staley State A #4 release site.

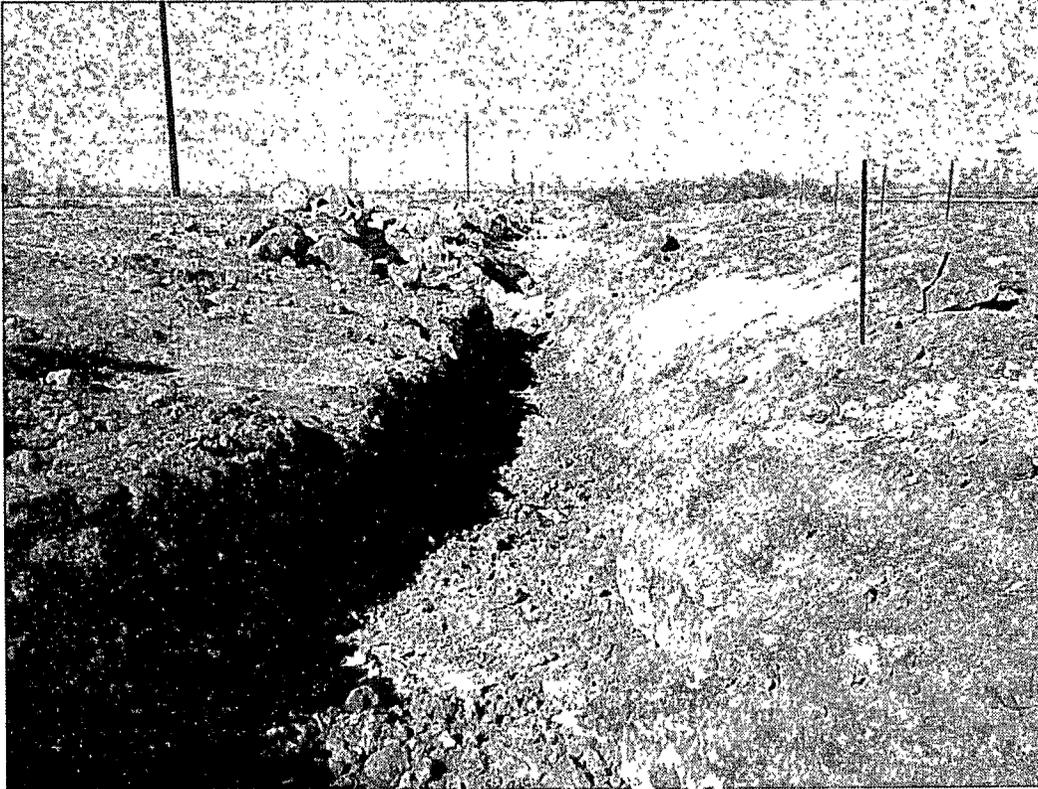
Staley State A #4 – excavation in drainage channel, looking west

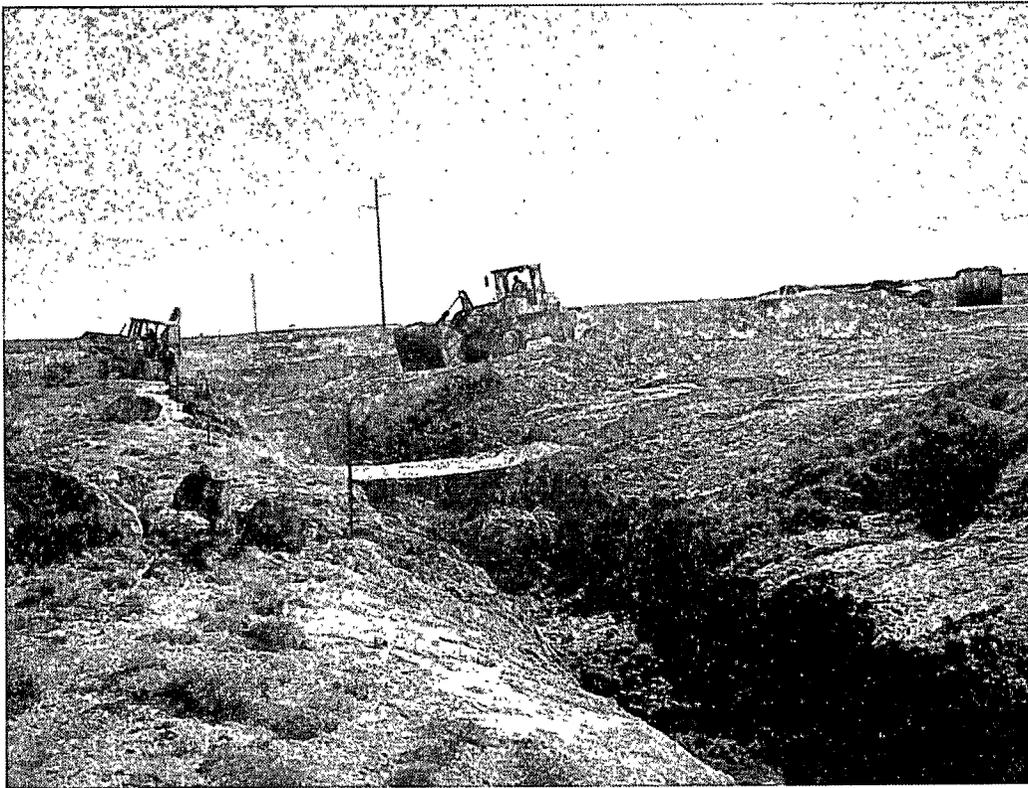
Staley State A #4 – excavation in drainage channel, looking east

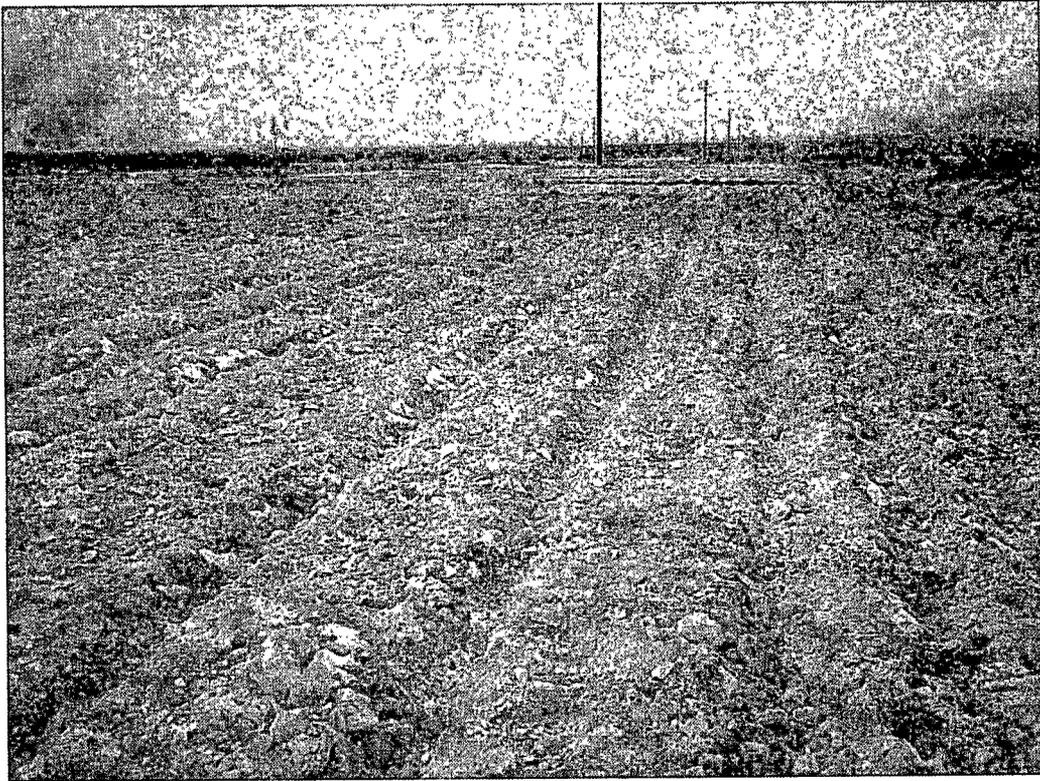
Staley State A #4 – soil remediation complete and contoured, looking west

were placed in the drainage channel to minimize wind and water erosion. The site will be reseeded with vegetation acceptable to the landowner when soil moisture conditions are optimal.

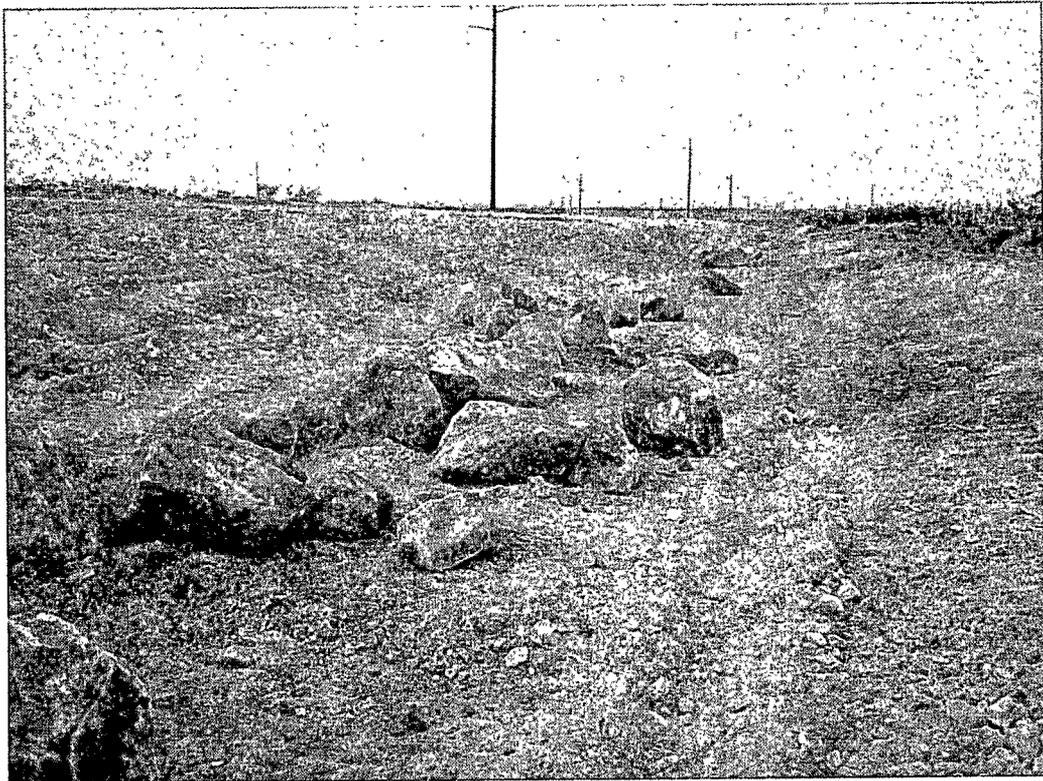
Staley State A #4 – soil remediation complete and contoured, looking west
