Release Closure Report

Southwest Royalties, Inc.
Wilderspin Federal Battery
S-11, T-21S, R-27E
Eddy County, New Mexico

Re: **Release Closure Report**
Southwest Royalties, Inc.
Wilderspin Federal Battery
Section 11, T-21S, R-27E
Eddy County, New Mexico

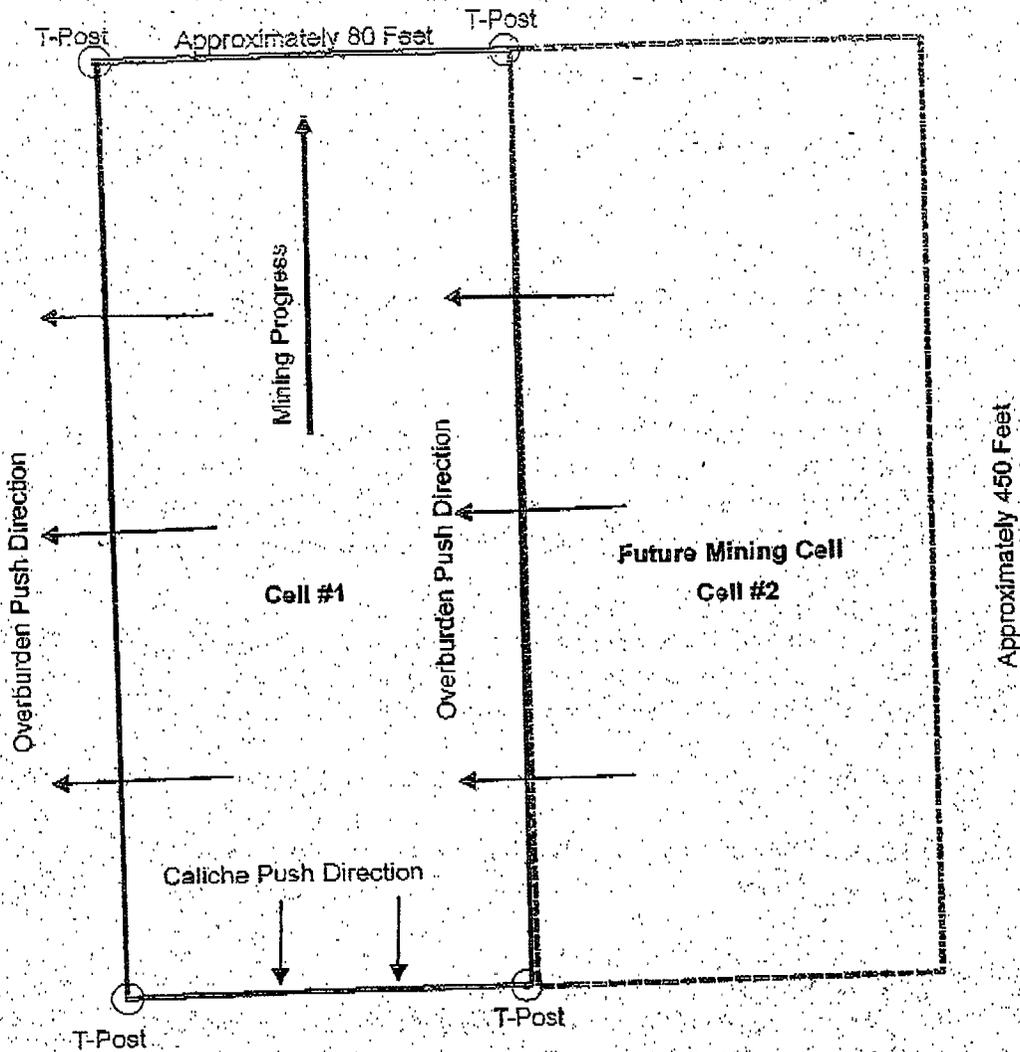
Typical Mine Plan Development Map

Approximately 1 acre of excavation and,
with 8 feet of mineable material, approximately
11,000 LCY of material per mine cell.
