**Annual GW Mon.
REPORTS**

RE: **Annual Report**
Rice Operating Company
Vacuum K-35-1 Boot, UL K, Sec 35, T17S, R35E
OCD Case Number 1R0425-03

Vacuum K-35-1 Annual Report

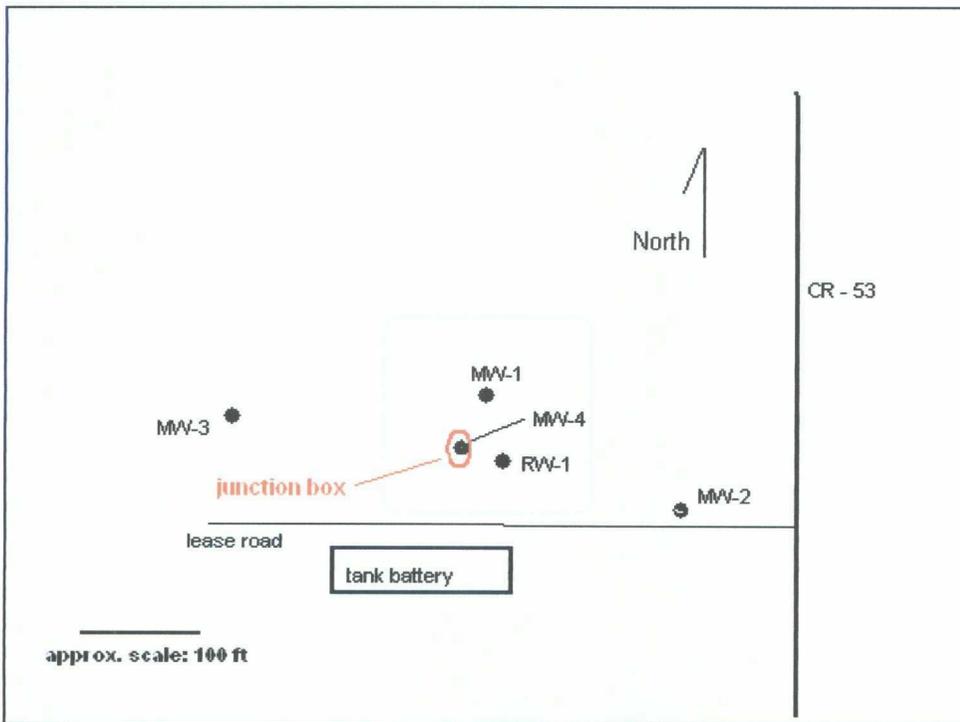
Figure 2 – Vac K-35-1 approx. monitor/recovery well locations.

- Approximately 9,200 barrels of chloride affected groundwater have been withdrawn from a near-source recovery well (RW-1) over the period June 2008 through December 2009 (Figures 2, 3 and 4). A portion of this water has been treated on-site using reverse osmosis and used for site irrigation. The balance has been used for Rice SWD line and well maintenance purposes.
- Groundwater chloride concentrations in the at-source monitor well (MW-4) have declined from approximately 6,770 ppm in February 2007 to 1,200 ppm by October of 2009 (Figure 5).
- The ground surface was restored and reseeded with native vegetation (Figures 6 and 7).

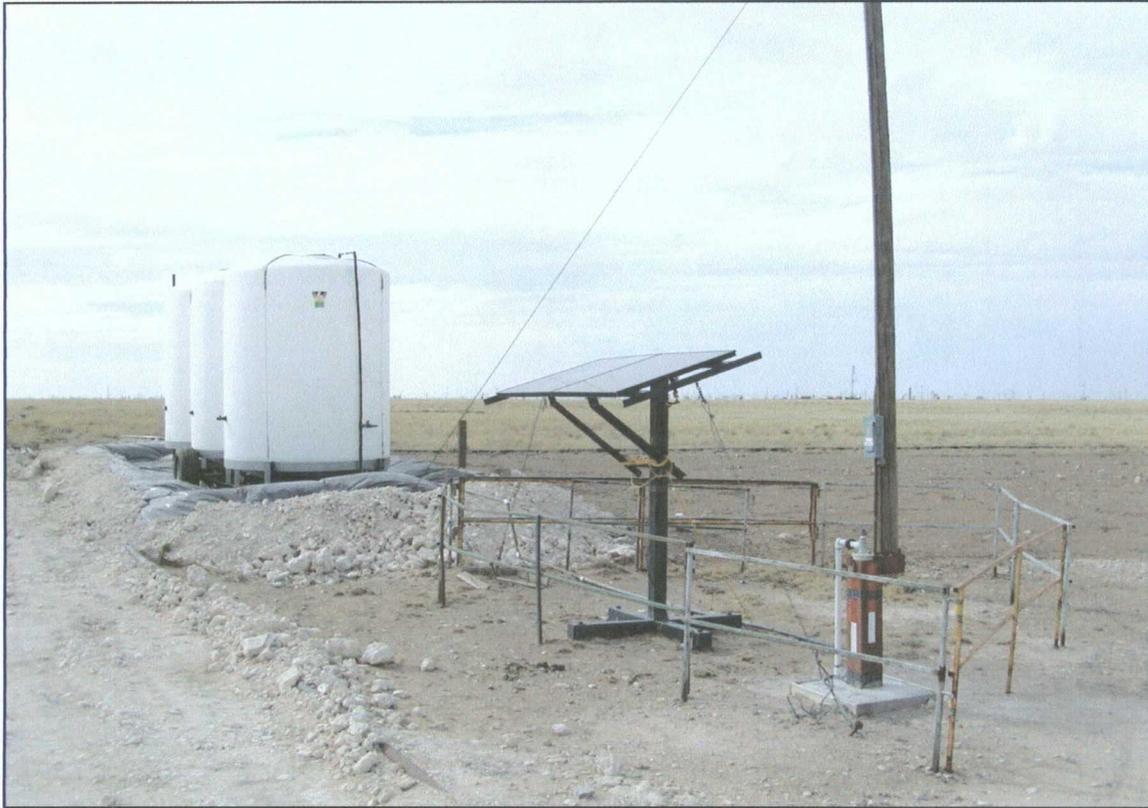
Figure 3 – Vac K-35-1 solar-powered groundwater recovery system.

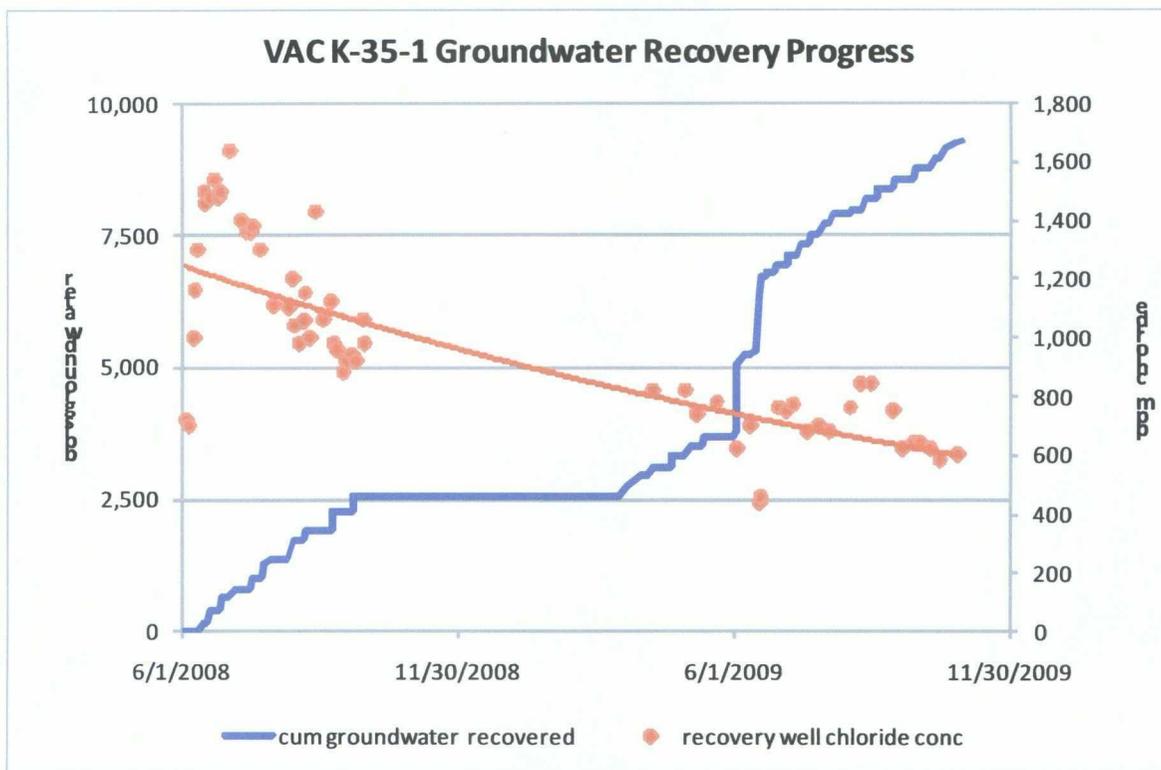
Figure 4 – Vac K-35-1 cumulative groundwater recovery volumes (left axis) and recovery well (near-source) groundwater chloride concentrations (right axis). **Note that the early rise in chloride concentrations during the first two months of pumping is likely due to the entrainment of more highly affected groundwater from beneath the former junction box. The subsequent decline in recovery well groundwater concentrations indicates that the most severely contaminated groundwater is being effectively removed.**

The marked decline in at-source and near-source groundwater chloride concentrations since groundwater withdrawals began indicates that groundwater quality is improving substantially. If this trend continues and we are able to successfully re-vegetate the site we may propose remediation "termination" by this time next year.

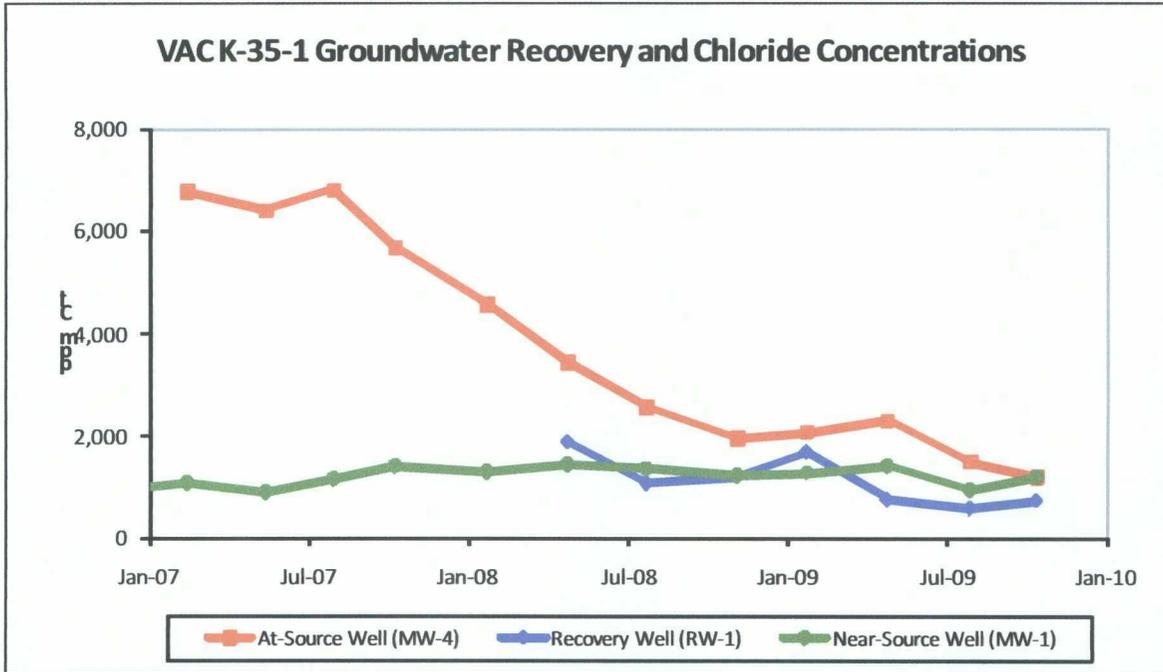
Figure 5 – Vac K-35-1 groundwater chloride concentrations. Chloride concentrations in the down-gradient monitor well (MW-2) have held below 30 ppm throughout 2009. (They are not shown on this graph because they are so low that they would obscure the horizontal axis).

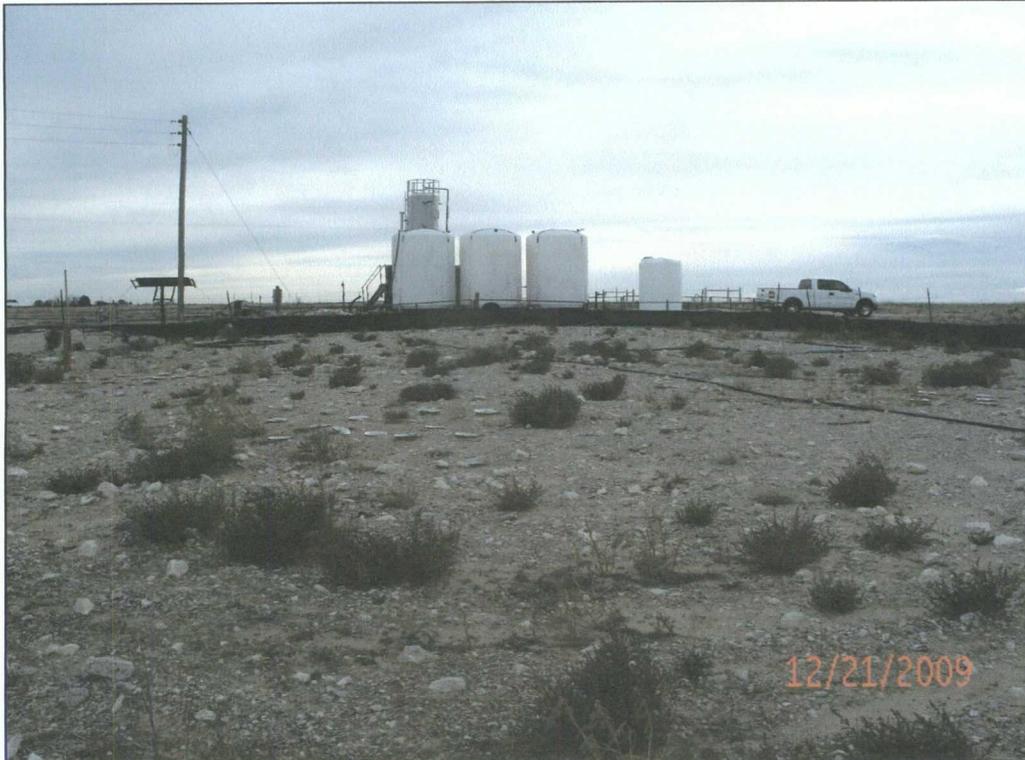
Figure 6 – Vac K-35-1 view south across restored surface, December 2009.

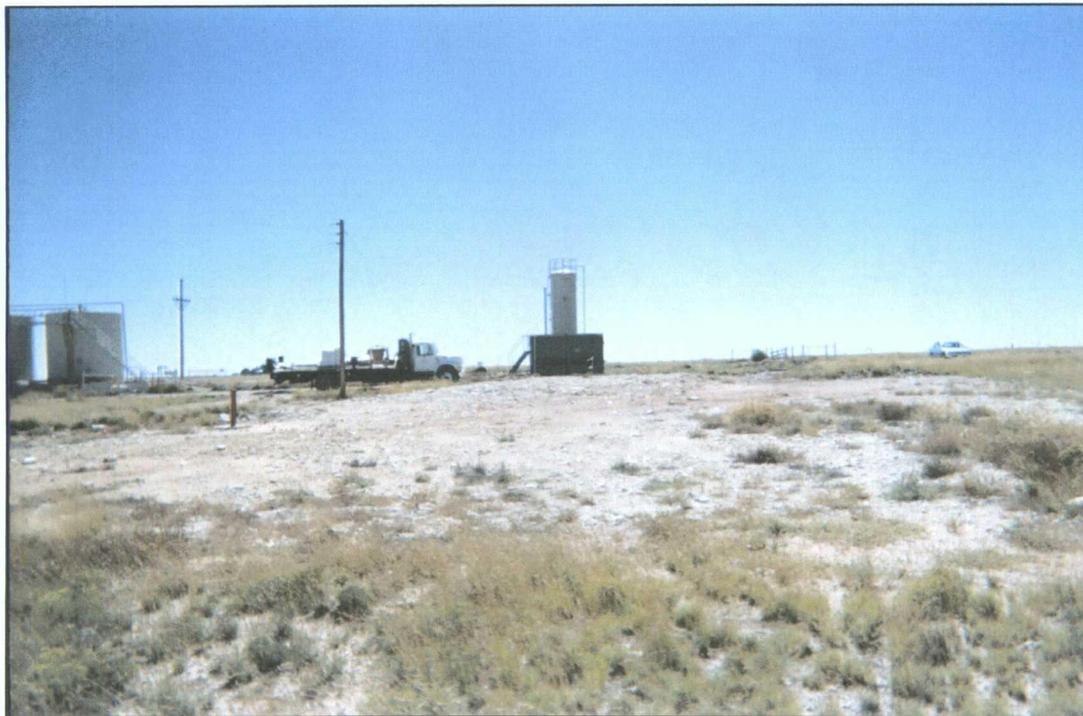
Figure 7 – Vac K-35-1 view south across affected surface before restoration efforts, October 2006.
