**Below-Grade Tank  
Closure Final Report**

**XTO Energy, Inc.**

**Eunice Monument South Unit – Central Battery Tank 2**

**Unit E (SW/4, NW/4), Section 4, T21S, R36E**

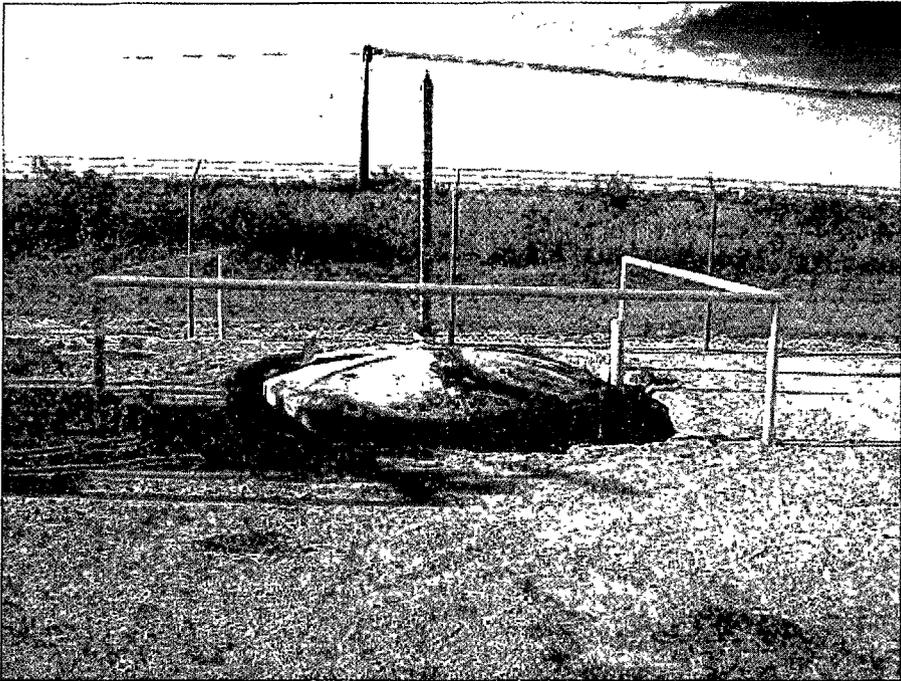
Below Grade Tank 2 is located near the south fence line

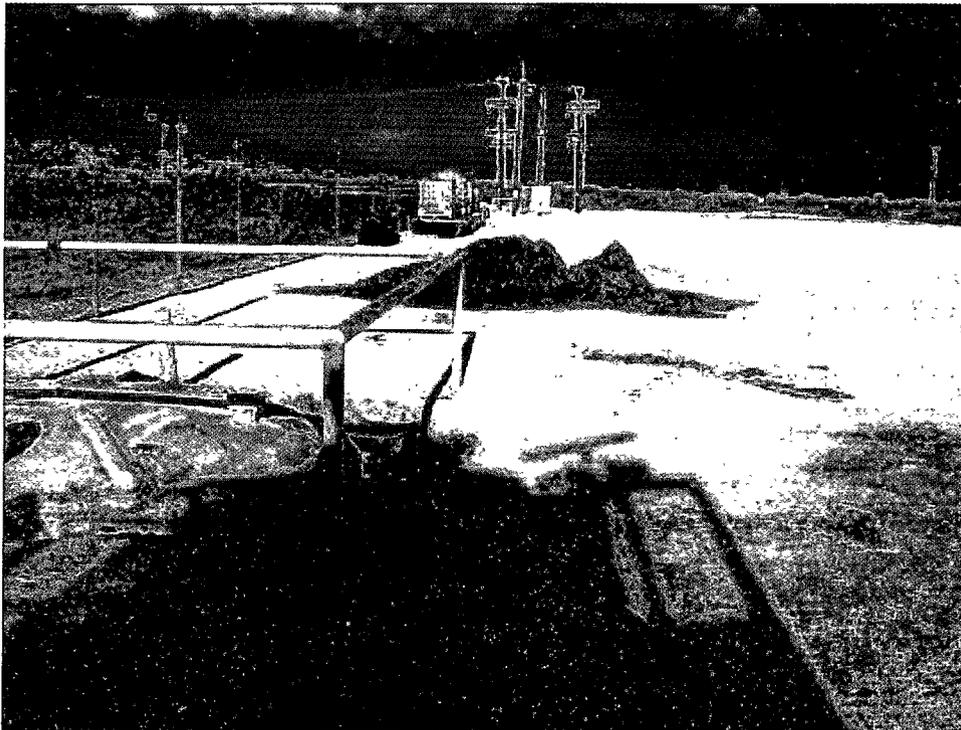
Tank 2 excavated soil pile

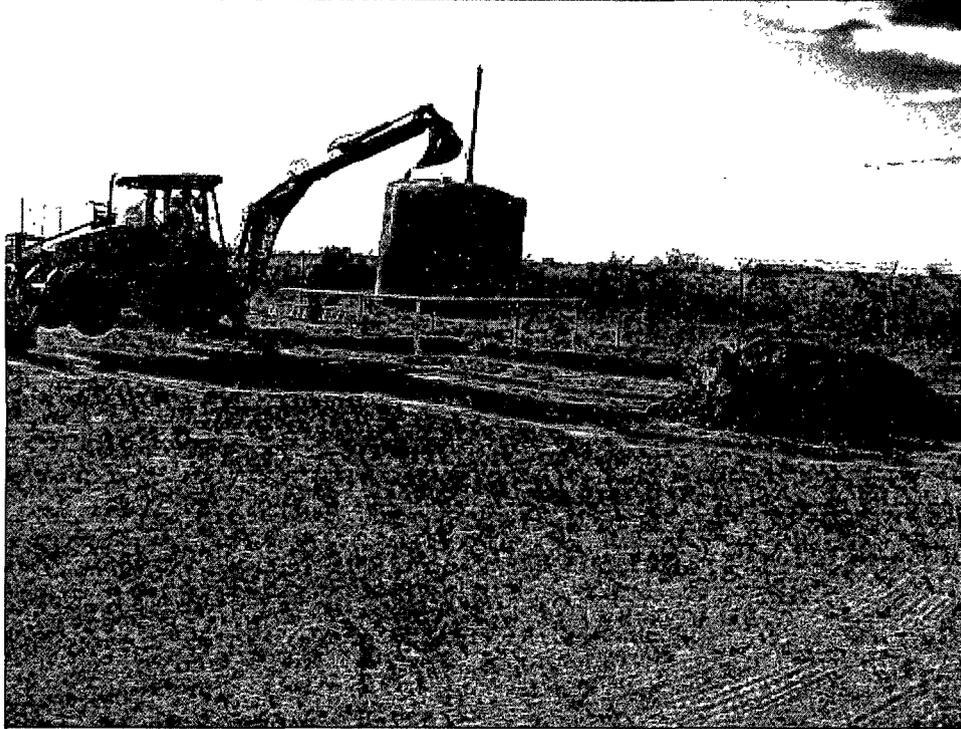
Backhoe removing Tank 2 from excavation

On August 26, 2009, XTO used a HydroVac truck to excavate around the tank, and a backhoe to remove the tank. Approximately 85 barrels of tank bottoms and 10 cubic yards of excavated soil were disposed at Sundance Services, Inc. (OCD Permit R5516/NM-01-0003). Waste manifests are presented as Appendix C.

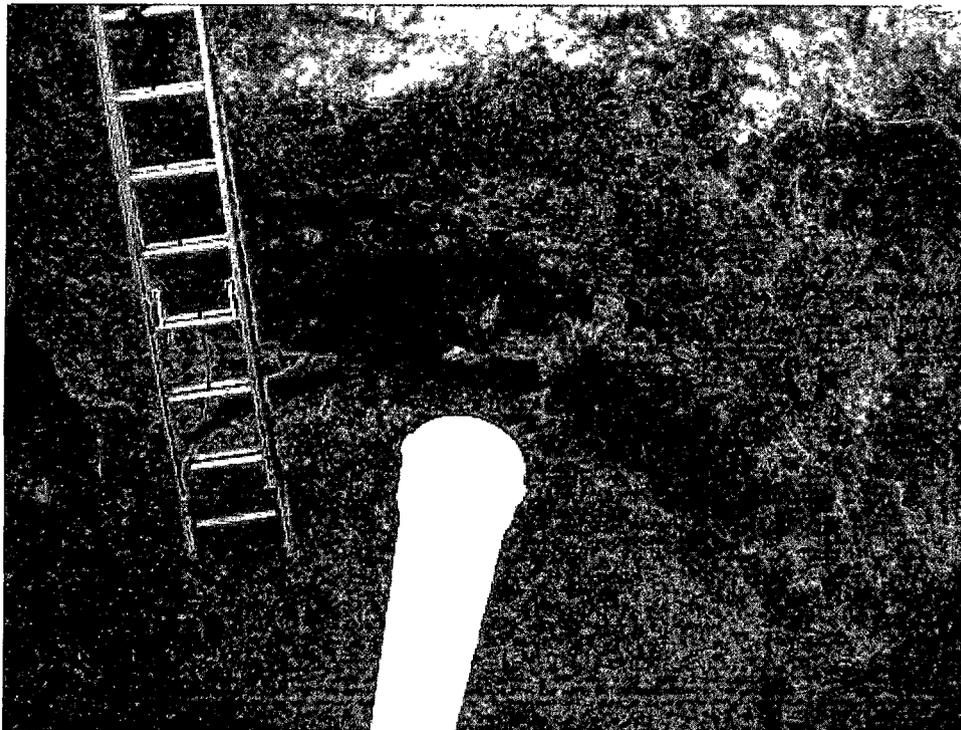
Excavation East Wall

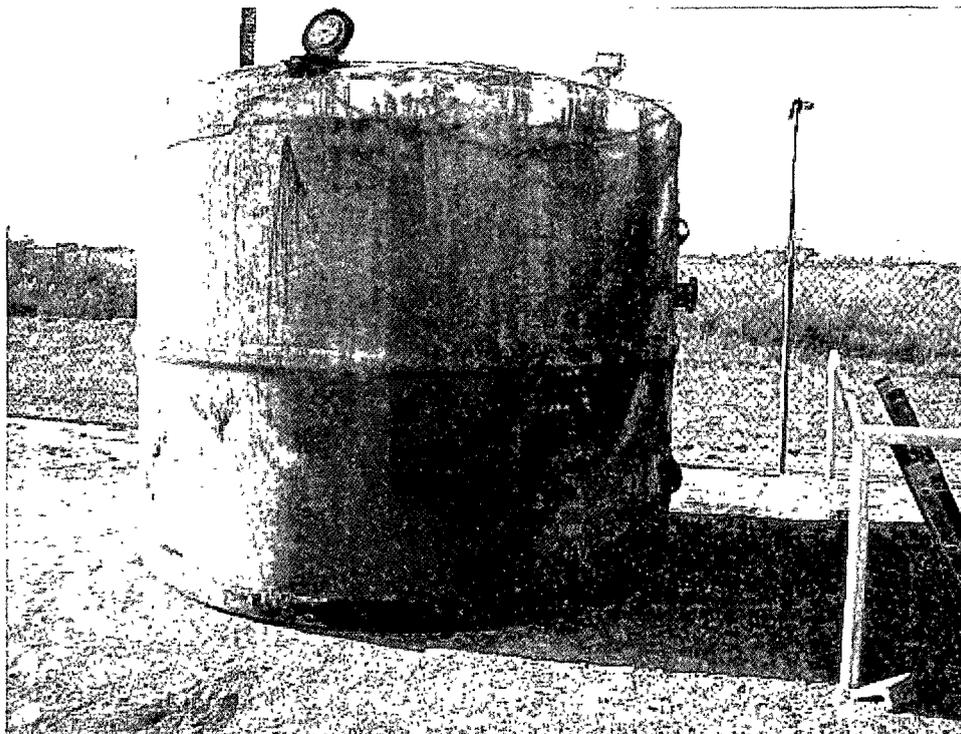
Tank 2 removed from excavation

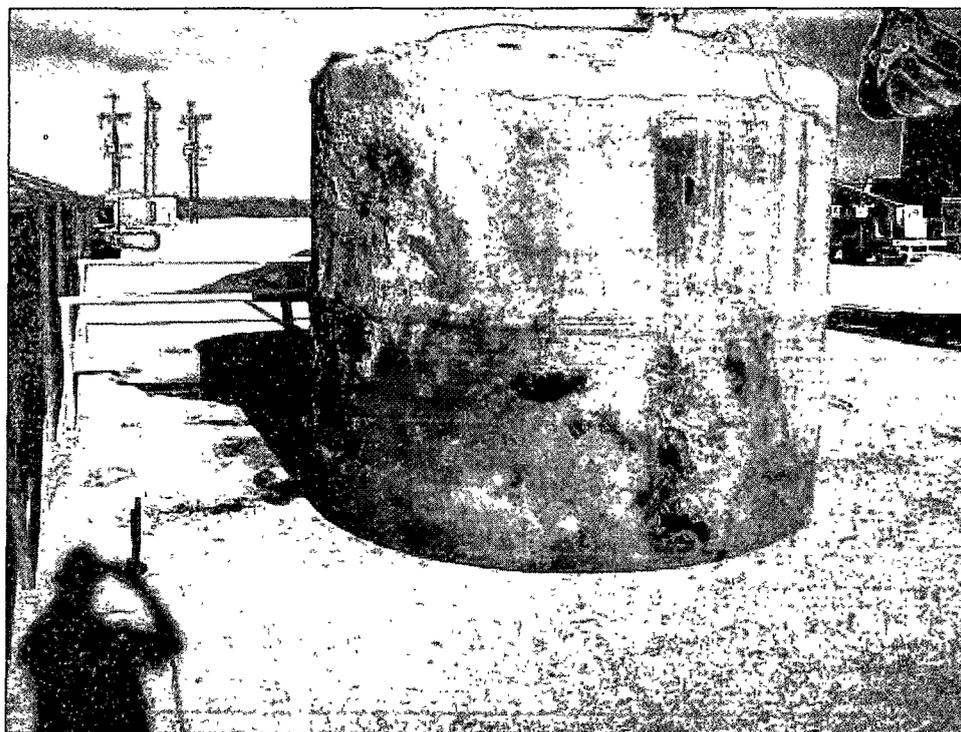
Alternate view of Tank 2

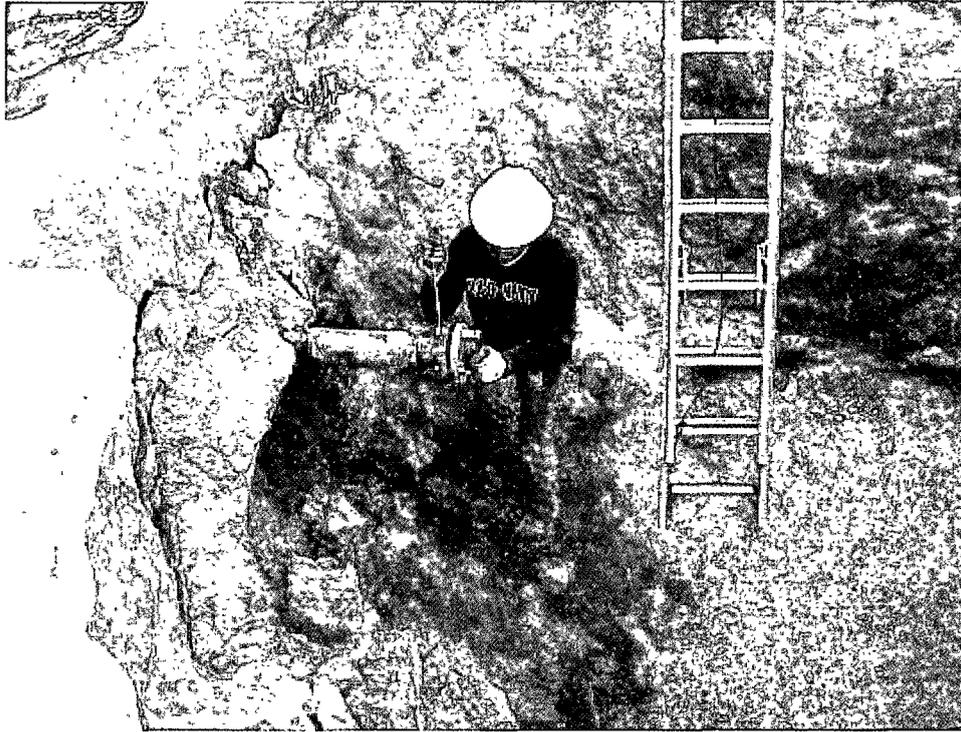
Installing a Slip Plate Cover over discharge line

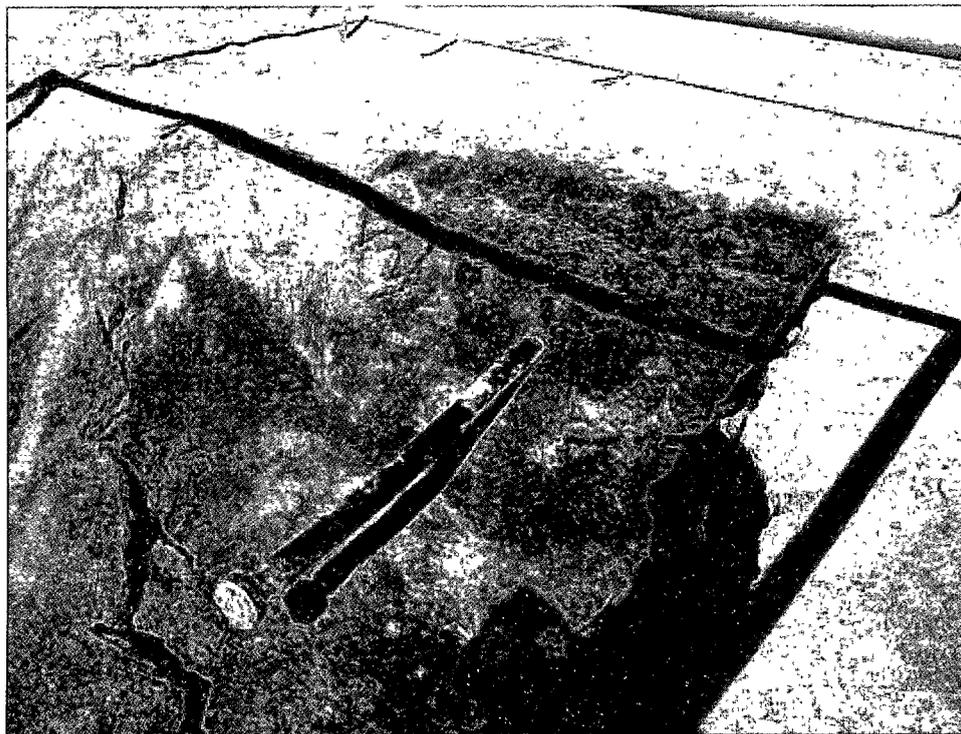
Visibly stained soil was further excavated.

Additional excavation of the North Wall was conducted on October 15, 2009. Approximately 20 cubic yards of excavated soil was disposed at Sundance Services, Inc., and a confirmation sample was collected and submitted to Xenco Laboratories, Inc. in Odessa, Texas. Benzene, BTEX, and TPH were not detected in the sample, and the chlorides were reduced to 8.7 mg/kg, well below the OCD reporting limits.

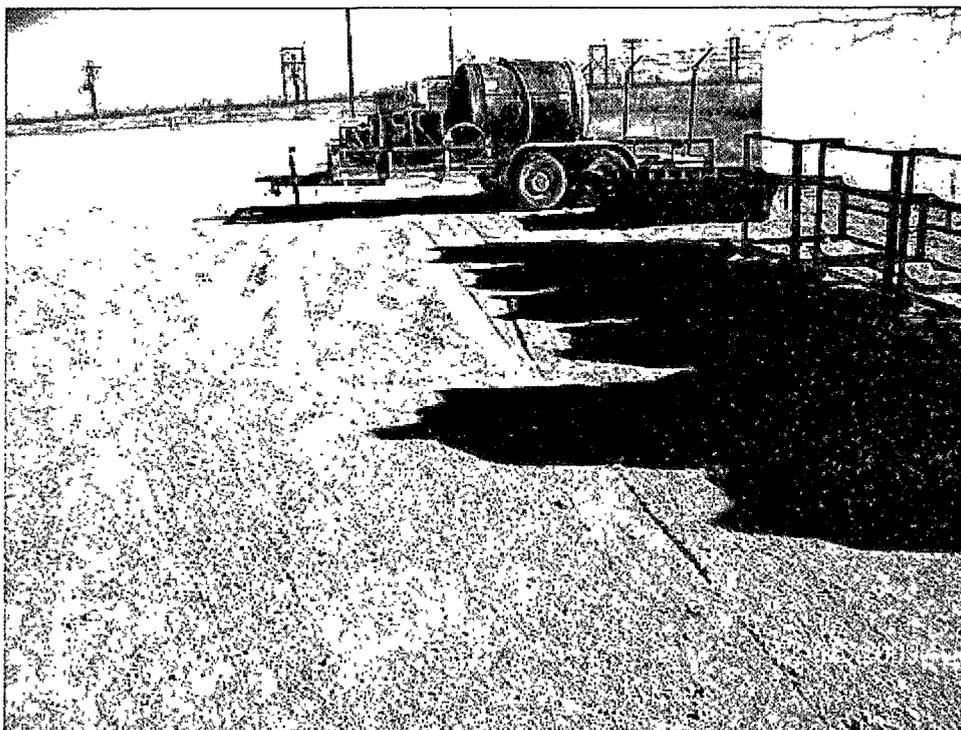
The site was backfilled with clean fill purchased from Jimmy Cooper, a local surface lease and landowner.

An Initial and Final form C-141 was submitted to the OCD Hobbs office for excavation backfilling approval (Appendix E). Backfilling consisted of compacting six- to eight-inch lifts of clean soil purchased from the Mr. Jimmy Cooper, a nearby rancher and soil supplier, and compacting each lift with heavy equipment. The uppermost 18-inches consisted of topsoil also purchased from Mr. Jimmy Cooper. The topsoil was graded to level with the surrounding surface.
