Release Notification and Corrective Action

Closure Report

C A Russell Battery
Eddy County, NM

2RP - 392

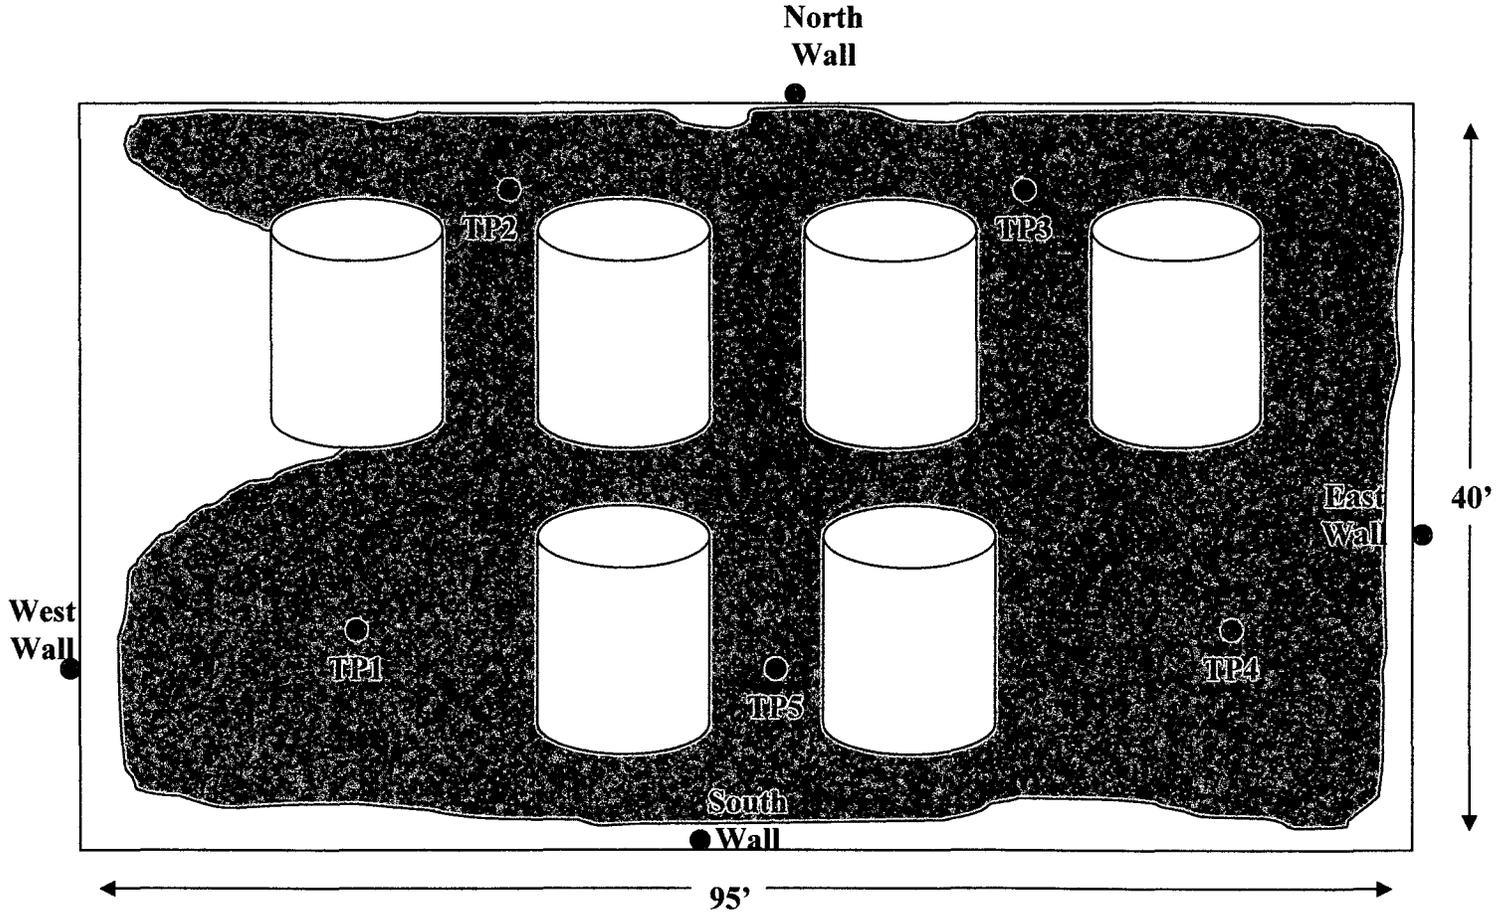
Plat Map

Elke Environmental was contracted by Linn Operating to complete the remediation of the leak at the CA Russell Battery. A delineation of the site was completed using a backhoe on 3/3/10. Attached is a plat map, field analytical and lab confirmations for the site.

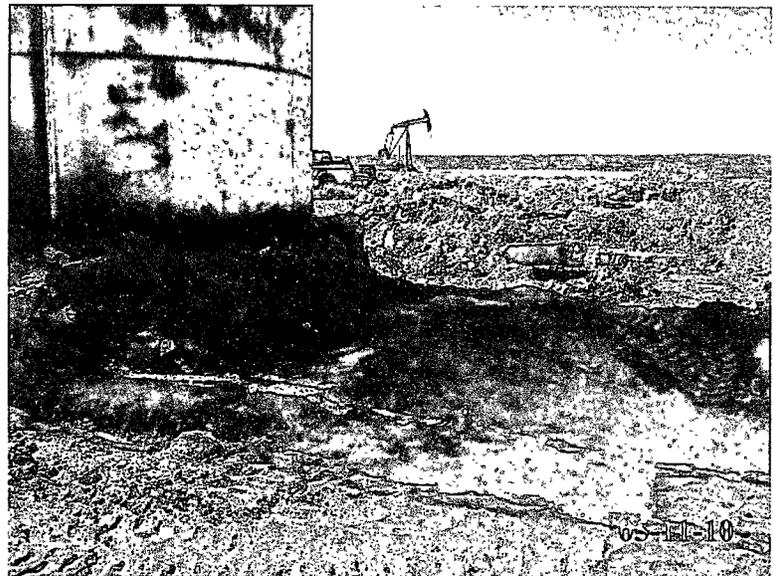
East side of battery after excavation

As per the approved plan the area inside the battery was excavated to 2' bgs and re-evaluated. Test Point 2 and Test Point 3 were then excavated an additional 1' to a final depth of 3' bgs. The area around Test Point 4 was excavated to a final depth of 2.5' bgs and Test Point 5 was excavated to 5.5' bgs. Lab samples were then obtained from each Test Point and evaluated for BTEX. All impacted soil was hauled to LEA Land for disposal and clean native soil was hauled to the site for backfill.

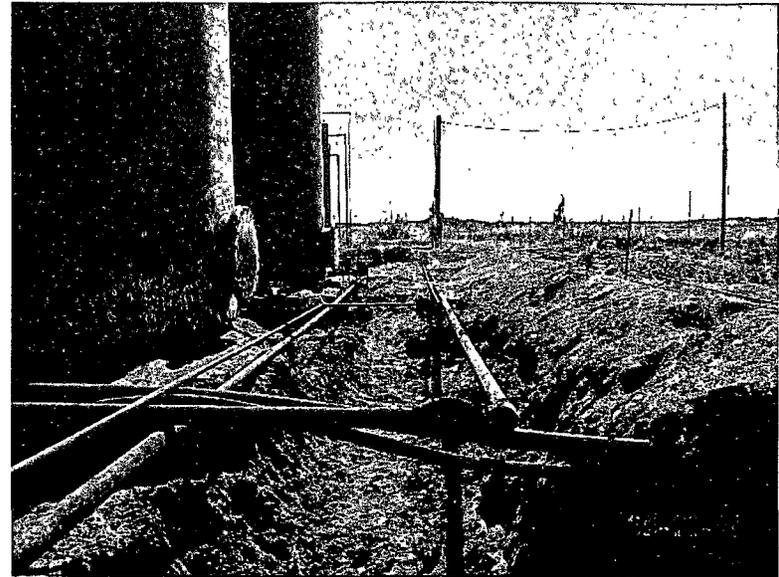
North end of battery after excavation

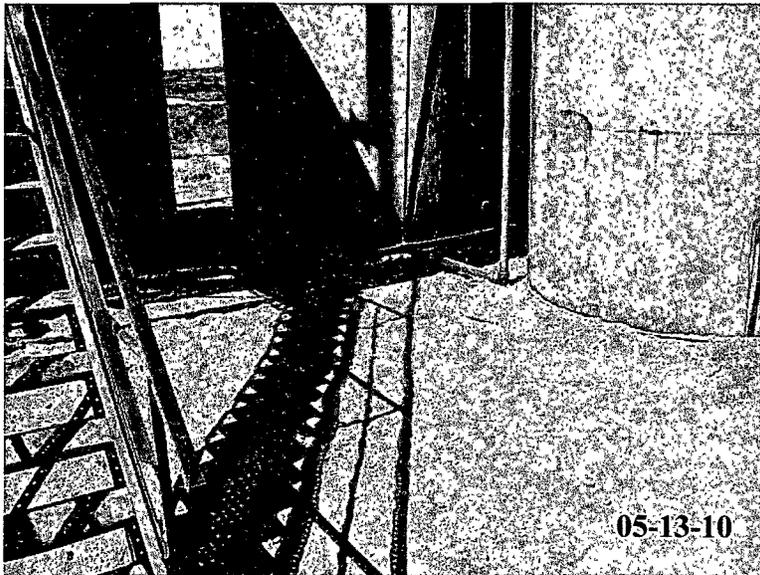
Test point 1 after backfill

Describe Area Affected and Cleanup Action Taken.* All impacted soil was excavated vertically and horizontally until the RAL's were met 2' – 5.5'. The impacted soil was hauled to Lea Land Disposal. Clean native soil was hauled to the site and backfilled into the excavation. The site was not re-vegetated since it was a caliche location for a battery. Attached is a final report of the remediation at the site.

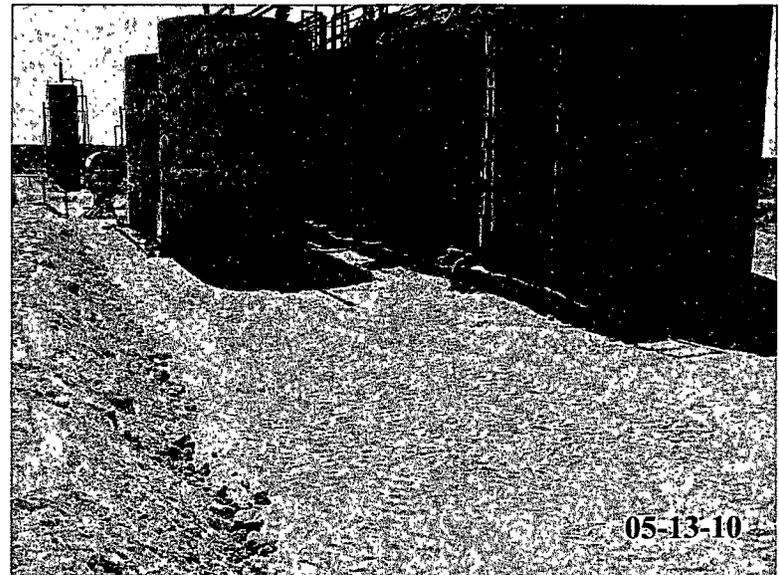
East end of battery after backfill
