Release Notification and Corrective Action

Name of Company: Targa Resources	Contact: James Lingnau
Address: P.O. Box 1909 Eunice, NM 88231	Telephone No.: 575.394.2534 X 226
Facility Name: Eunice Middle Plant	Facility Type: Compressor Station

Executive Summary Targa Resources Eunice Middle Plant Remediation Plan

Exhibit Index

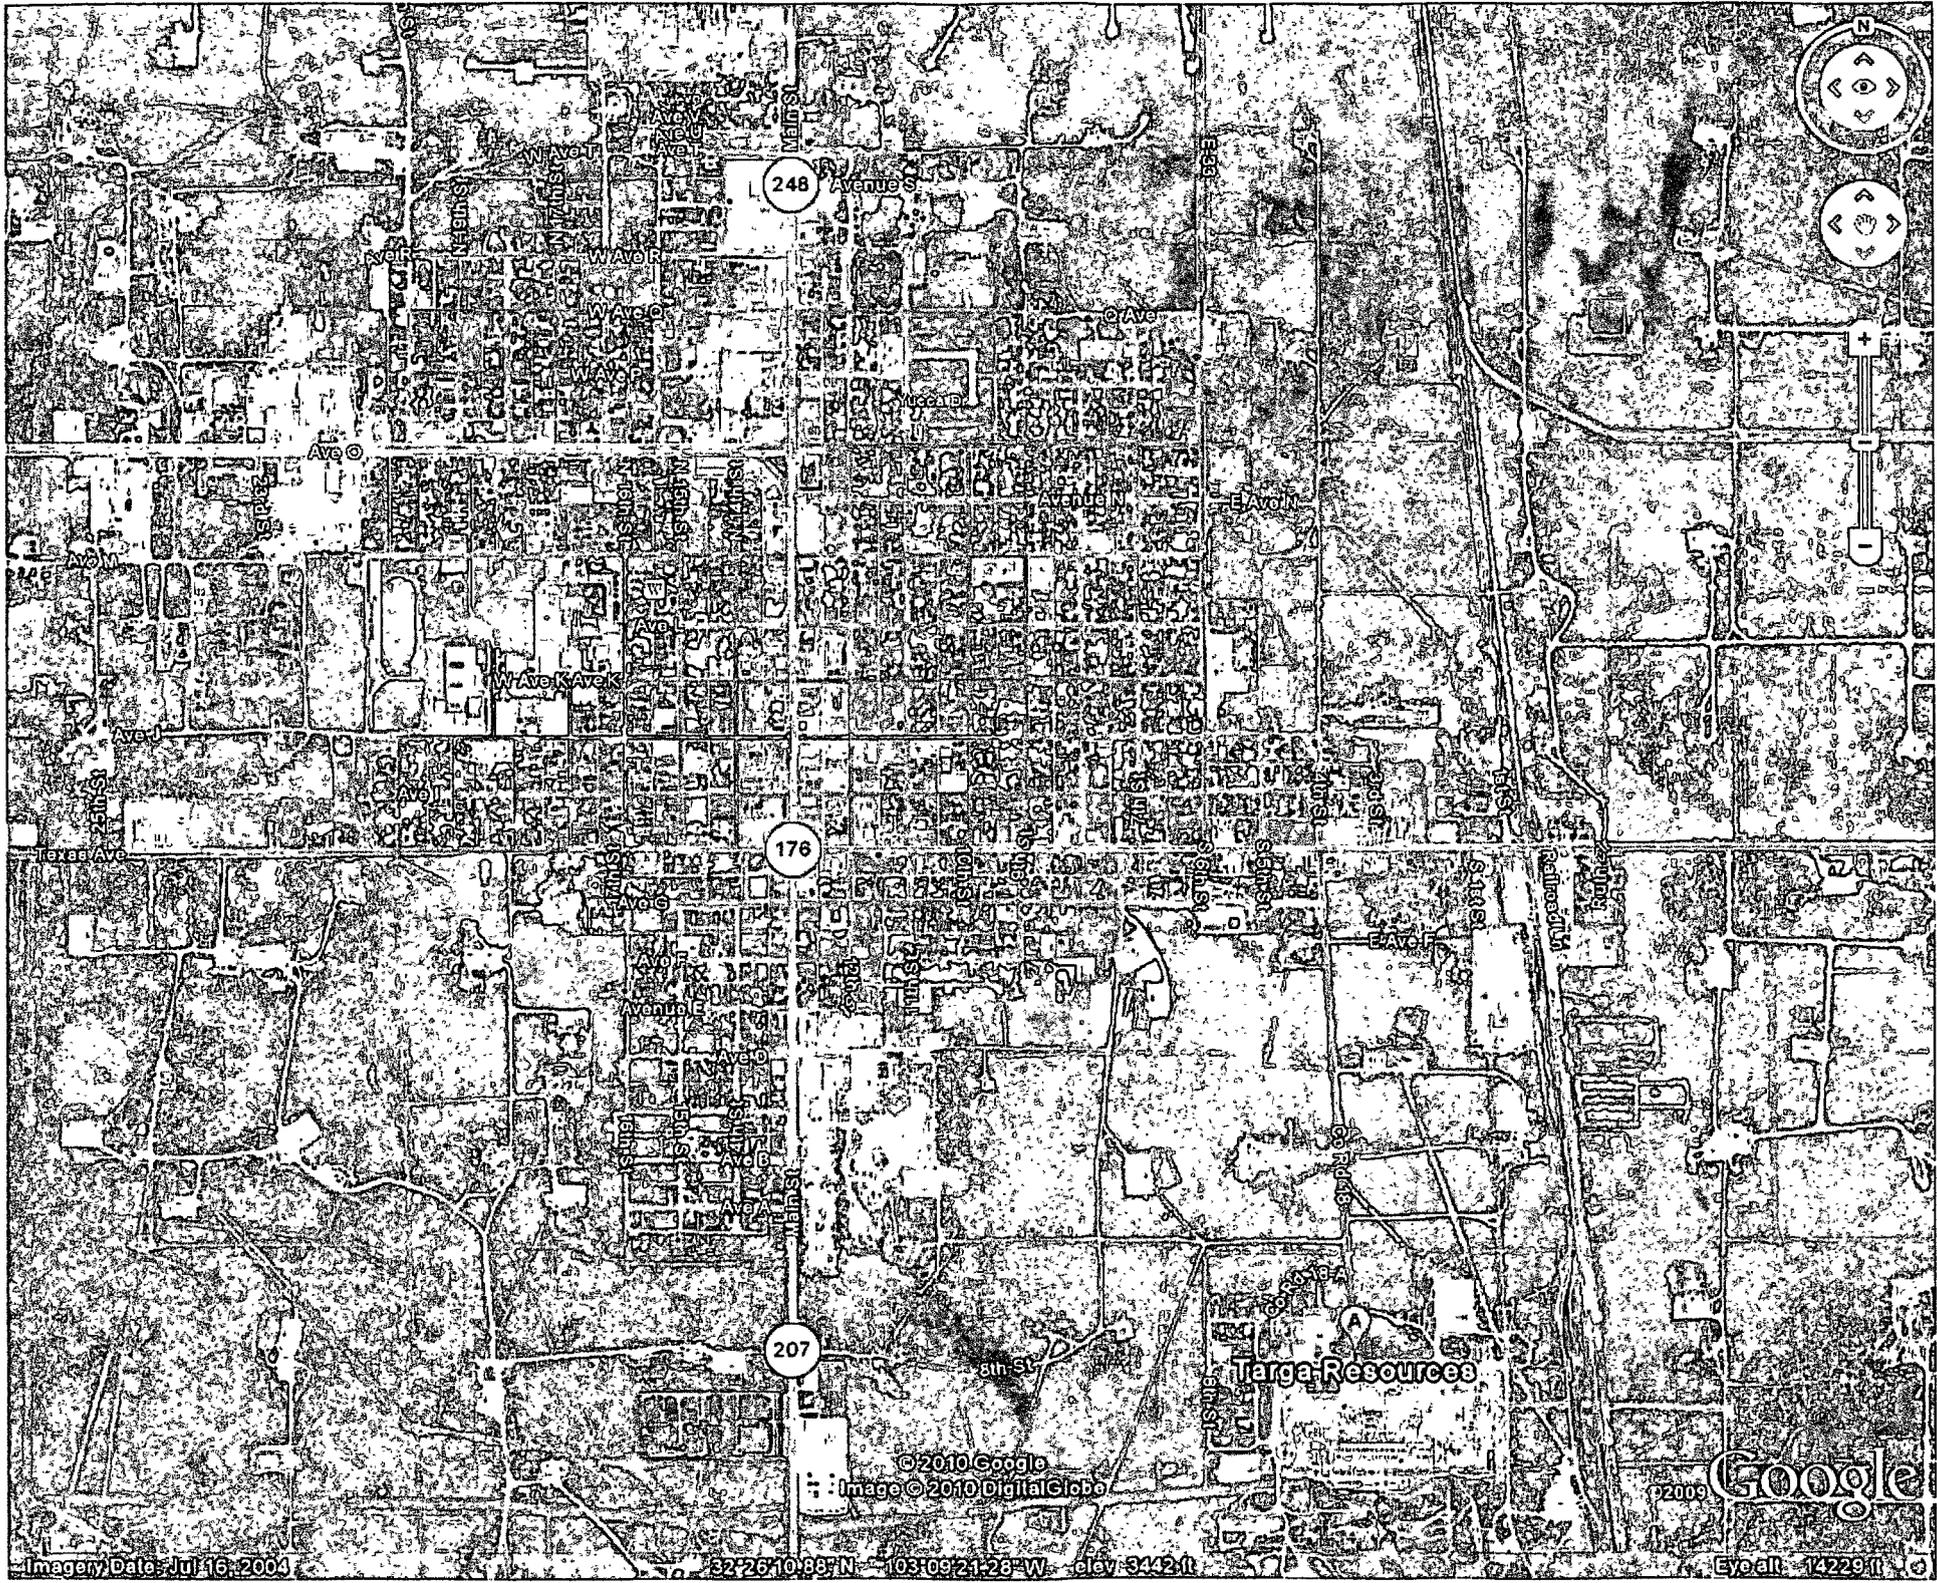
Targa Resources

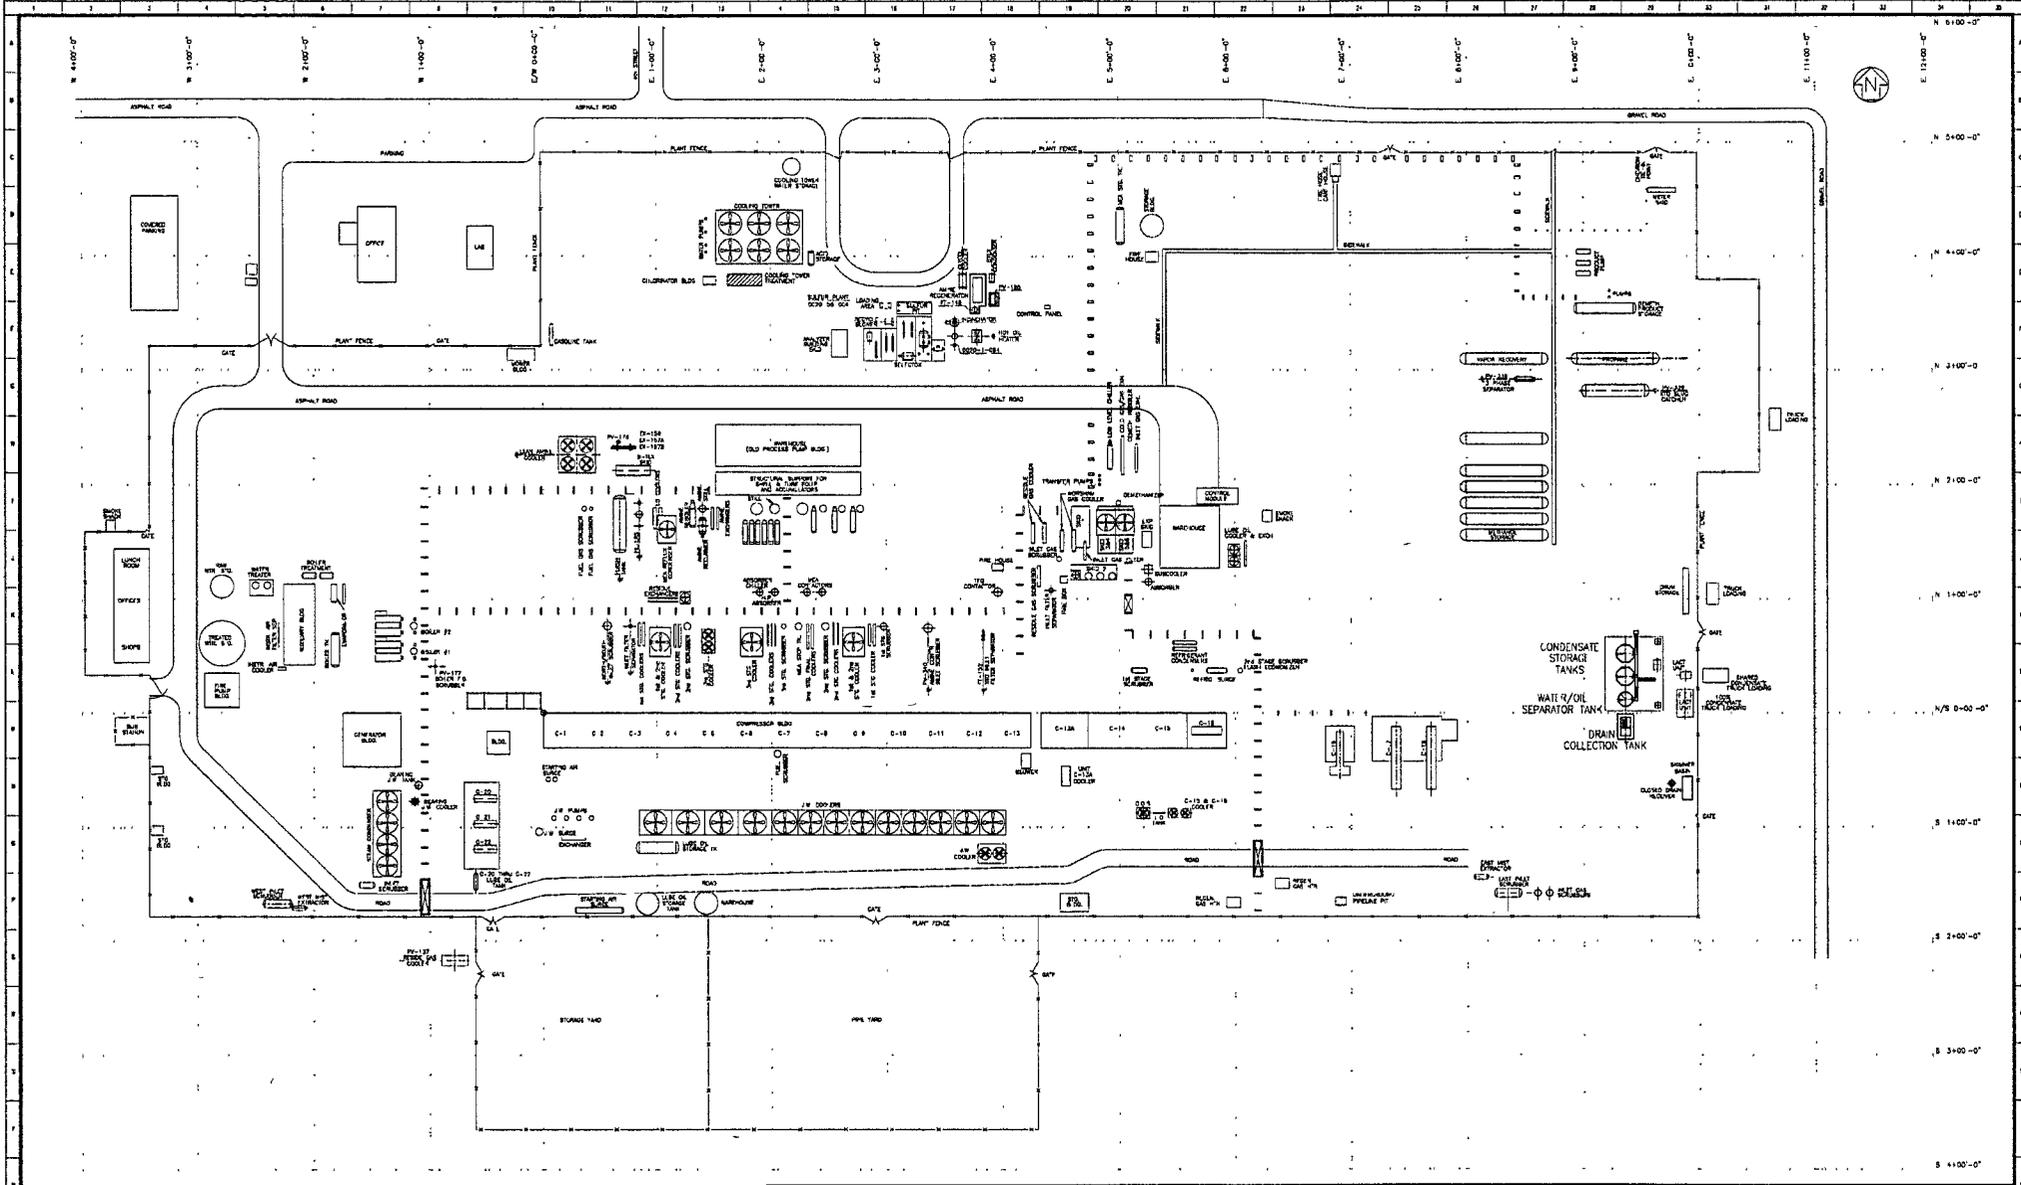
DRAWING NUMBER	161-100-E
CO. P.L. NAME	EUNICE
REVISION	11

REFERENCE DWG	REV	DESCRIPTION	OWN	CHG	DATE	REV	DESCRIPTION	OWN	CHG	DATE	SCALE	1"=33'	DATE
	10	ADDED NEW CONDENSATE STORAGE TANKS	ATN		12/13/05	5	REVISED 3rd STAGE COOLER LOCATION	ATN		3/3/06	OWN BY	DOB	8/98
	9	ADDED AIRLINE REPLACEMENT	ATN		8/11/04	4	REVISED PER FIELD MARKS	ATN		1/18/05	CHG BY		
	8	ADDED EQUIPMENT PV-228, PV340 & FT-152	ATN		3/7/02	3	UPDATED & SHORDED PROPOSED EQUIPMENT RELOCATION	ATN	JE	11/18/98	FINAL	OK	
	7	ADDED UNIT UNIT, PV-224 AIRLINE COOLER & BRU	ATN		8/19/02	2	UPDATE WITH STREET TITLE BLK & DWG NO	US		8/25/98	ENGR.		
	6	REVISED PER FIELD MARKS	ATN		8/20	1	REVISED PER FIELD MARKS	ATN		1/27/98	ATN
