SUMP CLOSURE REPORT

Targa Midstream Services, L.P.

Eunice South Compressor Station

GW-344

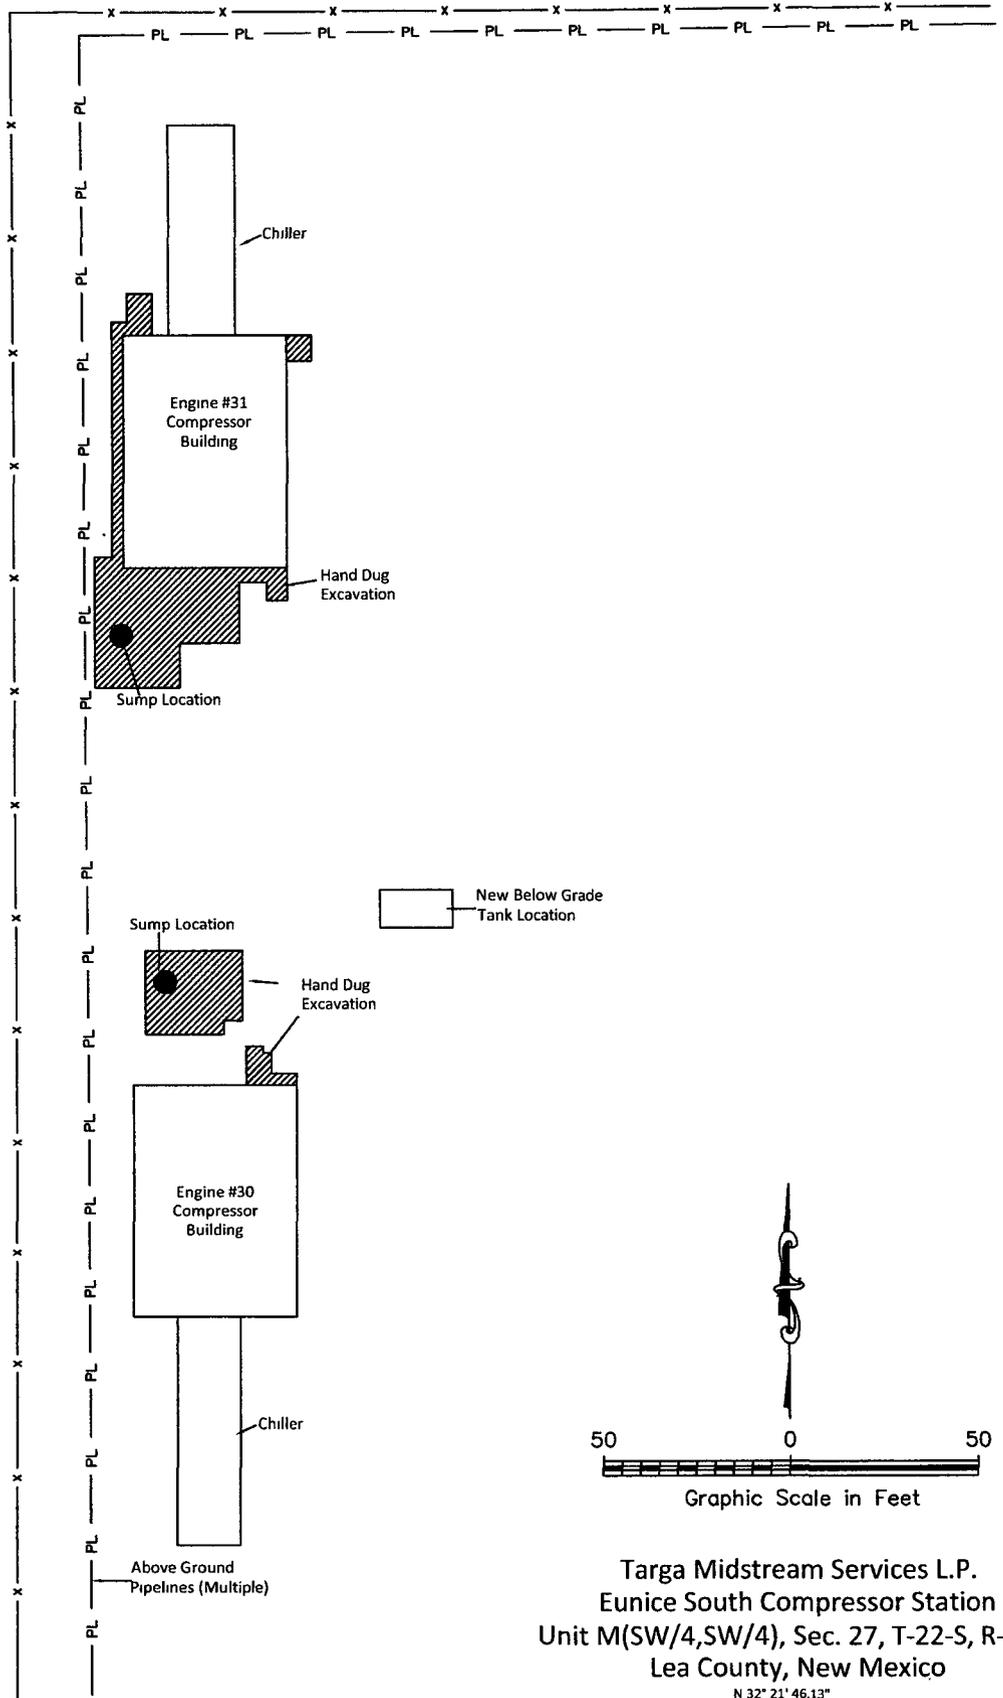
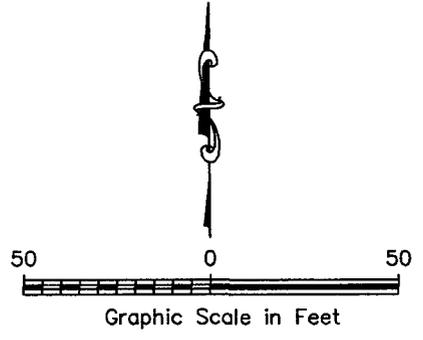
Figure 3 - Sump Location Drawing

Each compressor engine had a concrete drain sump that received natural gas liquids and drips from engine oil that was conveyed via subsurface piping to a central below grade tank located near the east-central area of the gas plant. The Site is located in Unit M (SNW/4, SW/4), Section 11, Township 22 South, Range 37 East, Lea County, New Mexico. The geodetic position is latitude 32.362832° north and longitude 103.159165° west. Figure 1 presents a location and topographic map. Figure 2 presents a Site drawing.

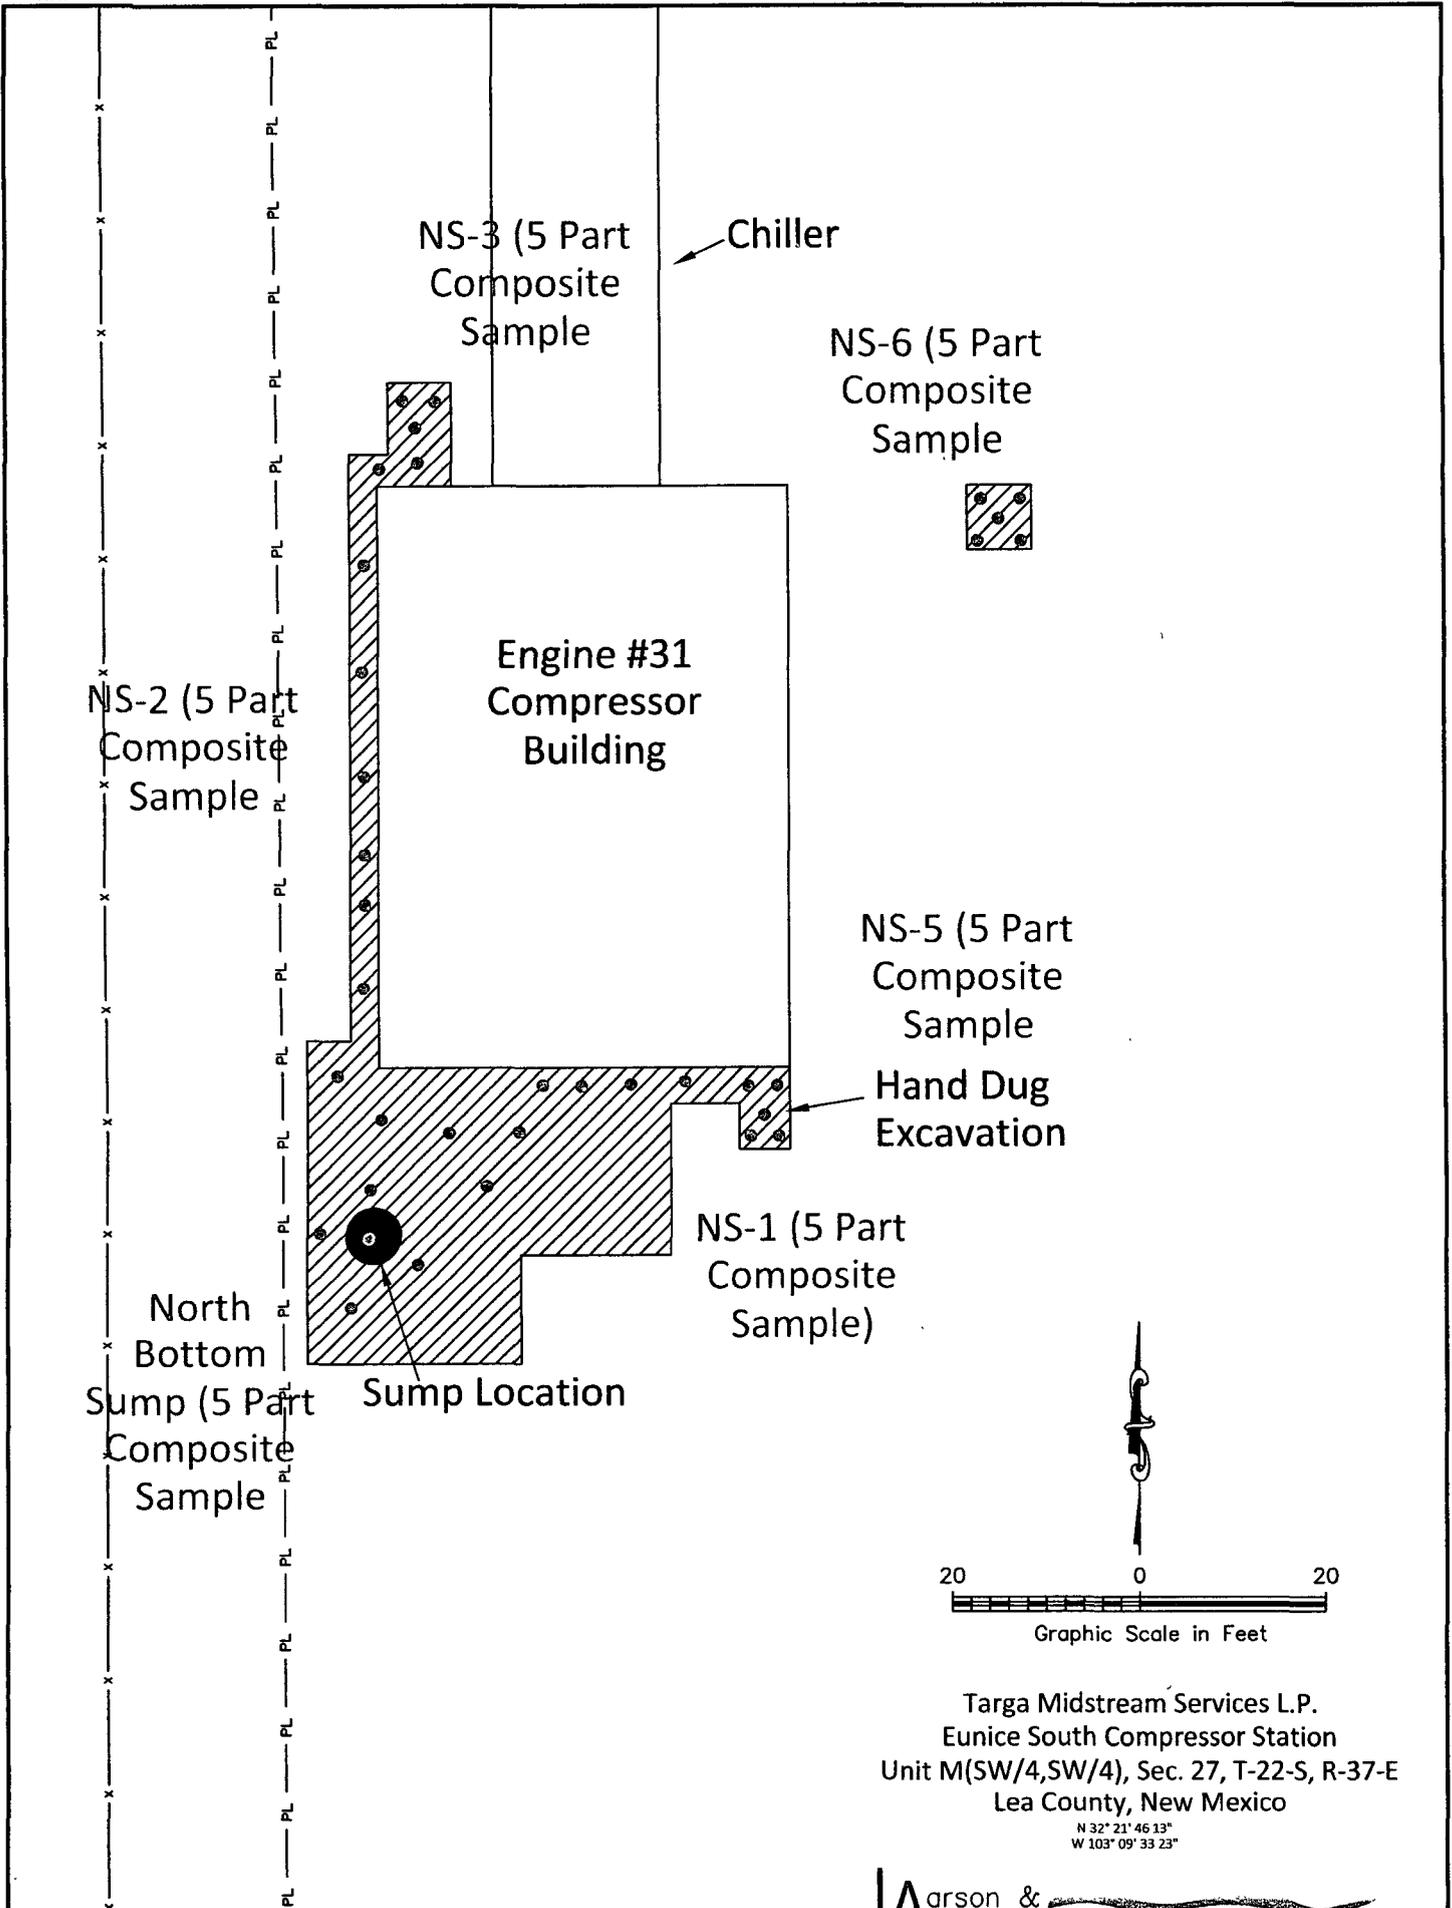
Figure 5 - Engine #31 Sample Locations

On April 23, 2010, LAI personnel collected a grab sample from approximately 3 feet below ground surface (bgs) on the south side wall of the Engine #30 (south) sump excavation (SS-1A) and north side of the Engine #31 (north) compressor building (NS-5A). The samples were analyzed for TPH by methods 418.1 and SW-8015 (DRO and GRO). TPH (418.1) was reported at 80,100 mg/kg (SS-1A) and 10,600 mg/kg (10,600 mg/kg). TPH (SW-8015) was 28,410 mg/kg (SS-1A) and 2,412.8 mg/kg (NS-5A).

The bottom samples demonstrate that the vertical extent of the impact has been defined but no further lateral exaction was possible at locations SS-1 and NS-5 due to interference from building foundations and subsurface piping.

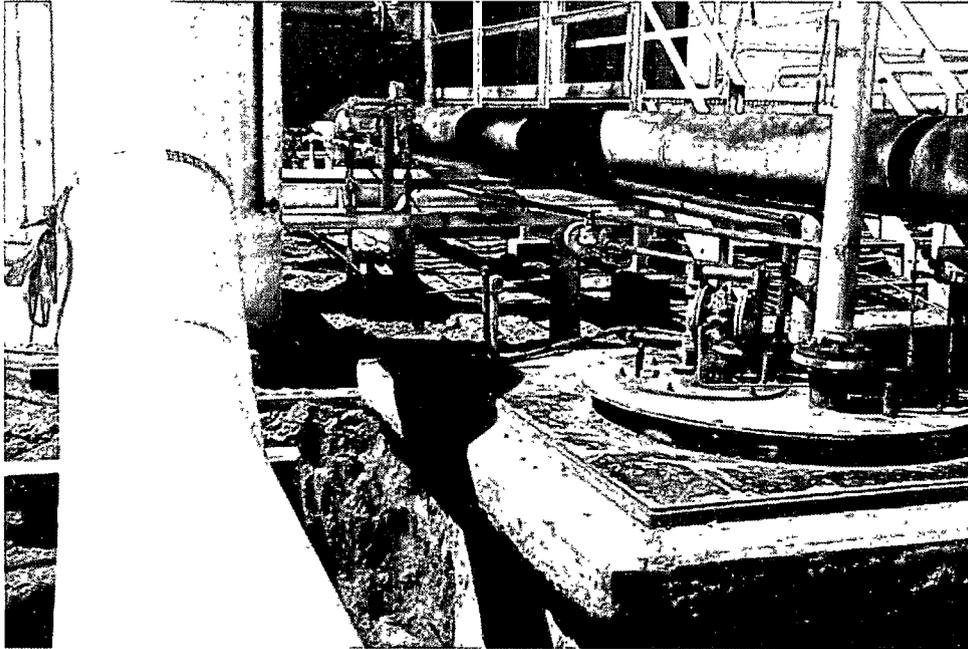
Engine #30 (South) Sump Prior to Removal Looking Southwest

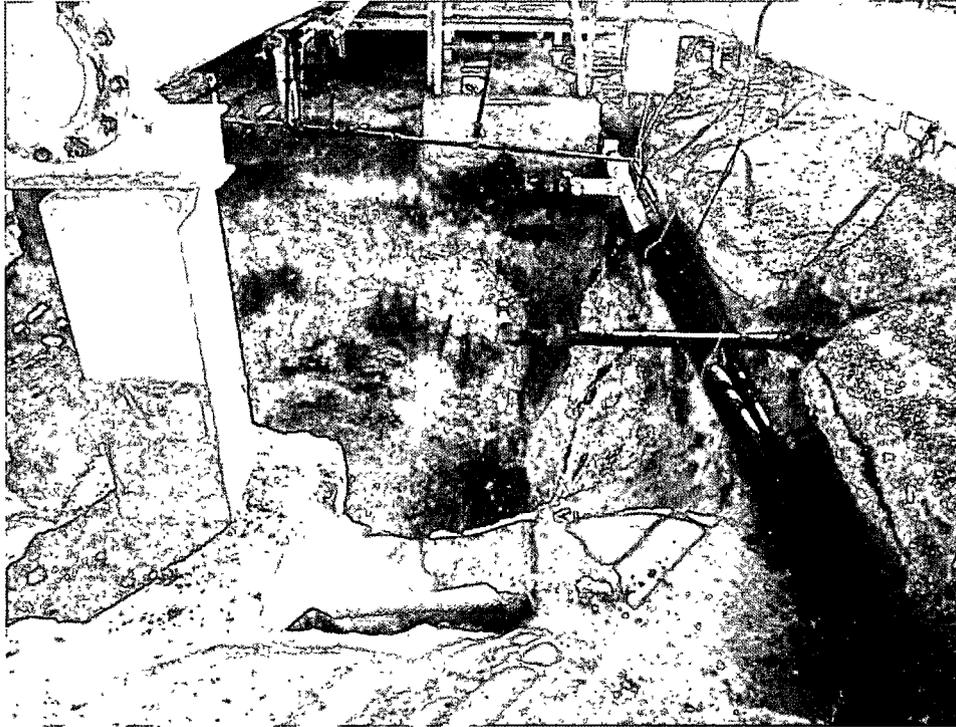
Engine #30 (South) Sump Following Removal Looking South

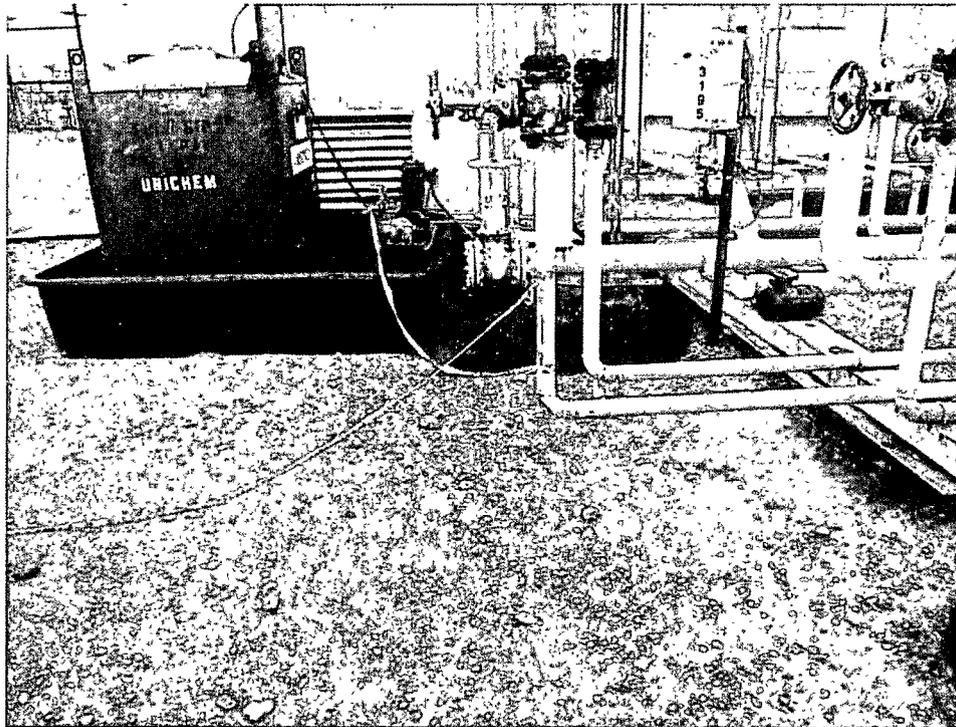
Engine #30 (South) Sump Soil Excavation Looking South

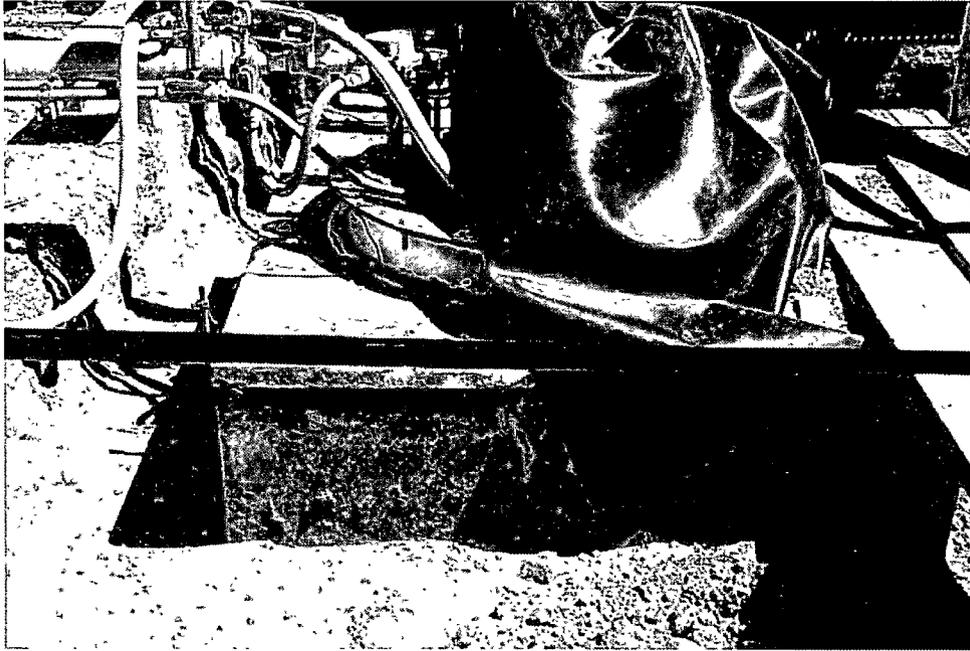
Engine #31 (North) Sump Prior to Removal Looking North

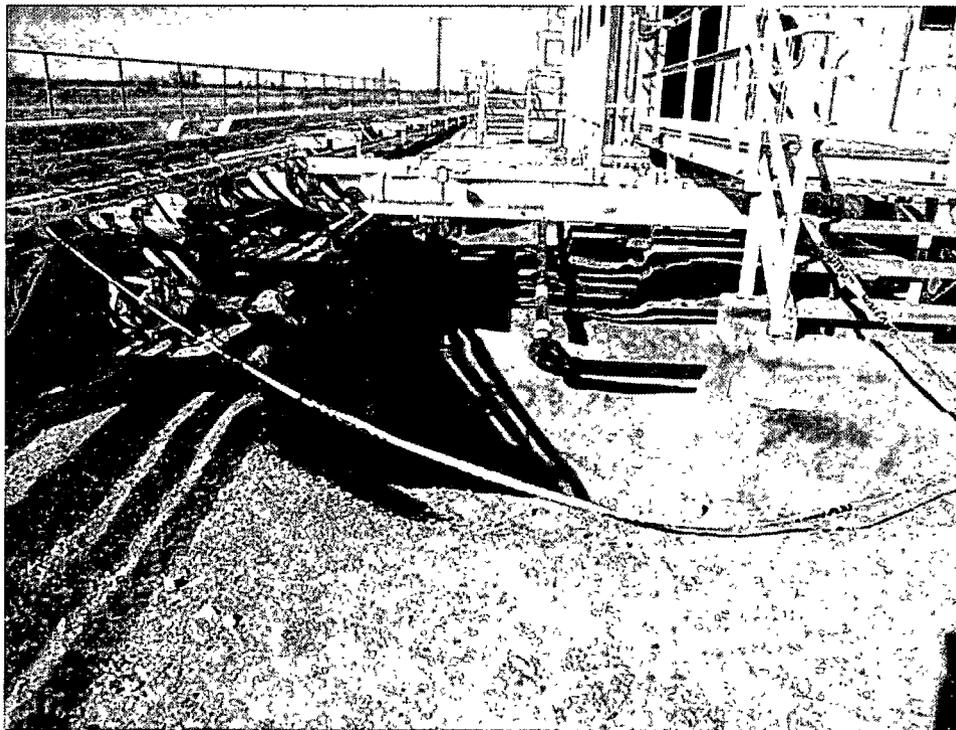
Engine #31 (North) Sump Following Removal Looking North

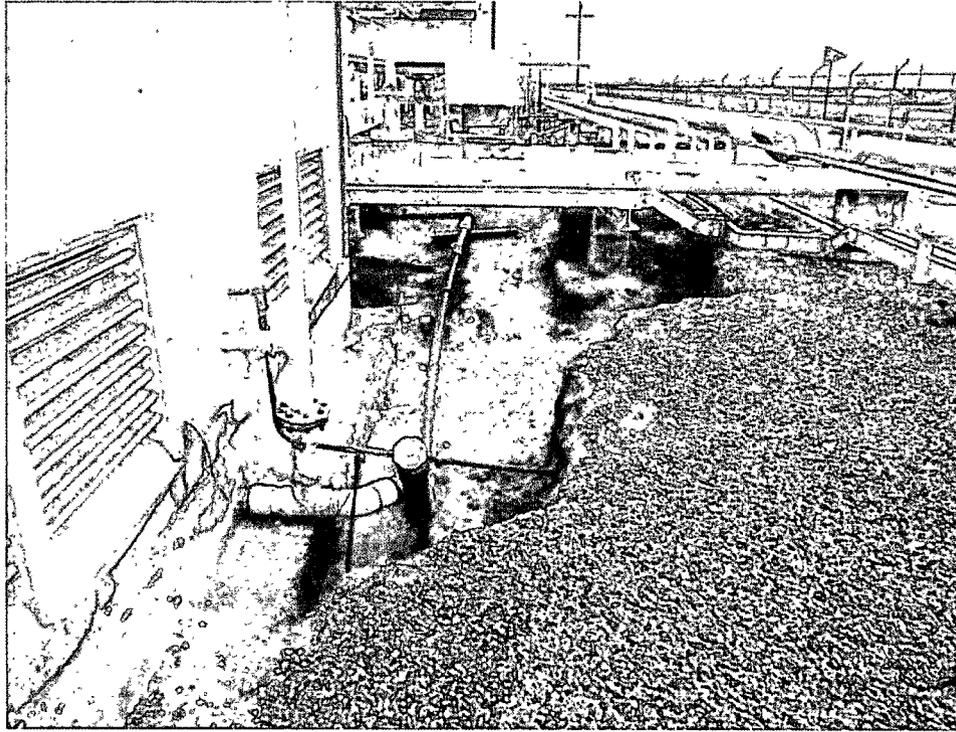
Engine #31 (North) Sump Following Removal and Soil Excavation Looking South

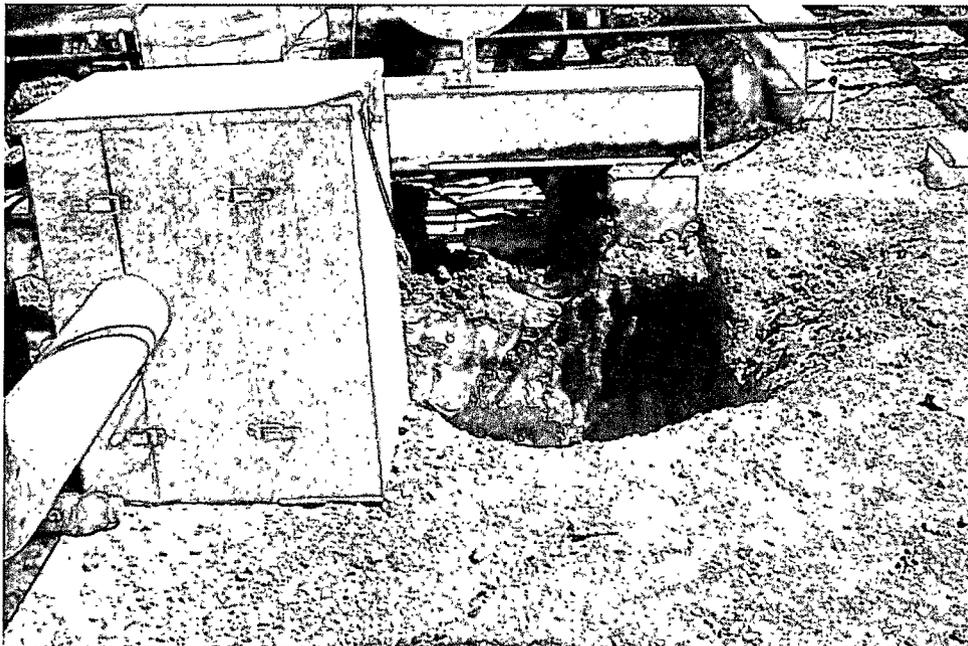
Engine #31 (North) Sump Soil Excavation Looking West

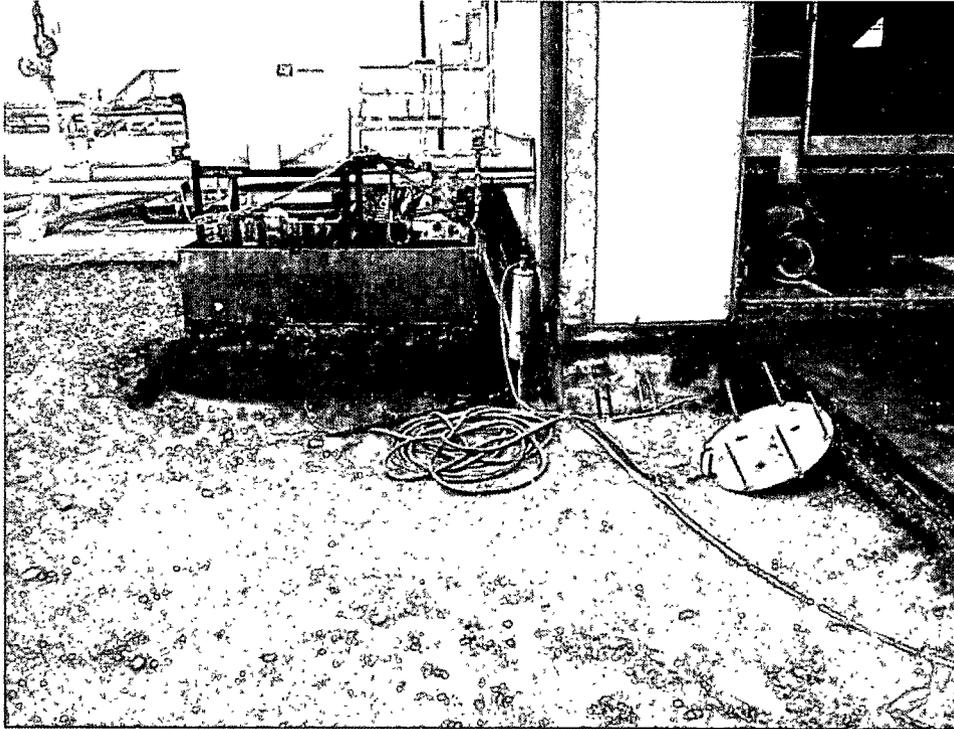
Engine #31 (North) Foundation Soil Excavation (South Side) Looking West

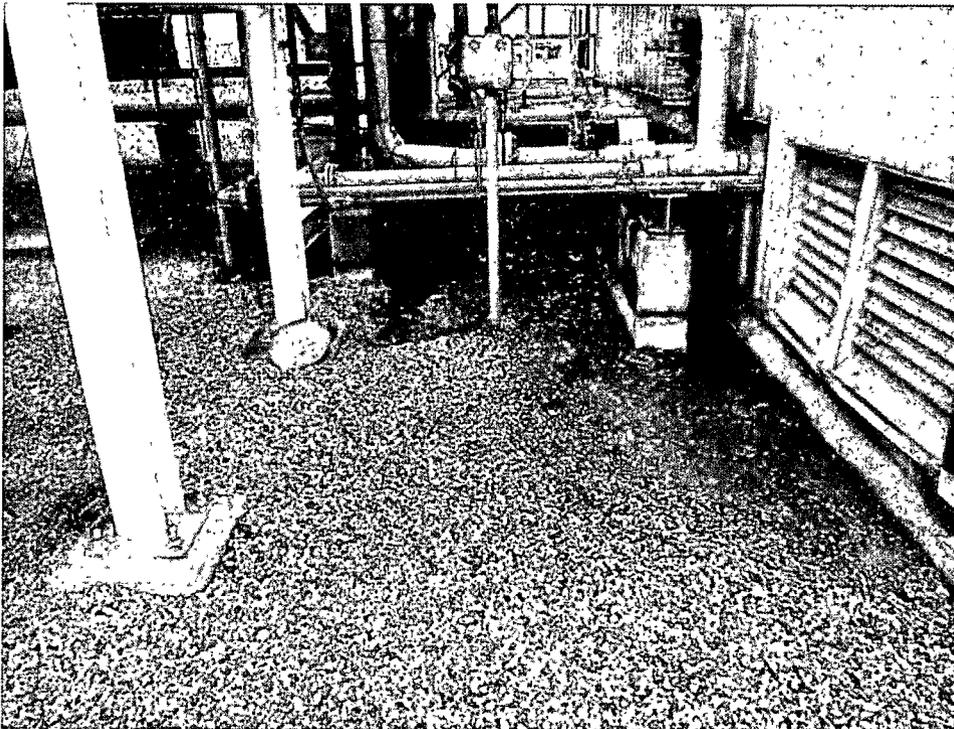
Engine #31 (North) Foundation Soil Excavation (North Side) Looking East

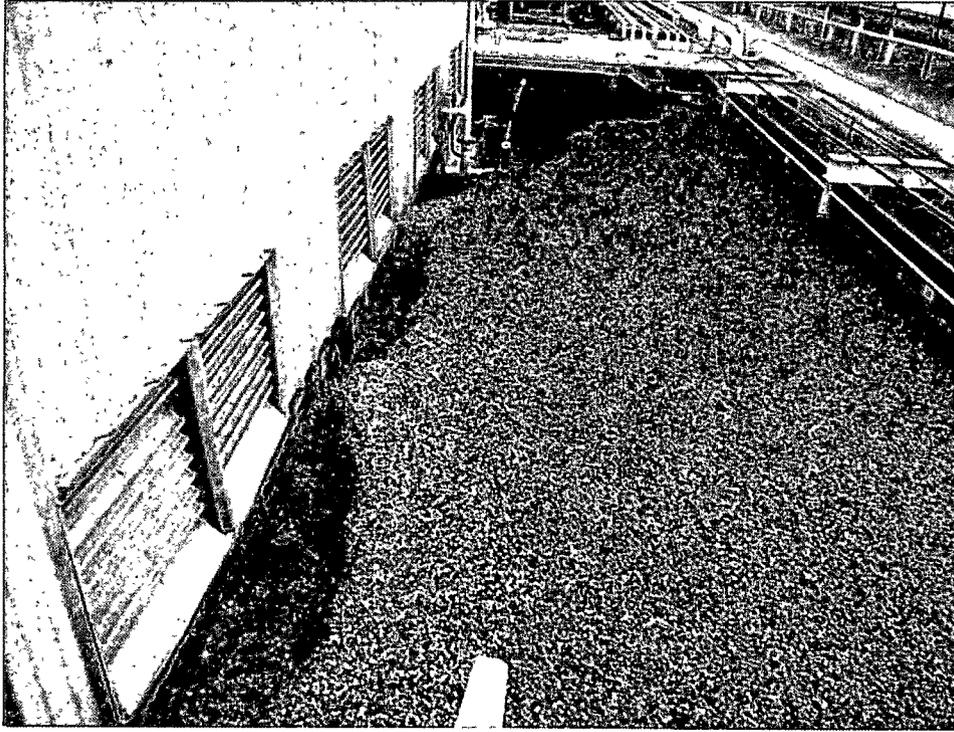
Engine #31 (North) Sump Following Removal and Soil Excavation Looking South

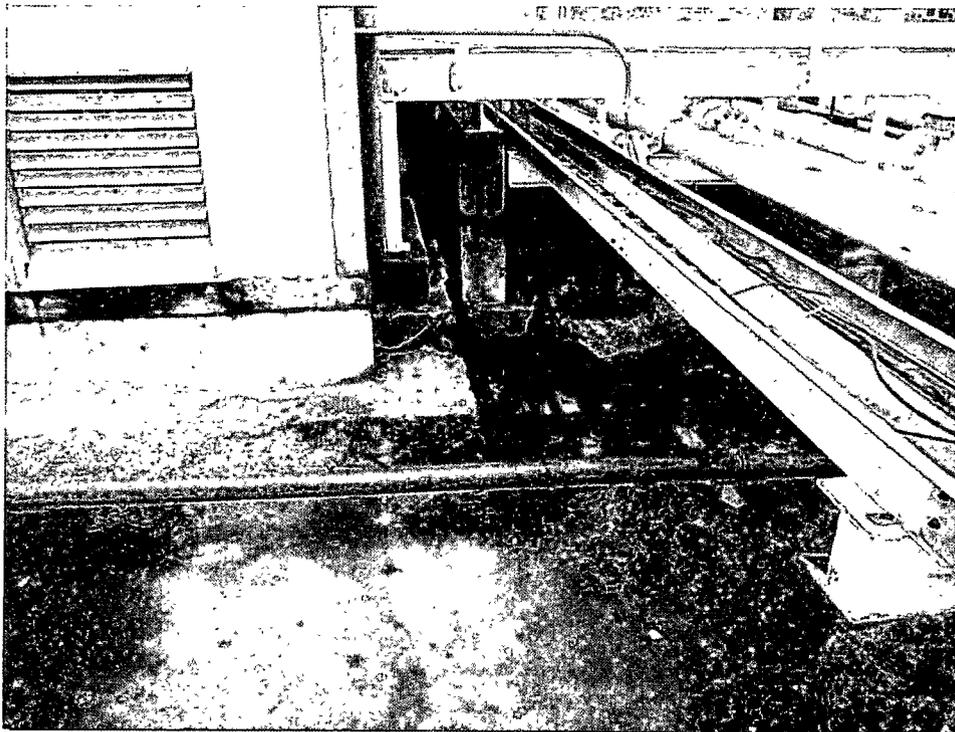
Engine #31 (North) Sump Following Removal and Soil Excavation Looking West

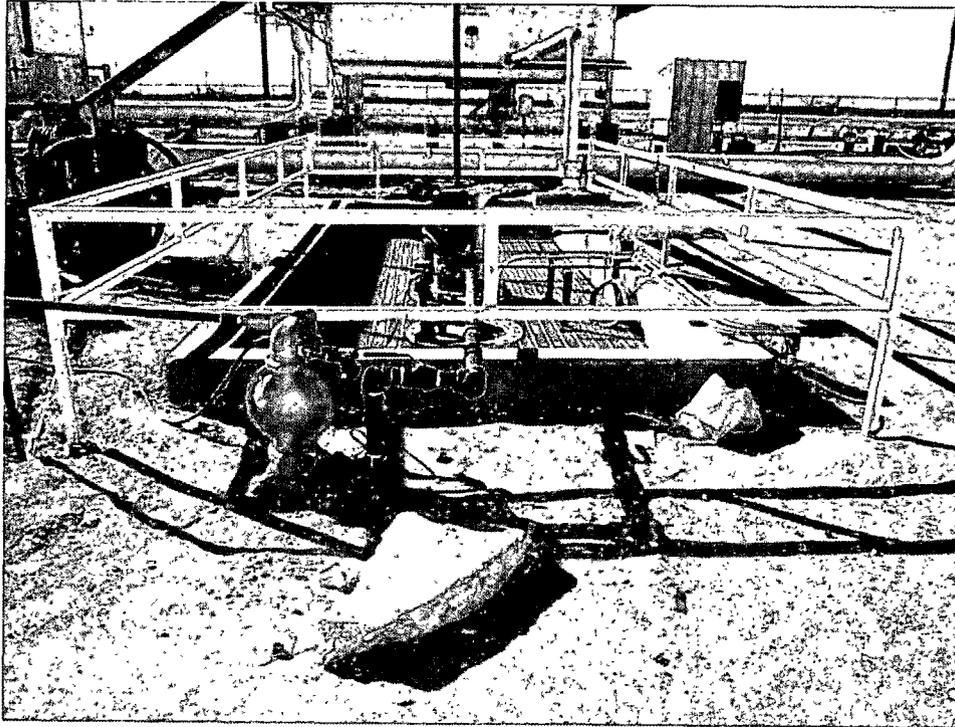
New Below Grade Tank Looking East

Describe Area Affected and Cleanup Action Taken.*
Sumps were removed and replaced by a single below-grade tank meeting standards of NMAC 19.15.17. Impacted soil was hand excavated to the extent possible with consideration for foundations and employee safety. Final bottom samples (5-part composite) were below regulatory level of 1,000 mg/Kg for TPH by method SW-8015 (DRO and GRO) and chloride action level of 250 mg/Kg.

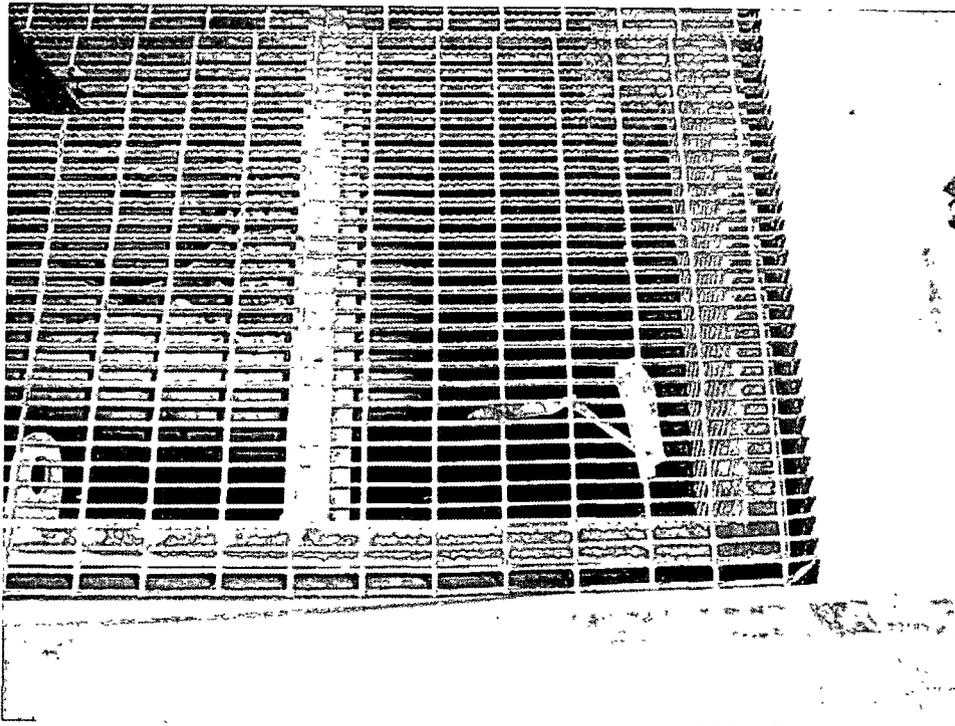
New Below Grade Tank

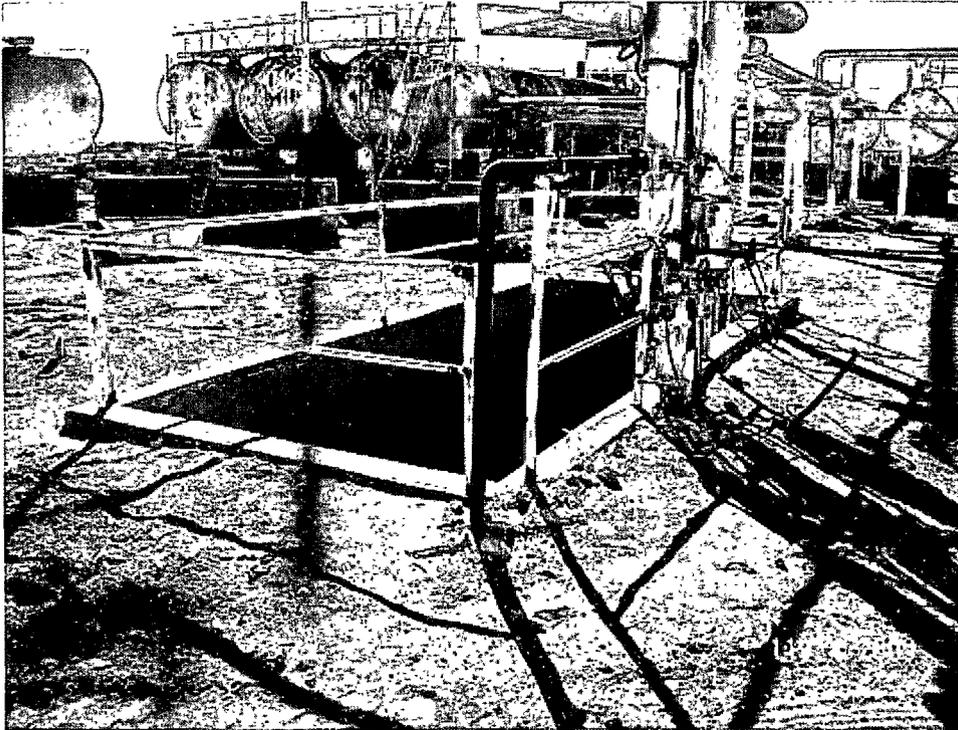
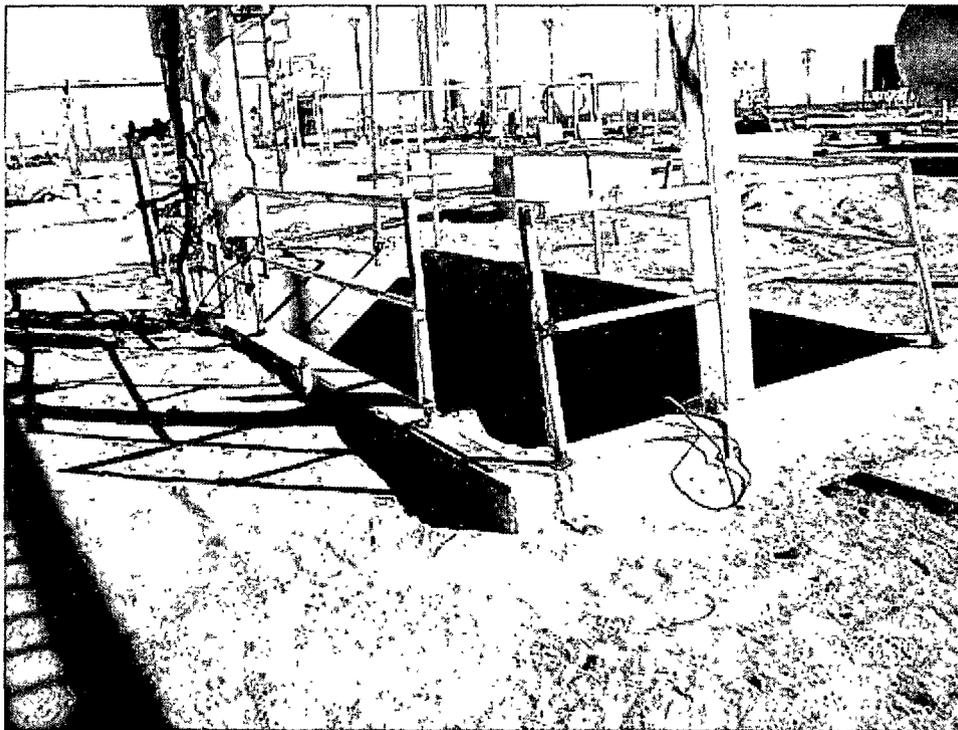
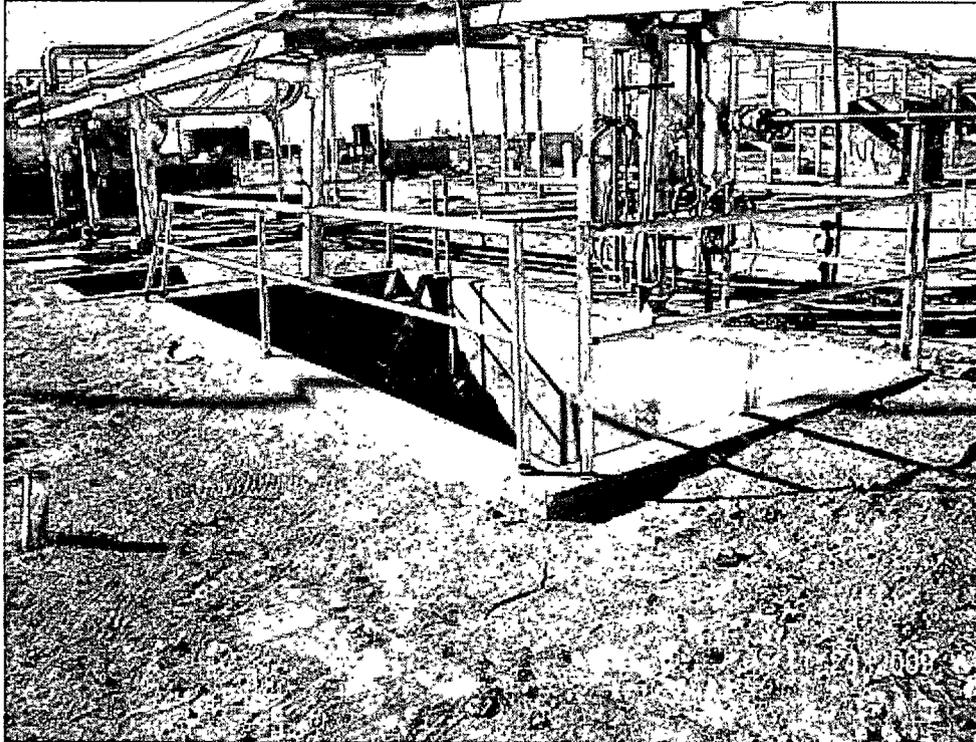
On November 24, 2009, the concrete of the containment at the former below grade tank location near the east central area of the plant was inspected for cracks after the containment was cleaned. No cracks were observed in the bottom or sidewalls of the containment. Appendix B presents photo documentation. Appendix C presents the initial and final C-141.

Old Below Grade Tank Containment Looking Southeast

Old Below Grade Tank Containment Looking Northeast

Old Below Grade Tank Containment Looking Southwest

Based on the documented activities performed at the site, LAI requests approval to close the sump excavations and concrete containment. The sump excavations will be closed by filling with clean soil. The concrete containment will be closed by collapsing the concrete walls into the containment so that the walls are approximately three (3) feet below ground surface covering with clean soil.

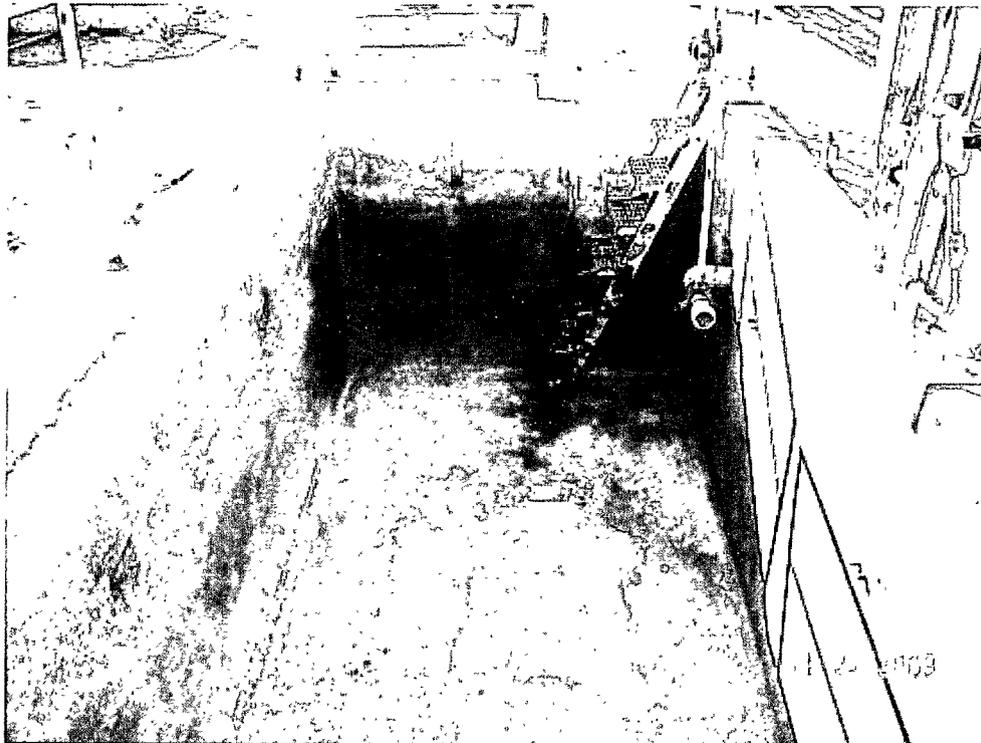
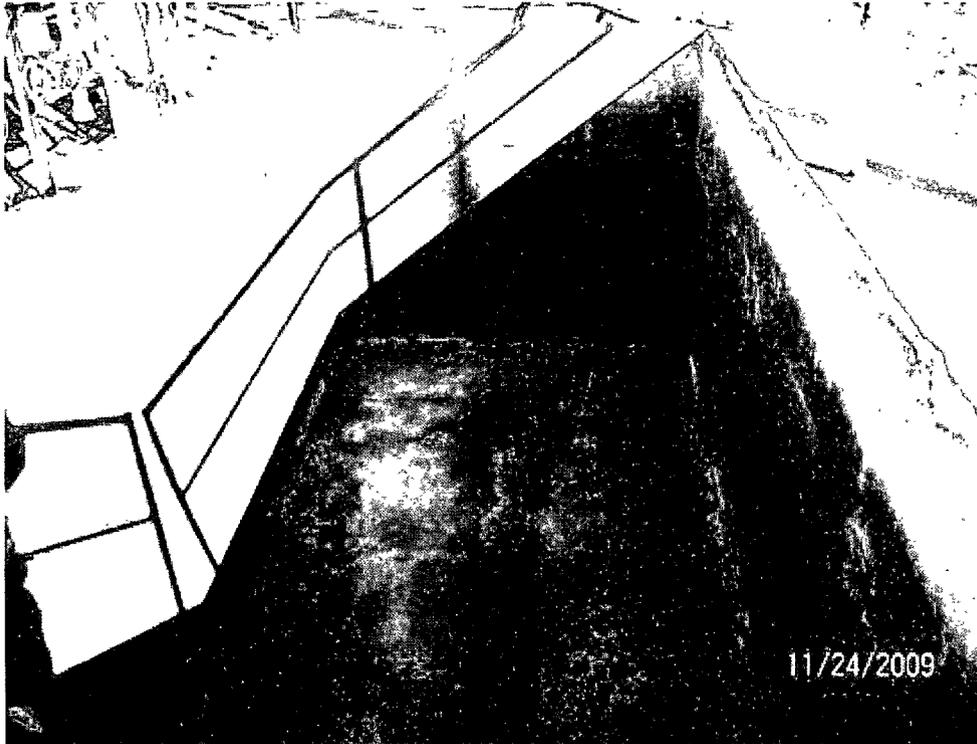
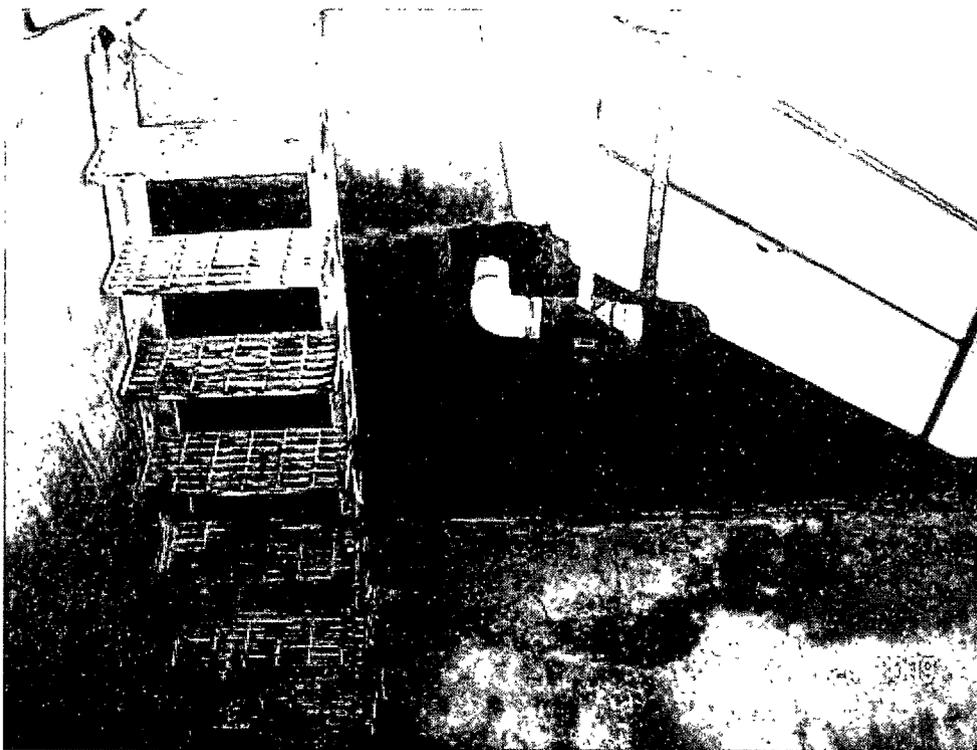
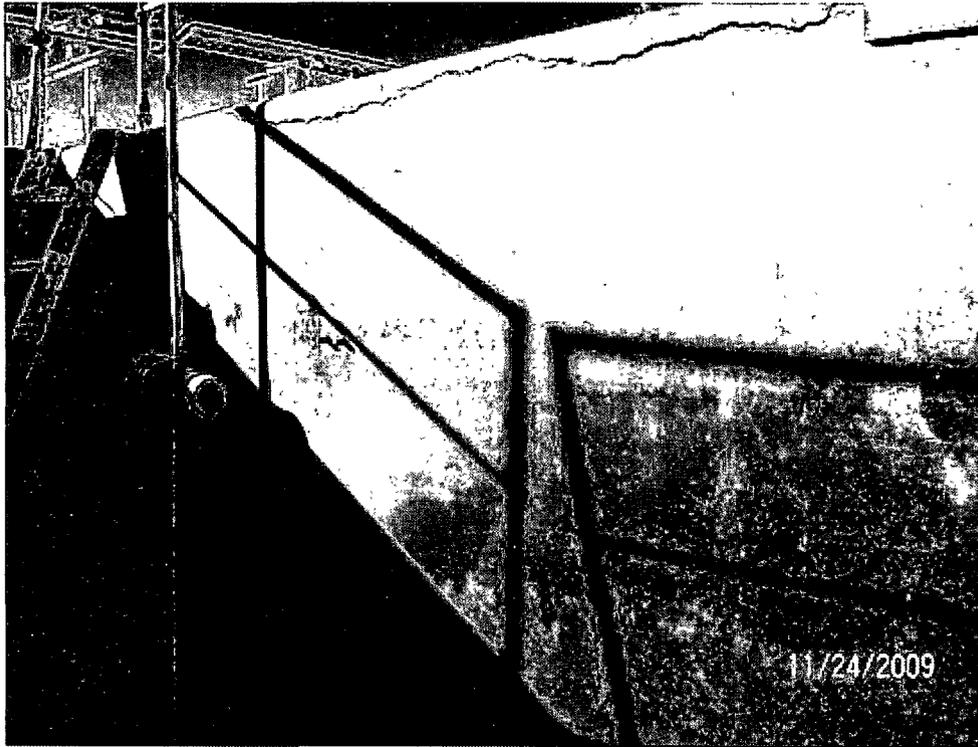
Interior of Old Below Grade Tank Containment Looking South

Interior of Old Below Grade Tank Containment Looking North

Interior of Old Below Grade Tank Containment South End Looking West

Interior of Old Below Grade Tank Containment South End Looking South

Interior of Old Below Grade Tank Containment North End Looking North

Interior of Old Below Grade Tank Containment West Side Looking Northwest

Interior of Old Below Grade Tank Containment East Side Looking Northeast

Interior of Old Below Grade Tank Containment West Side Looking Southwest

Interior of Old Below Grade Tank Containment East Side Looking Southeast
