Release Notification and Corrective Action

**RE: Rice Operating Company**  
**Justis P-2 Leak**  
**INVESTIGATION REPORT AND REMEDIATION WORK PLAN**  
**Unit Letters I & P, Sec. 2, T25S, R37E**  
**Lea County, New Mexico**

## Justis P-2 leak

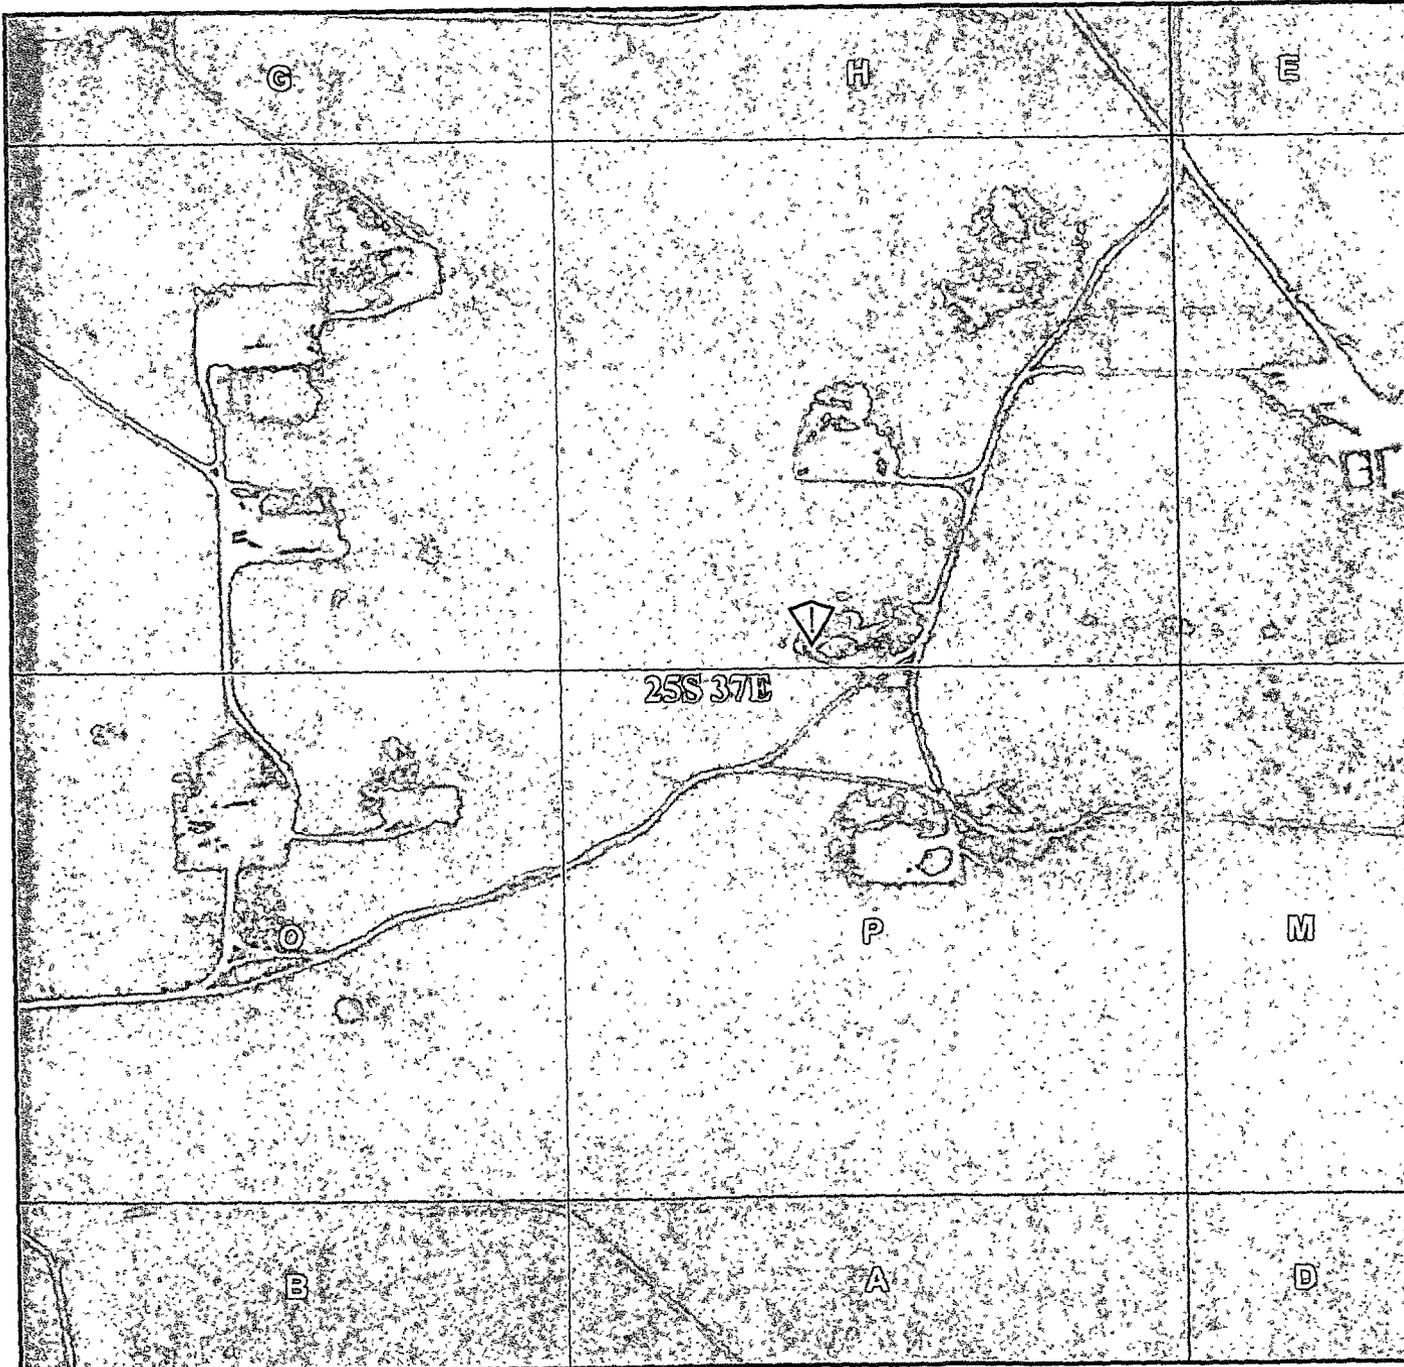
FIGURE 1

# Location of site

The site is located approximately 5 miles northeast of Jal, New Mexico in Unit Letters I & P, Sec. 2, T25S, R37E as shown on the Site Location Map (Figure 1). NM OSE records indicated that groundwater would likely be encountered at a depth of approximately 83 feet.

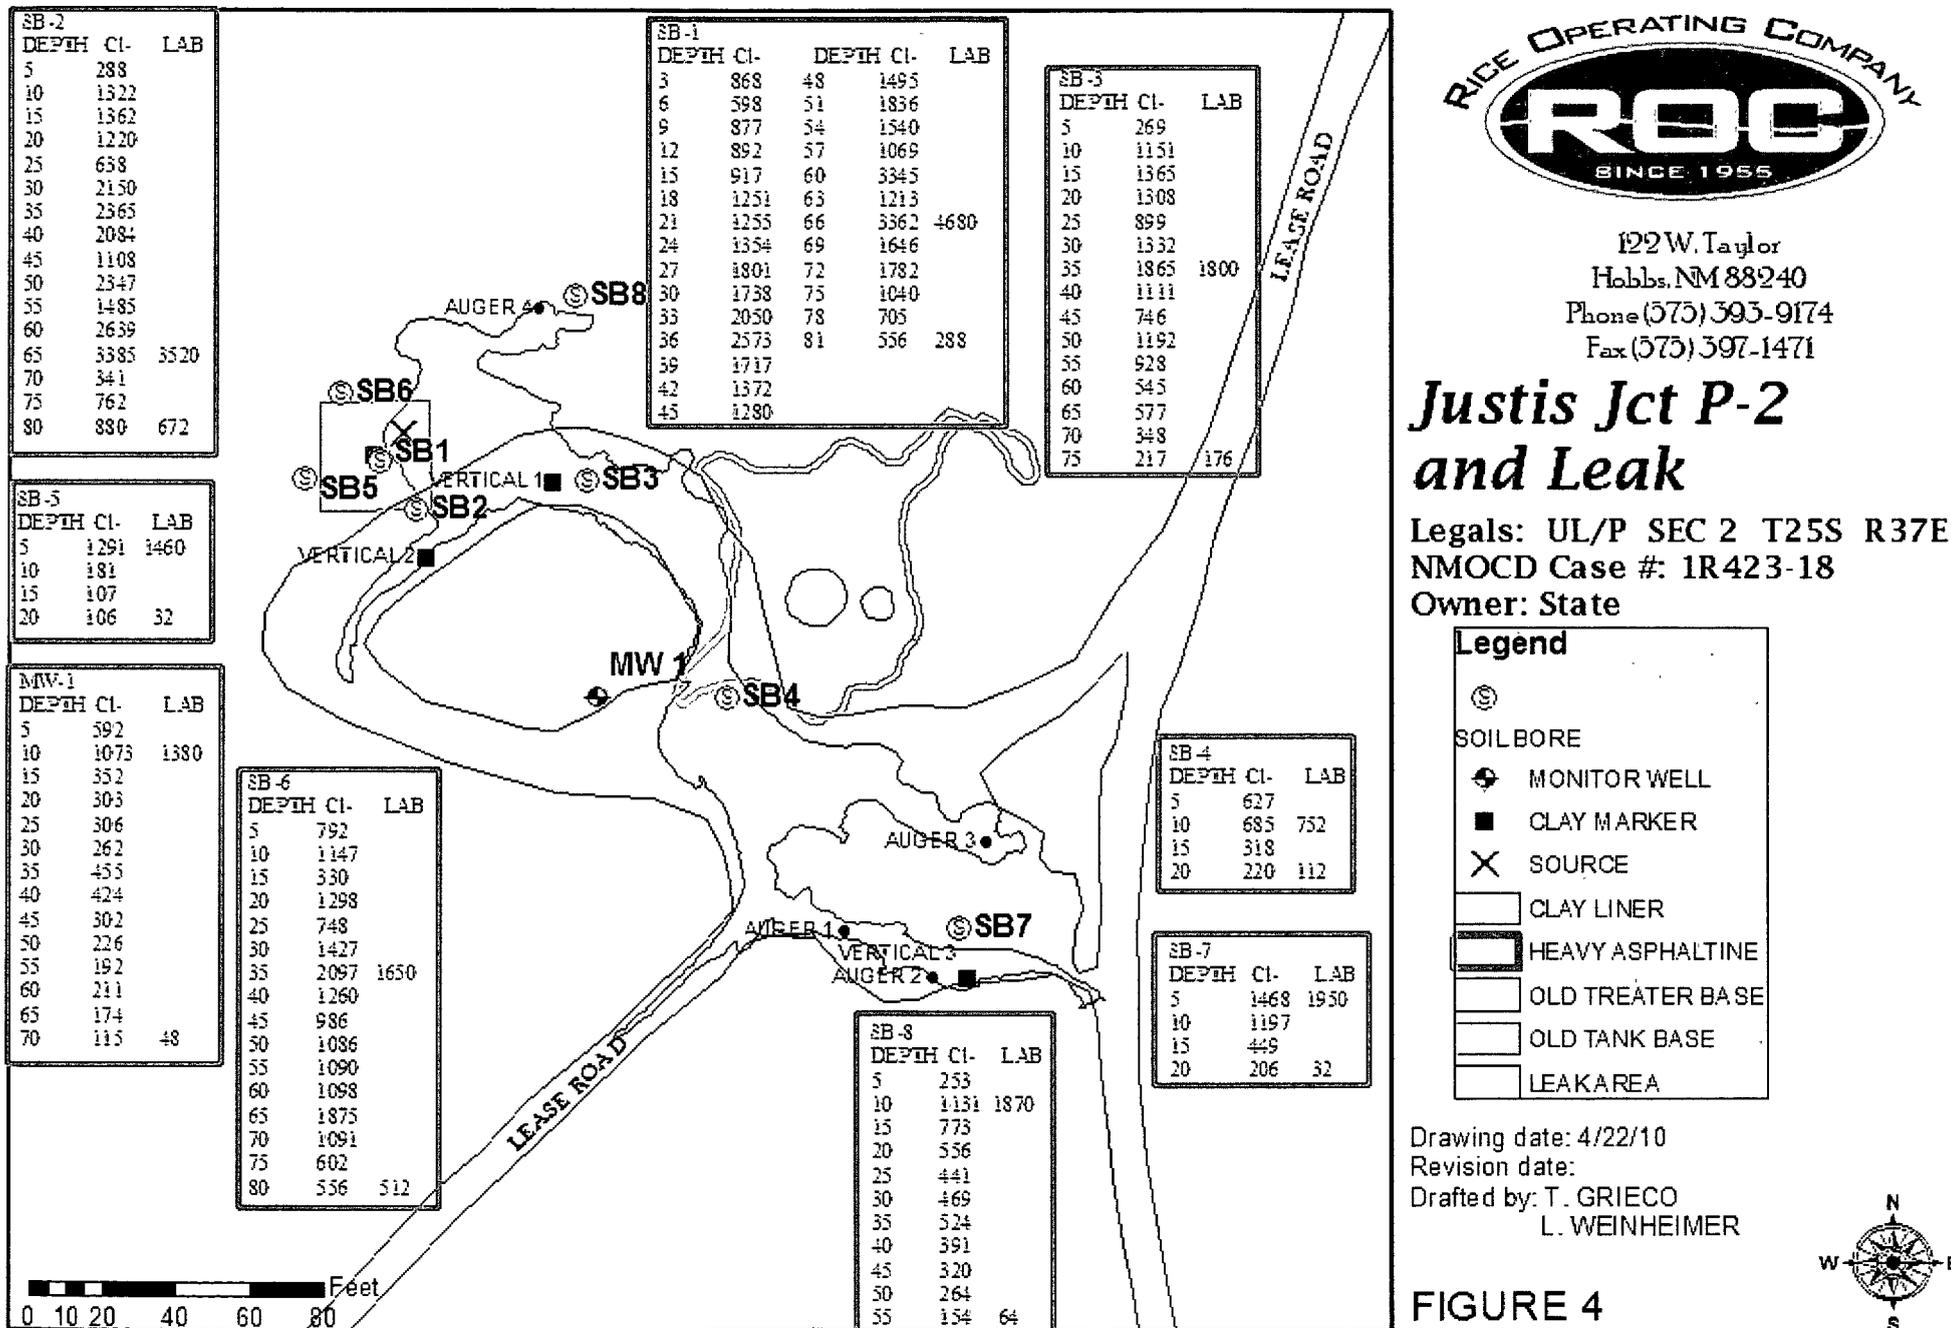
**Figure 3**

VERTICAL #1	DEPTH	CI (PPM)
1 FT		3701
1 FT (LAB)		3520
2 FT		3089
2 FT (LAB)		4200
3 FT		1709
4 FT		542
5 FT		515
6 FT		423
7 FT		1285
7 FT (LAB)		2000

VERTICAL #2	DEPTH	CI (PPM)
1 FT		1173
1 FT (LAB)		1360
2 FT		1328
2 FT (LAB)		1780
3 FT		486
4 FT		990
5 FT		1070
6 FT		1080
7 FT		1023
7 FT (LAB)		1470

VERTICAL #3	DEPTH	CI (PPM)
1 FT		356
1 FT (LAB)		336
2 FT		361
3 FT		415
4 FT		713
4 FT (LAB)		832
5 FT		471
6 FT		480
7 FT		423
7 FT (LAB)		544

# Location of soil bores and monitor wells

In order to assess the horizontal and vertical limits of the spill, ROC installed seven (7) soil borings (SB-2 through SB-8) and one (1) monitoring well (MW-1) at the site on March 15, 16 and 17, 2010. The borings and monitoring well were installed using an air rotary drilling rig operated by Harrison & Cooper, Inc., of Lubbock, Texas.

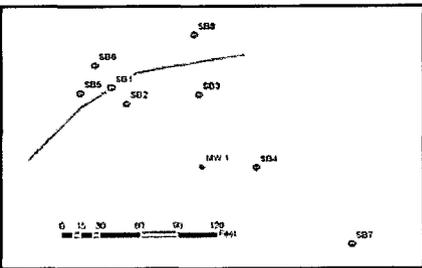
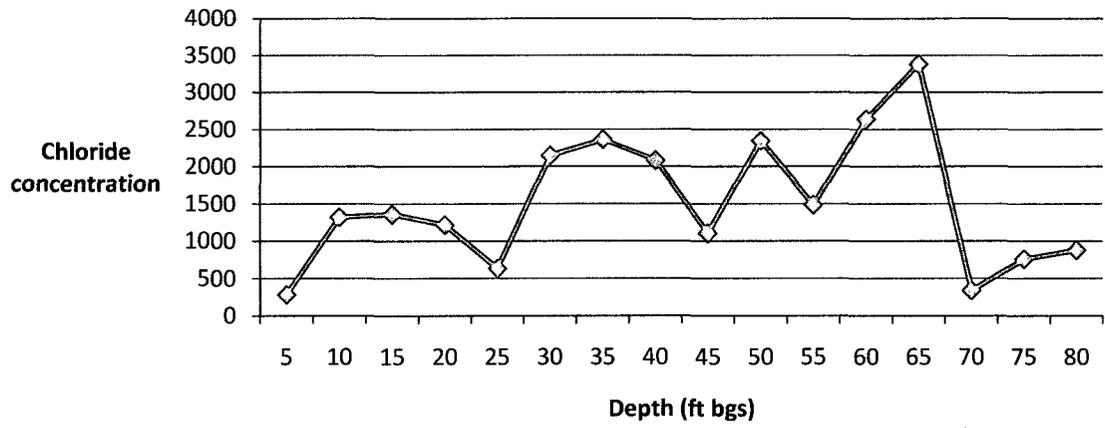
**Project Name:** Justis jct. P-2 and leak  
**Well ID:** SB-2  
**Location:** UL/P sec. 2 T25S R37E  
**Lat:** 32°9'21.353"N      **County:** Lea  
**Long:** 103°7'39.481" W      **State:** NM

**Comments:** Split spoon sampling through 20 ft. All others were from cuttings. Located 19 ft SE of former junction box site.  
 Drafted by: Lara Weinheimer  
 TD = 80 ft      GW = 77 ft

Depth (feet)	chloride field tests (ppm)	LAB	PID	Description	Lithology	Bore Construction
40	2084		0.9	37 - 80 ft SILTY SAND; FINE SAND light to dark red, well sorted, loose, dry, no odor

45	1108		0.8			
50	2347		0.9			
55	1485		0.3			
60	2639		0.3			
65	3385	Cl- 3520 GRO <10.0 DRO <10.0	0.4			
70	341		0.2			
75	762		0.1			
80	880	Cl- 672 GRO <10.0 DRO <10.0	0

### Chloride concentration versus depth

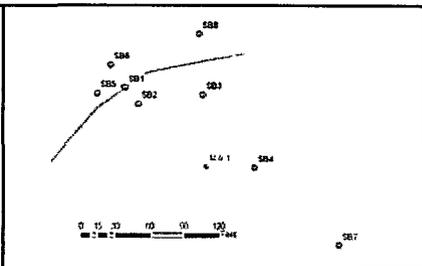
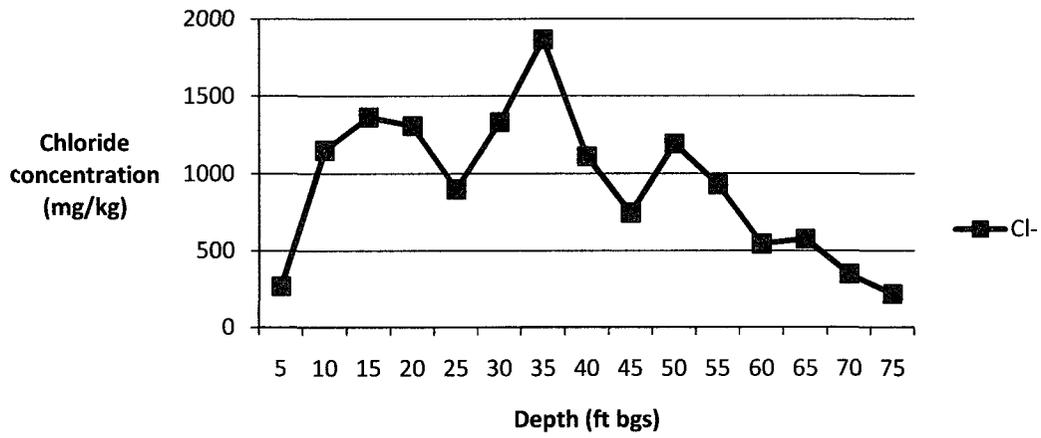
**Project Name:** Justis jct. P-2 and leak  
**Well ID:** SB-3  
**Location:** UL/P sec. 2 T25S R37E  
**Lat:** 32°9'21.428"N      **County:** Lea  
**Long:** 103°7'39.927" W      **State:** NM

**Comments:** Split spoon sampling through 20 ft. All others were from cuttings. Located 60 ft E of former junction box site.  
 Drafted by: Lara Weinheimer  
 TD = 75 ft      GW = 77 ft

Depth (feet)	chloride field tests (ppm)	LAB	PID	Description	Lithology	Bore Construction
				28.5 - 37 ft		
35	1865	Cl-1800		SILTY SAND; FINE SAND; SANDSTONE		
		GRO <10.0		tan, moderately well sorted, dry, no odor		
		DRO <10.0				
40	1111					
				37 - 53 ft		
45	746			SILTY SAND; FINE SAND		
				light red, well sorted, loose, dry, no odor		
50	1192					
55	928					
				53 - 75 ft		
60	545			FINE SAND		
				light tan to light red, well sorted, loose, dry, no odor		
65	577					
70	348					
75	217	Cl-176				
		GRO <10.0				
		DRO <10.0

### Chloride concentration versus depth

Rice Operating Company proposes to excavate an approximately 25' x 25' area of soil in the vicinity of soil boring SB-3 to a depth of approximately five (5) feet below ground surface (bgs). Soil will be scraped from all other areas of the spill (north and south of the SB-3 location) to a depth of approximately six (6) inches to one (1) foot bgs. The spill area located west of boring SB-3 will be addressed in the remediation for the Justis P-2 Vent. All scraped soil will be hauled to an NMOCD approved disposal facility.

A 20 mil plastic liner will be installed at a depth of five (5) feet bgs in the excavation surrounding boring SB-3, and the excavation will be backfilled with blended soil to a depth of one (1) foot bgs. In order to promote successful revegetation of the site, additional clean soil will be blended with organic materials (ex.- hay or cotton gin) and used to backfill the upper one (1) foot of the SB-3 excavation and all other excavated areas. All backfilled areas will be graded to surface and re-seeded to achieve native conditions. ROC will submit a final report to the NMOCD following completion of the proposed remediation activities, and will submit a final C141 for closure at that time.

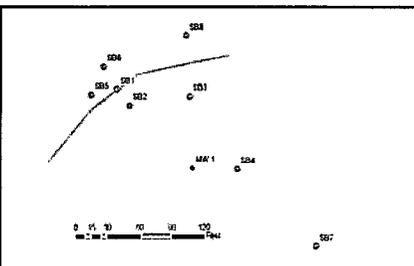
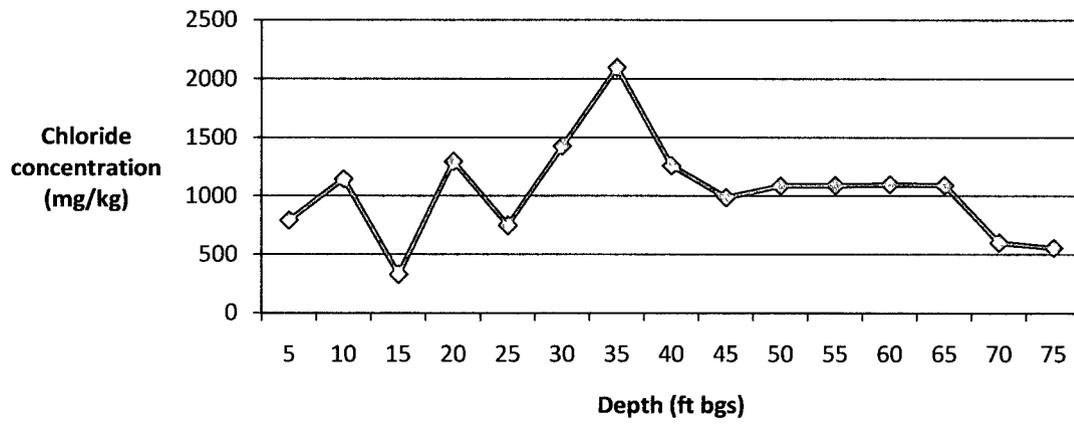
**Project Name:** Justis jct. P-2 and leak  
**Well ID:** SB-6  
**Location:** UL/P sec. 2 T25S R37E  
**Lat:** 32°9'21.672"N      **County:** Lea  
**Long:** 103°7'39.72" W      **State:** NM

**Comments:** Split spoon sampling through 5, 10, and 20 ft. All others from cuttings. Located 20 ft N of former junction box site.  
**Drafted by:** Lara Weinheimer  
 TD = 80 ft      GW = 77 ft

70	1091							
75	602						<p>70 - 80 ft</p> <p>FINE SAND</p> <p>red, well sorted, loose, dry, no odor</p>	
80	556	CI-512						
		GRO <10.0						
		DRO <10.0

## Chloride concentration versus depth

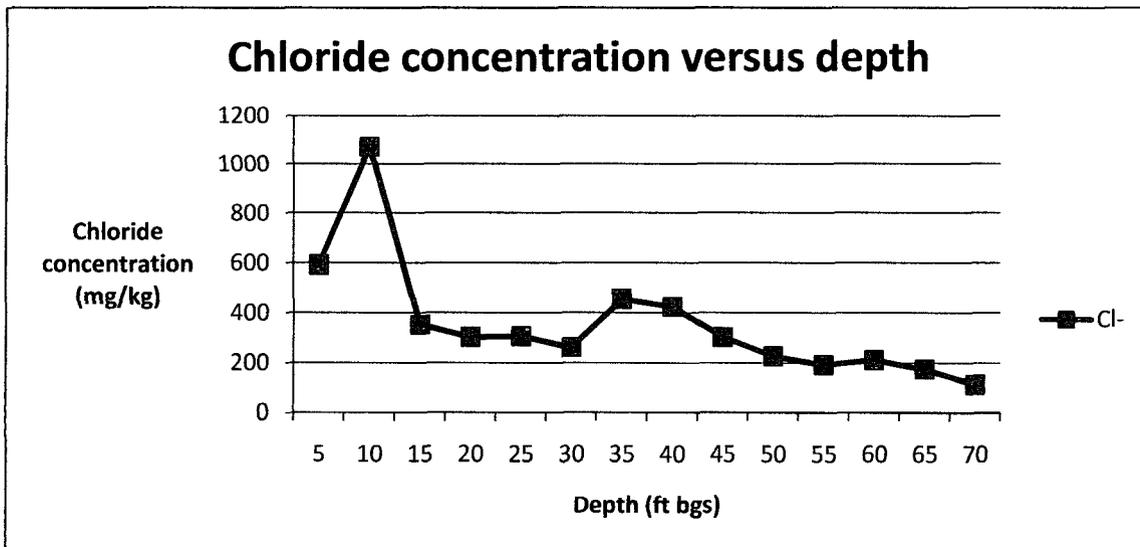
<b>Comments:</b>	Split spoon sampling through 20 ft. All others from cuttings. Located 90 ft SE of former junction box site.	<b>Project Name:</b>	Justis jct. P-2 and leak	<b>Well ID:</b>	MW-1
		<b>Location:</b>	UL/P sec. 2 T25S R37E	<b>County:</b>	LEA
		<b>Lat:</b>	N32°9'20.84"	<b>State:</b>	NM
		<b>Long:</b>	W103°7'38.898"		
		<b>TD =</b>	87 ft	<b>GW =</b>	77 ft

Depth (feet)	chloride field tests (ppm)	LAB	PID	Description	Lithology	Well Construction
50	226		0.8	44 - 53 ft SILTY SAND; FINE SAND red, well sorted, loose, dry, no odor

60	211		0.8			
65	174		0.8	62 - 70 ft SILTY SAND; FINE SAND red, well sorted, loose, dry, no odor

70	115	Cl- 48	1			
		GRO <10.0				
		DRO <10.0				
75				NO SAMPLES TAKEN		
80						
85

The monitoring well MW-1 was drilled to a depth of approximately 87 feet bgs and constructed with 2-inch diameter schedule 20 PVC casing and screen. Twenty feet of well screen was placed in the well, with approximately 15 feet of screen extending into groundwater, and 5 feet extending above groundwater. Silica sand was placed around the well screen to about 2 feet above the screen. A layer of bentonite pellets, approximately 3 feet thick, was placed over the sand, and hydrated with potable water.

On April 10, 2010, depth to groundwater was measured at 77.46 feet bgs. The well was developed until fine-grained sediments disturbed during drilling were removed, and the water was clear. Approximately 30 gallons of water were removed from the well.

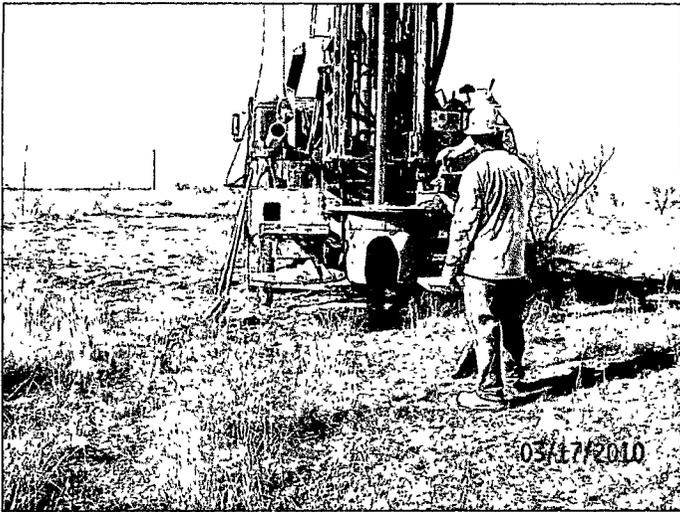
Drilling soil bores

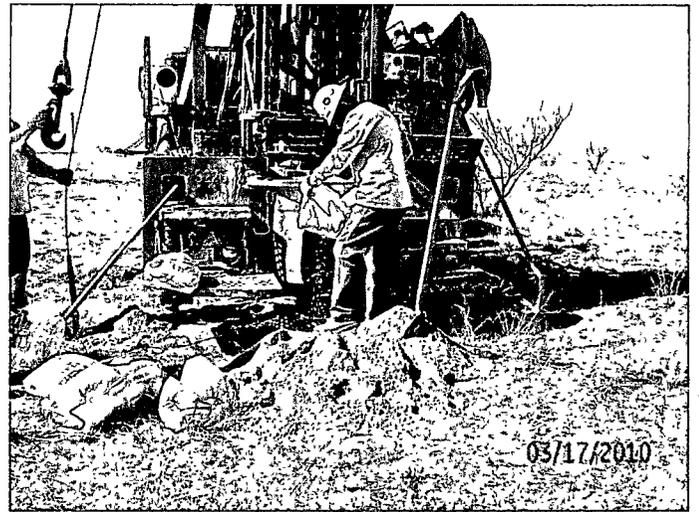
Plugging the soil bore in total with bentonite

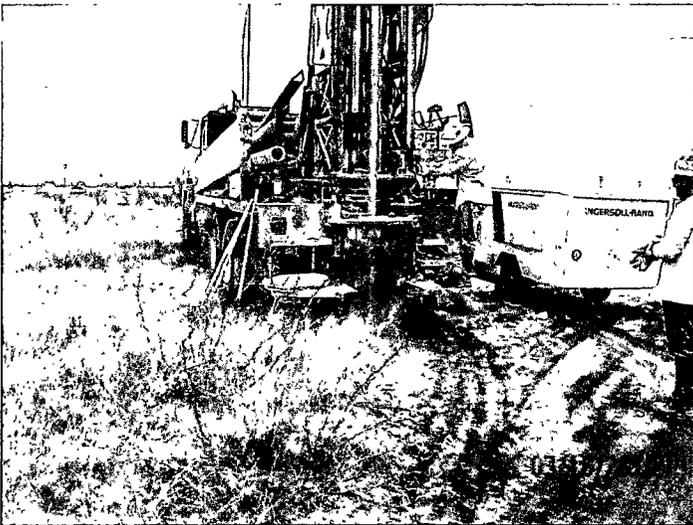
Drilling MW-1

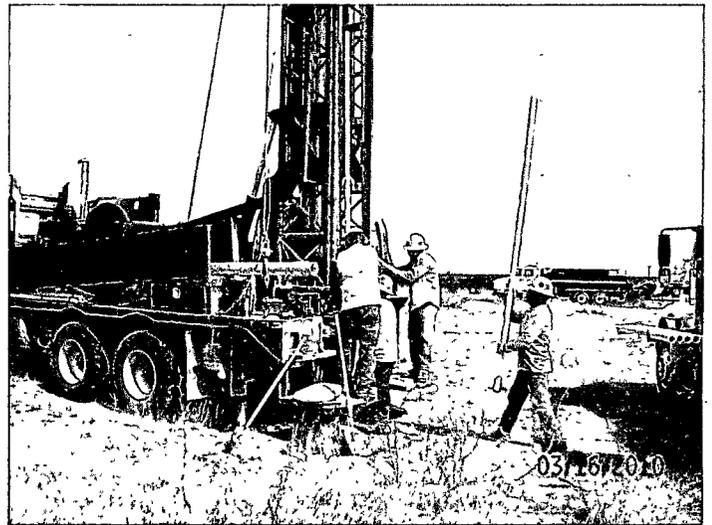
Setting the casing

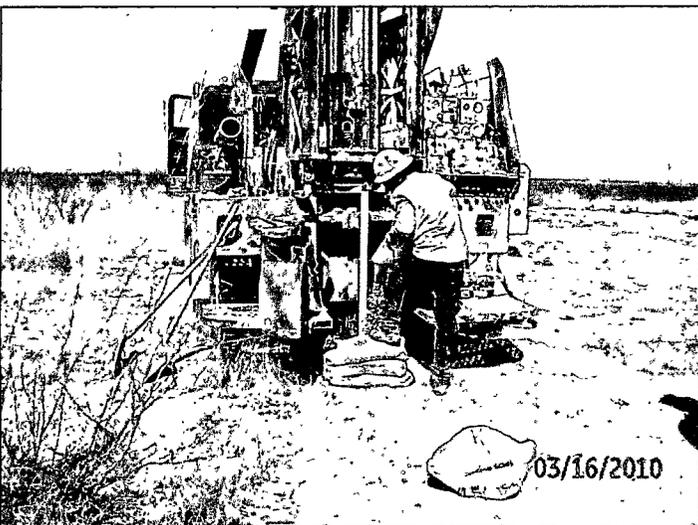
Sealing the well with bentonite

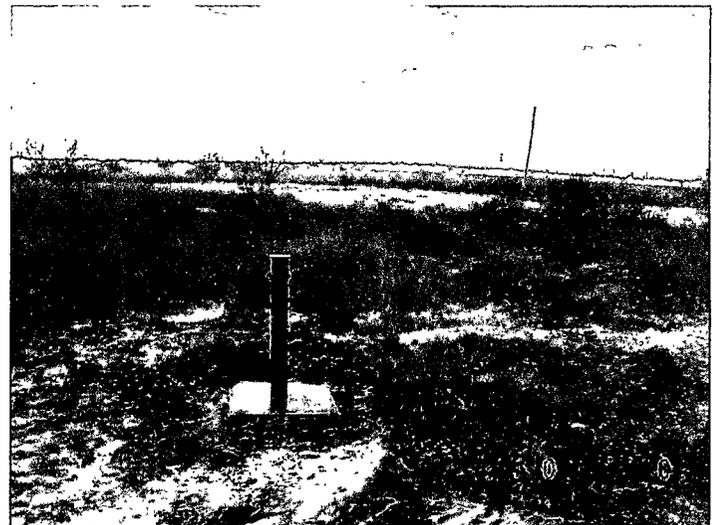
Completed well
