Vacuum B-27 Vent  
2009

RICE OPERATING COMPANY  
JUNCTION BOX FINAL REPORT

# Vacuum B-27 vent

Unit B, Section 27, T17S, R35E

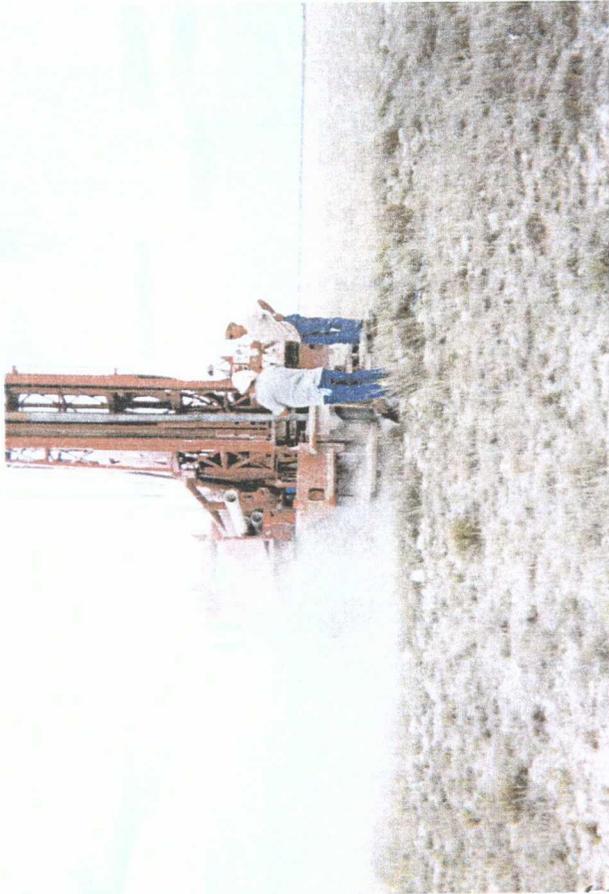
drilling SB #1 at the former junction box

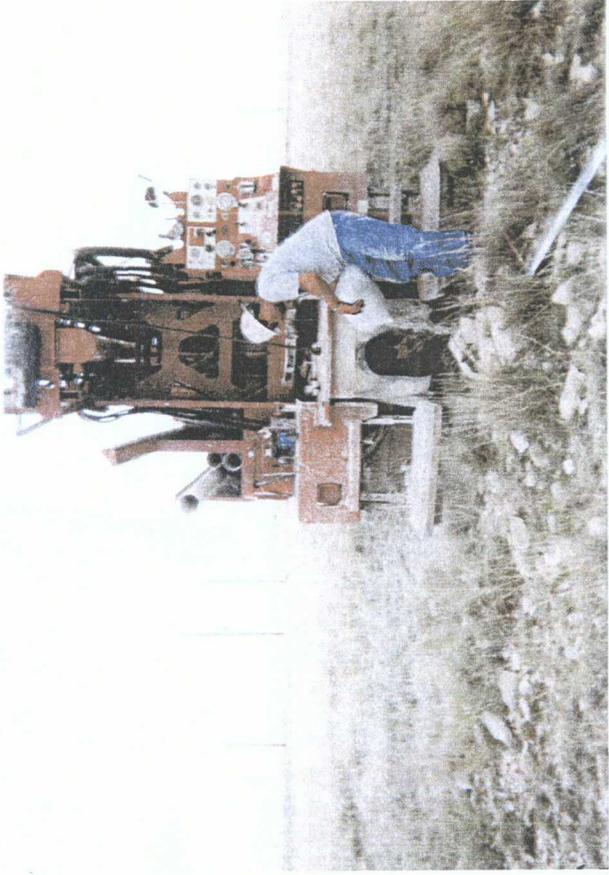
plugging SB #1 with bentonite

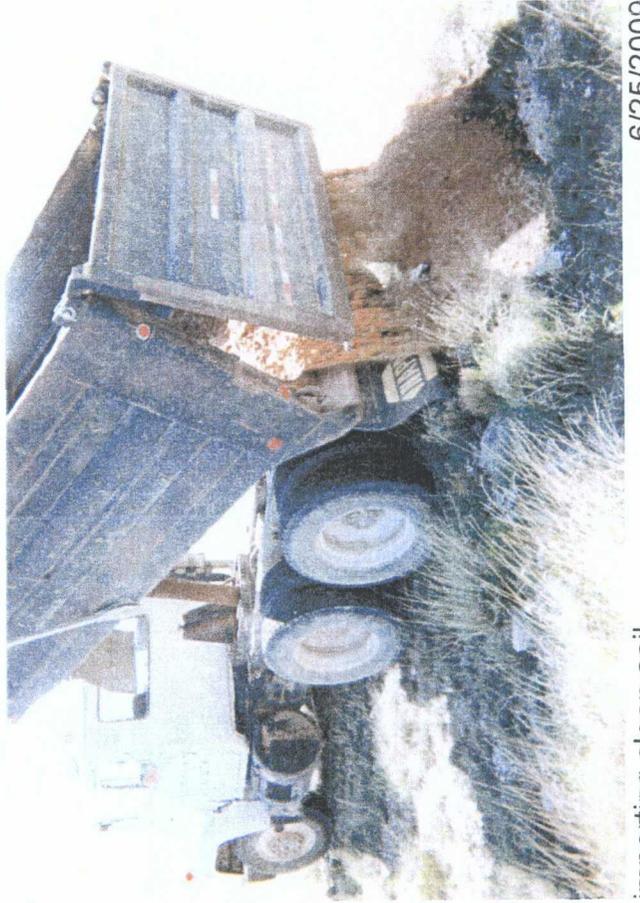
importing clean soil

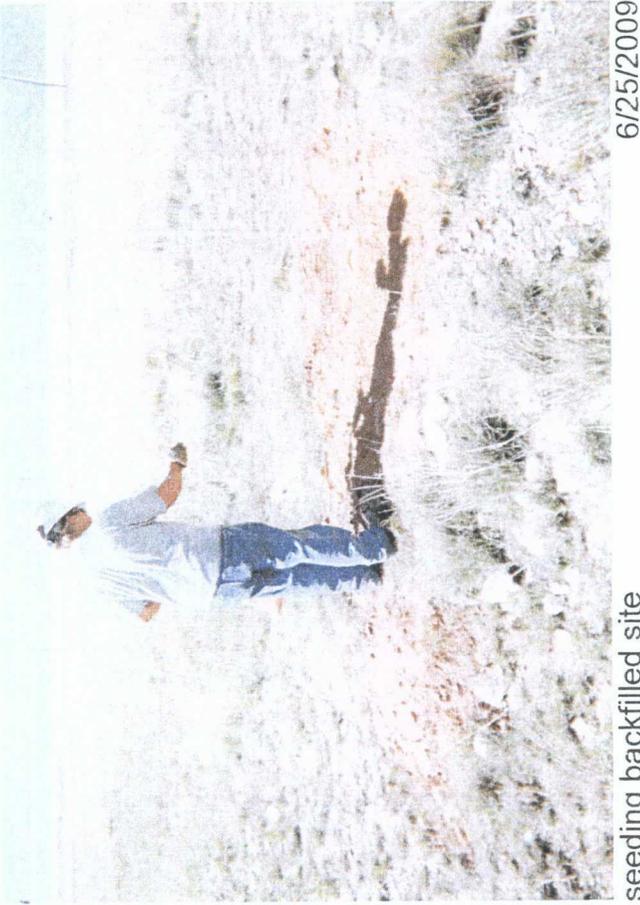
seeding backfilled site

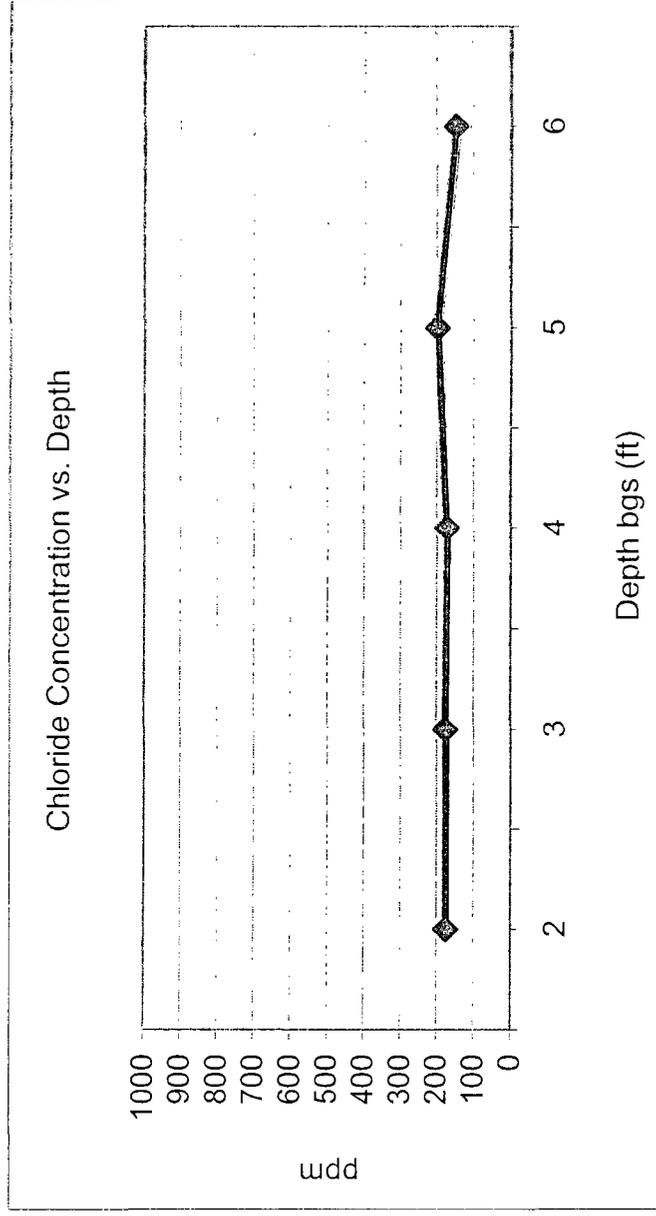
# CHLORIDE CONCENTRATION CURVE

Soil Boring samples at the junction (source)

Depth bgs (ft)	Cl <sup>-</sup> ppm
2	174
3	175
4	171
5	196
6	146

Groundwater = 52 ft
