**EME Texaco 'B' EOL  
2009**

RICE OPERATING COMPANY  
JUNCTION BOX FINAL REPORT

# EME Texaco 'B' EOL

Unit C, Section 16, T21S, R36E

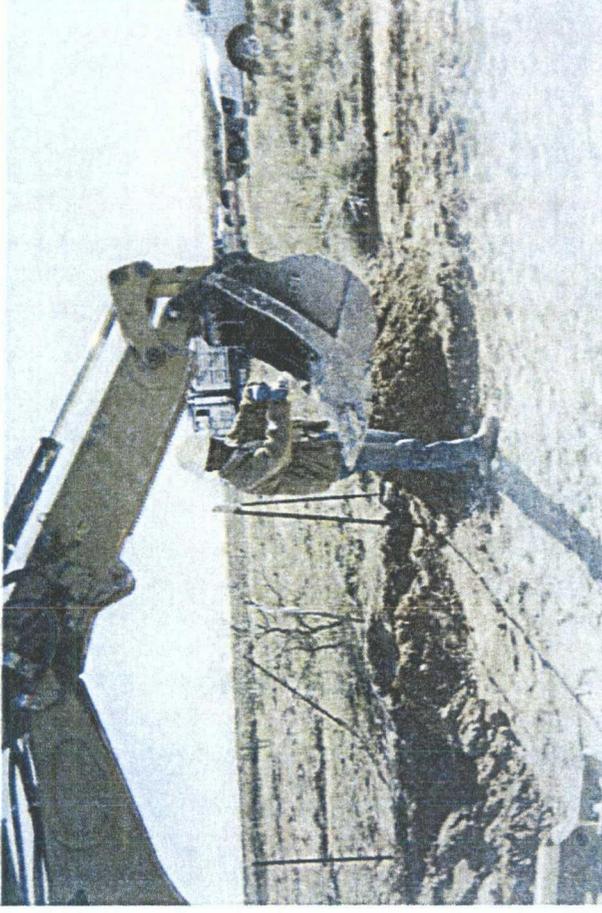
11/19/2008

collecting a soil sample

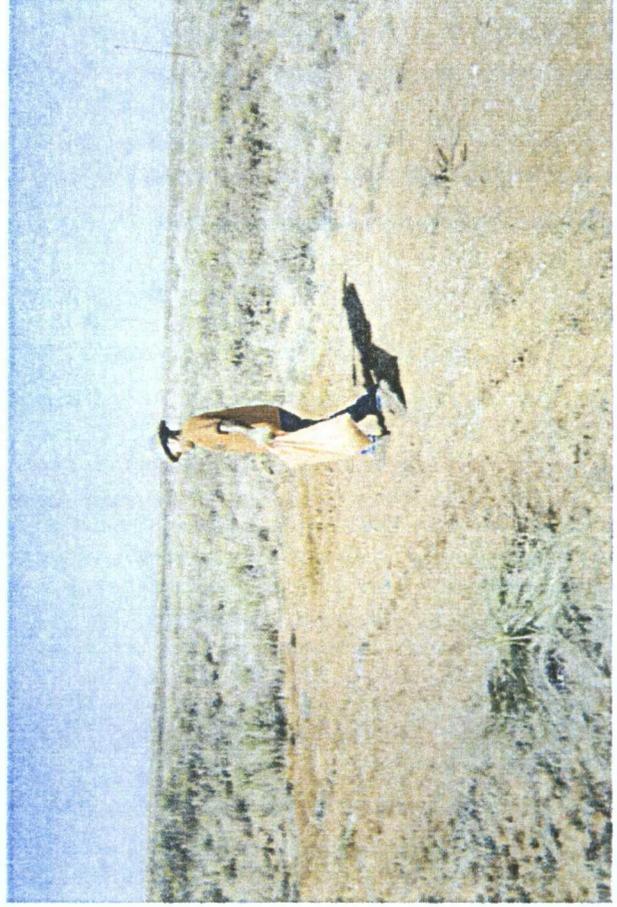
11/26/2008

seeding backfill site

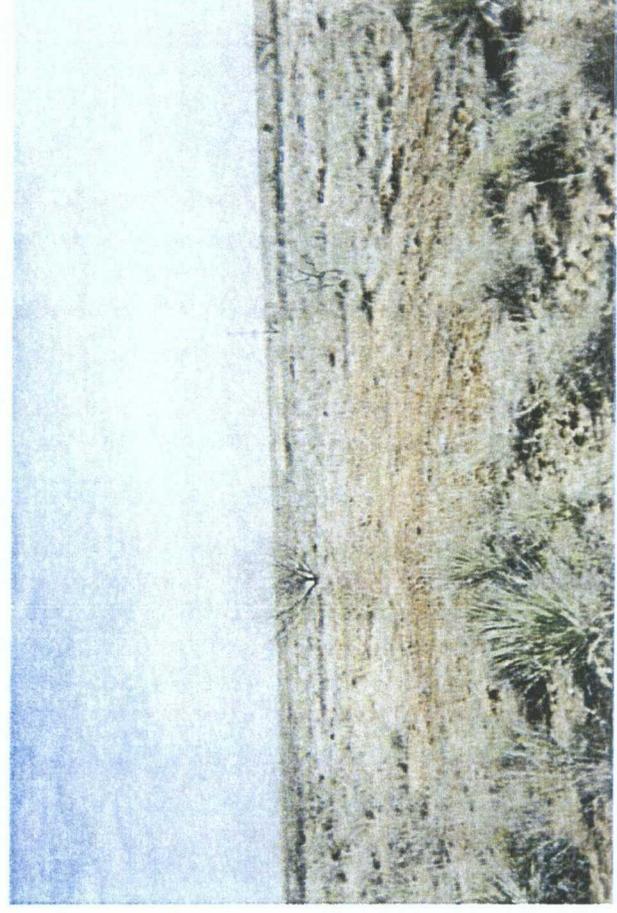
11/26/2008

site complete

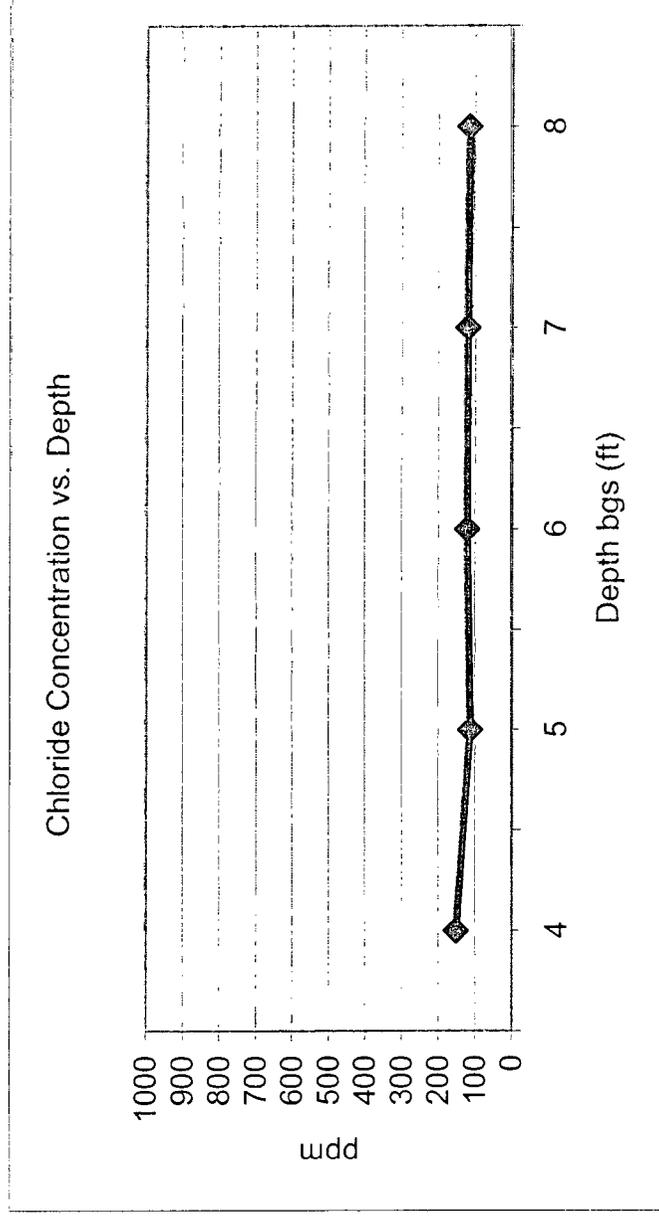
CHLORIDE CONCENTRATION CURVE

Backhoe samples at the junction (source)

Depth bgs (ft)	[Cl <sup>-</sup> ] ppm
4	151
5	112
6	120
7	117
8	112

Groundwater = 195 ft
