RICE OPERATING COMPANY
JUNCTION BOX FINAL REPORT

SWD SYSTEM	JUNCTION	UNIT	SECTION	TOWNSHIP	RANGE	COUNTY	BOX DIMENSIONS - FEET		
							Length	Width	Depth
Eunice Monument Eumont (EME)	Jct. P-8	P	8	21S	36E	Lea	Eliminated

EME Junction P-8

Unit P, Section 8, T21S, R36E

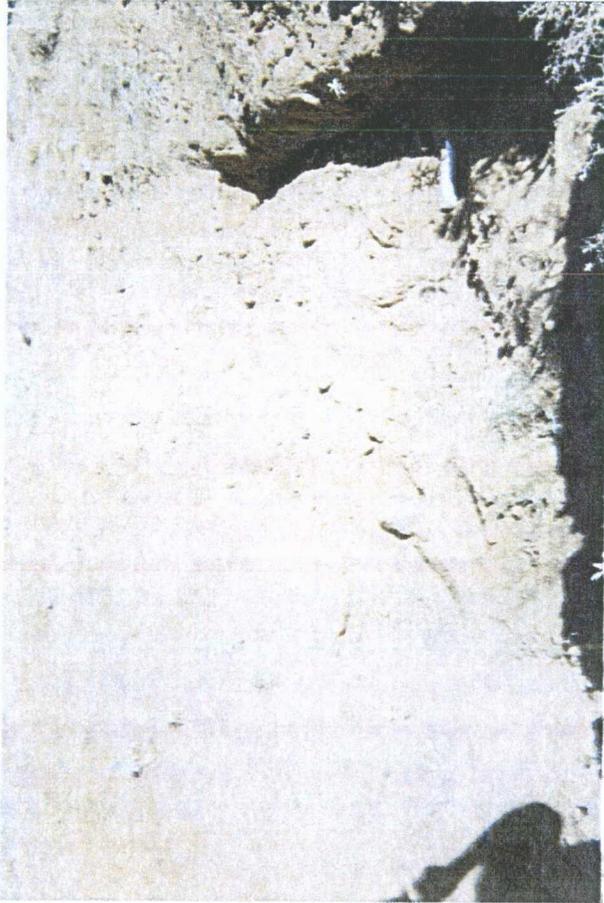
10/19/09

undisturbed junction box

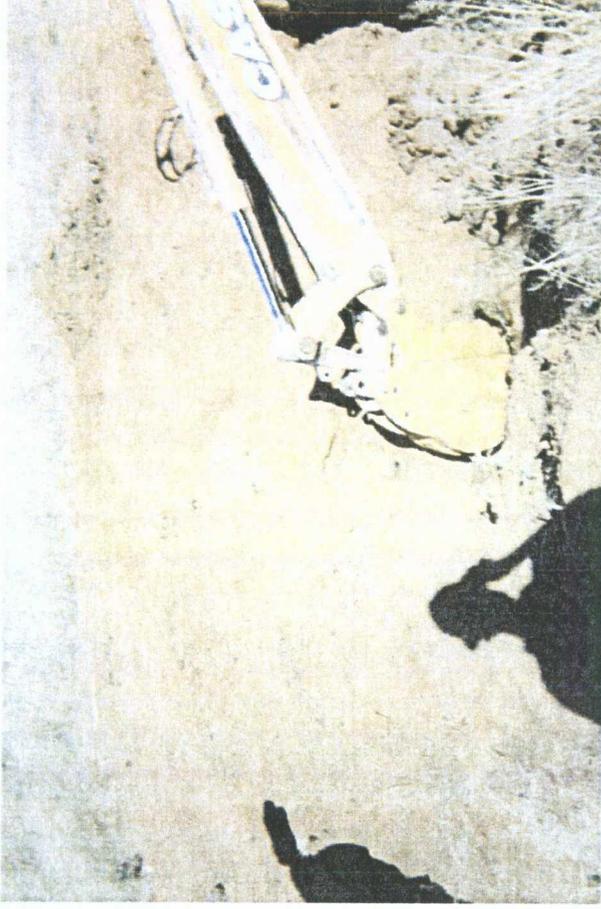
delineation trench at former junction box 10/19/09

General Description of Remedial Action: This junction was eliminated under the pipeline replacement/upgrade program. After the former junction was removed, an investigation was conducted using a backhoe to collect soil samples at regular intervals. Chloride field tests were performed on each sample, which yielded low concentrations of chloride similar to that of the background sample. Organic vapors were measured using using a PID, which also yielded low concentrations. The deepest sample, 8 ft BGS, was sent to a commercial laboratory for analysis, which confirmed low concentrations of chloride and organics. The excavated soil was returned to the excavation to ground surface and contoured to the surrounding area. On 12/30/09, the site was seeded with a native blend of vegetation and is expected to return to a productive capacity at a normal rate.

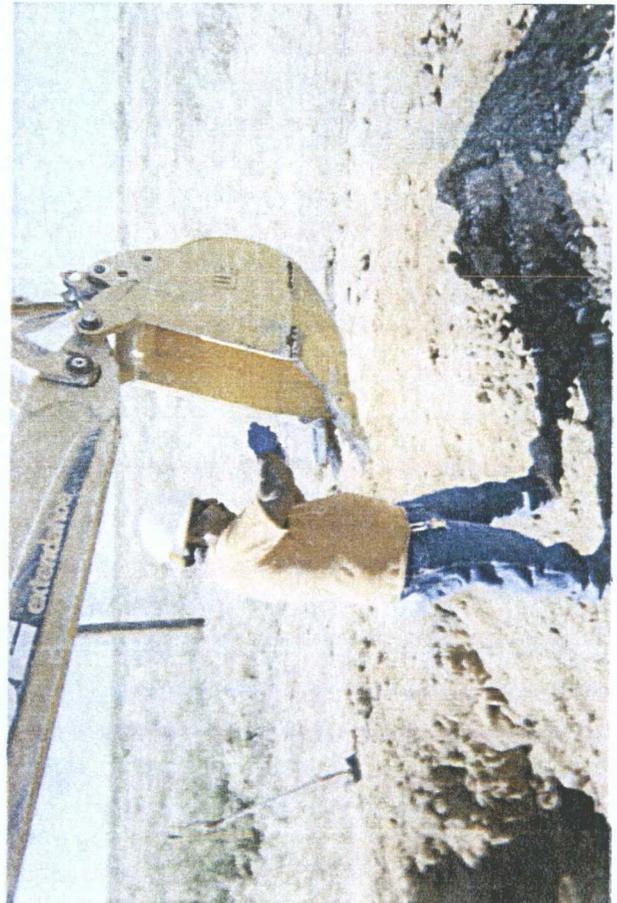
10/19/09

sample being taken

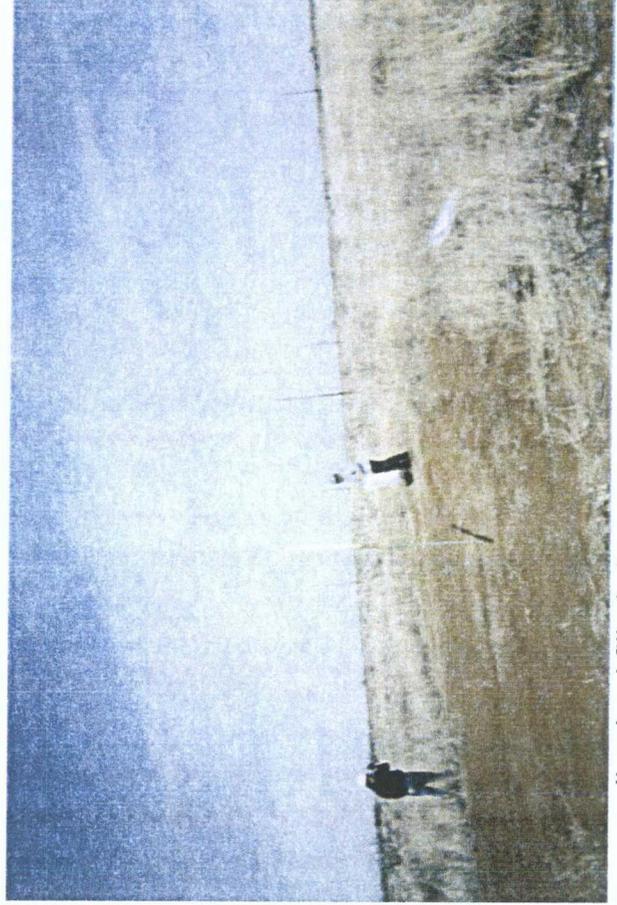
12/30/09

seeding backfilled site

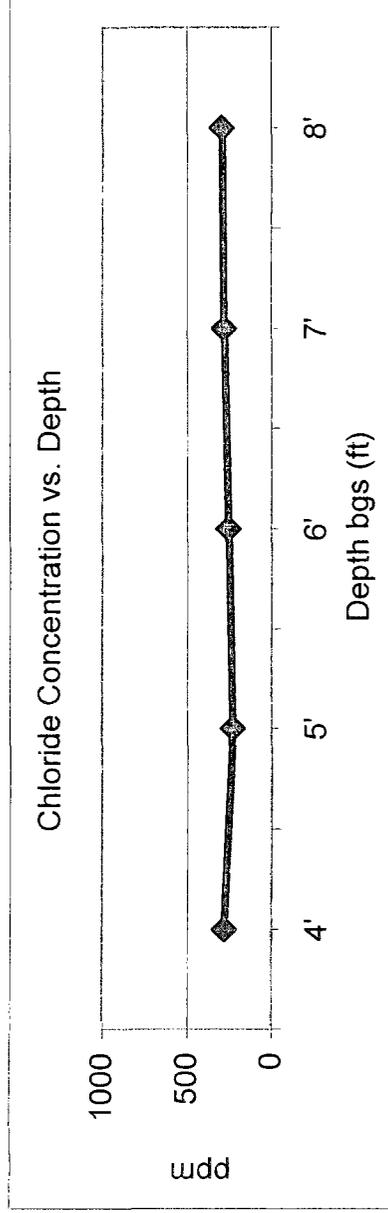
CHLORIDE CONCENTRATION CURVE

Backhoe samples at the junction (source)

Depth bgs (ft)	[Cl ⁻] ppm
4'	282
5'	229
6'	255
7'	281
8'	294

Groundwater = 184 ft

LOCATION	DEPTH	mg/kg
background	6"	223
vertical delineation trench at the junction (source)	4'	282
	5'	229
	6'	255
	7'	281
	8'	294
