**EME Jct I-2
2009**

RICE OPERATING COMPANY
JUNCTION BOX FINAL REPORT

EME Jct. I-2

Unit I, Section 2, T20S, R36E

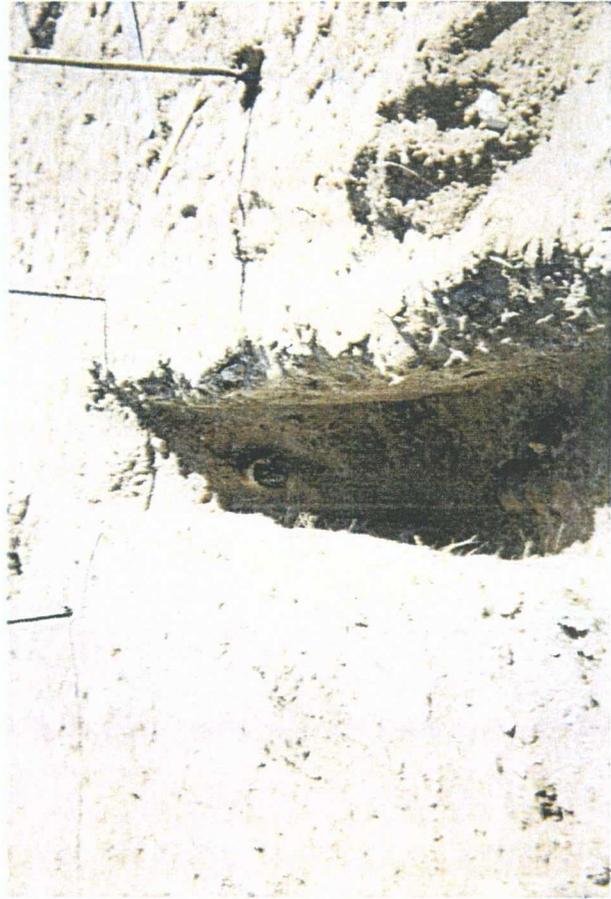
1/6/2009

capping lines at former junction box, facing east

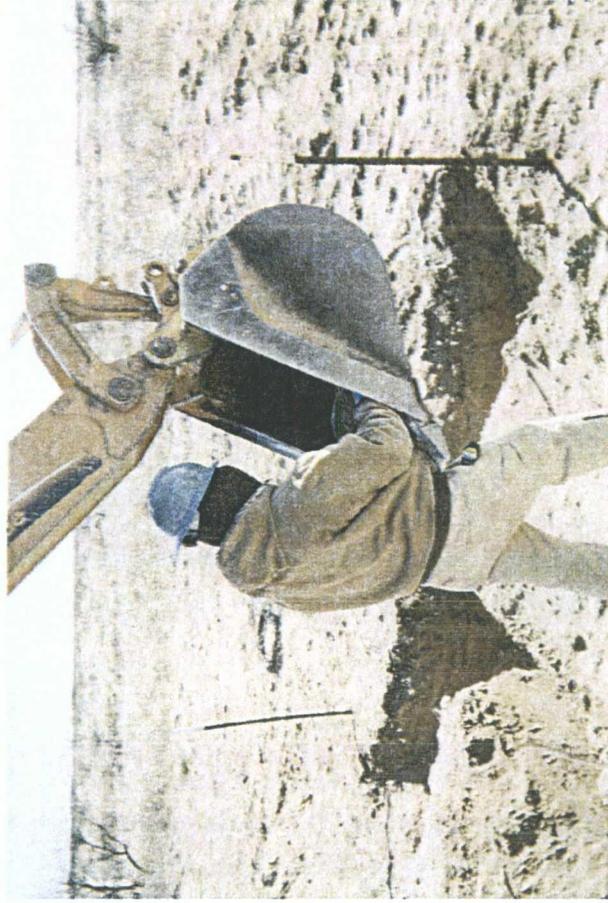
1/6/2009

collecting a soil sample, facing north

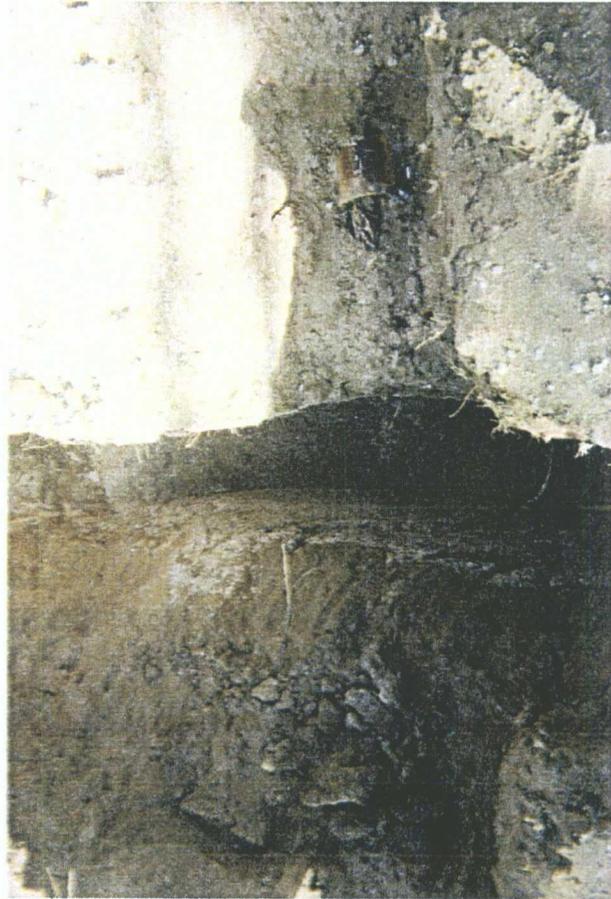
1/6/2009

final 5x3x8-ft-deep excavation, facing north

General Description of Remedial Action: This junction box was eliminated during the pipeline replacement/upgrade program. After the former junction box was removed, an investigation was conducted using a backhoe to collect soil samples at regular intervals producing a 5x3x8-ft-deep excavation. Chloride field tests performed on each sample yielded low concentrations similar to that of the background. Organic vapors were measured using a PID and also yielded low concentrations. The excavated soil was returned to the excavation to ground surface and contoured to the surrounding area. On 1/9/2009, the site was seeded with a blend of native vegetation and is expected to return to a productive capacity at a normal rate.

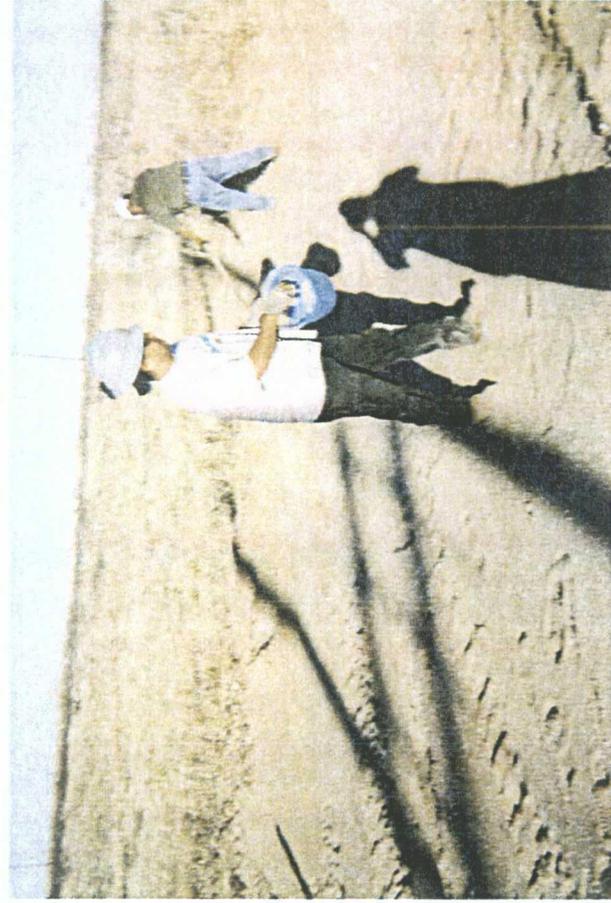
1/9/2009

seeding backfilled site, facing northeast

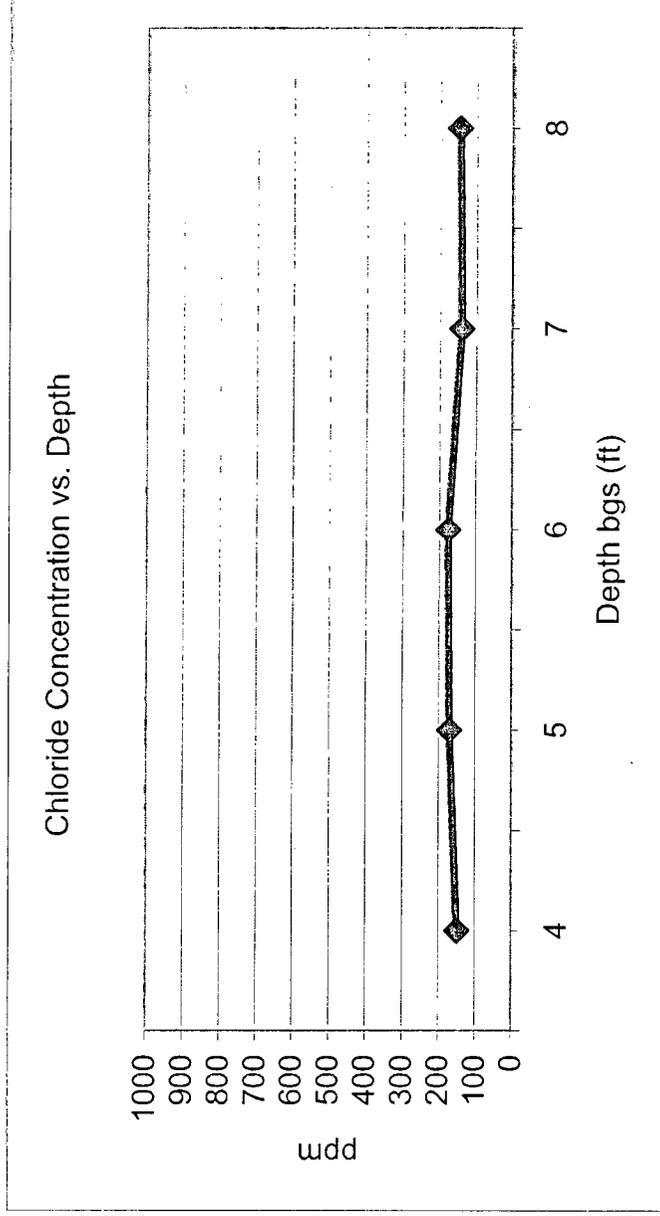
CHLORIDE CONCENTRATION CURVE

Backhoe samples at the junction (source)

Depth bgs (ft)	[Cl] ppm
4	149
5	170
6	175
7	138
8	143

Groundwater = 52 ft
