**EME Jct J-8
2009**

RICE OPERATING COMPANY
JUNCTION BOX FINAL REPORT

EME Junction J-8

Unit J, Section 8, T20S, R37E

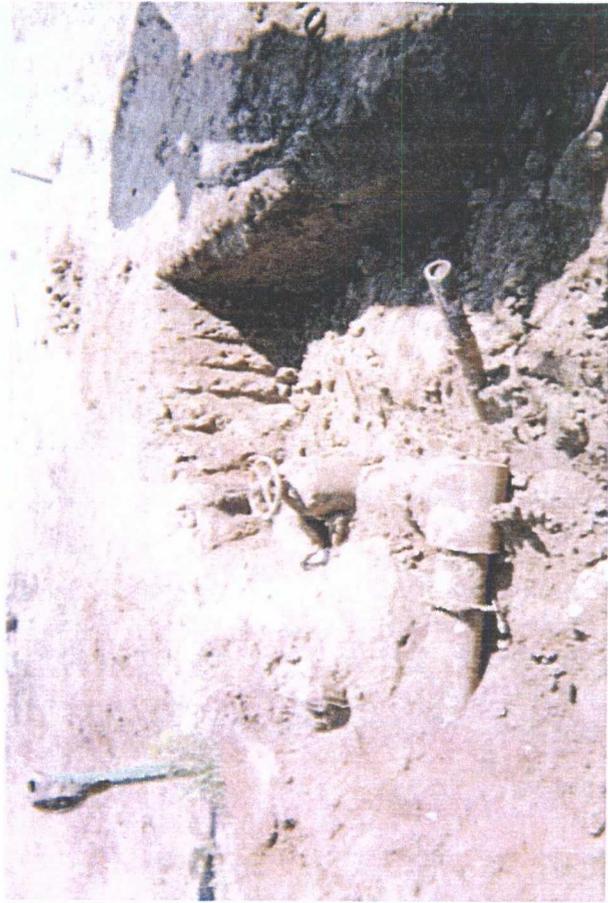
9/14/2009

Site prior to delineation

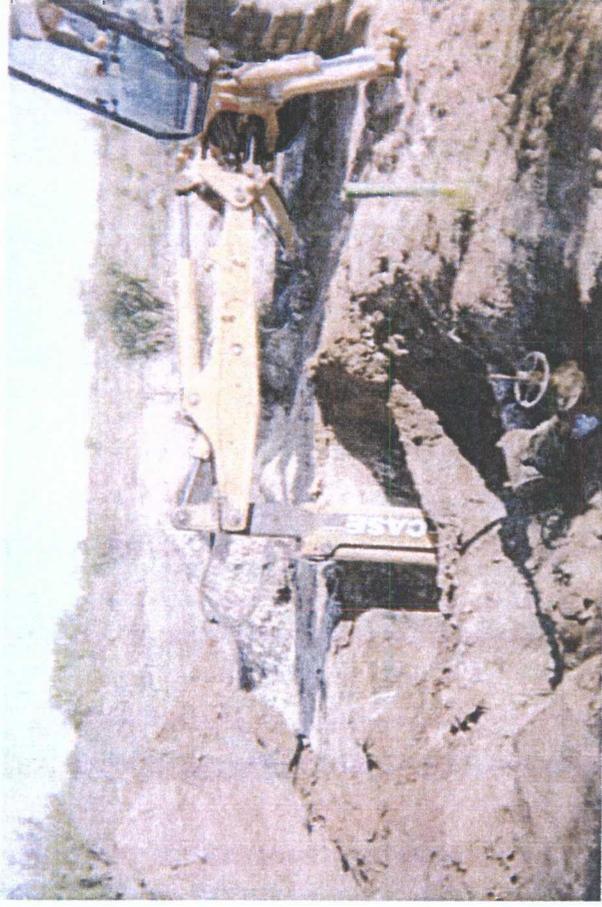
9/23/2009

Excavating 5 ft. north vertical

General Description of Remedial Action: This junction was eliminated during the pipeline replacement/upgrade program. After the former junction box was removed, an investigation was conducted using a backhoe to collect soil samples at regular intervals producing a 25x15x12-ft-deep excavation. Field data suggest the site is low in organic vapors and chloride concentrations are similar to that of the background. Representative composite samples were collected from the excavation walls, bottom, and blended excavated soil. The representative samples were analyzed by a commercial laboratory for chloride and TPH, which confirmed low concentrations. The blended backfill was hauled to an OCD approved facility. The site was backfilled with clean imported soil and contoured to the surrounding area. On 12/18/09, site was seeded with a blend of native vegetation and is expected to return to a productive capacity at a normal rate.

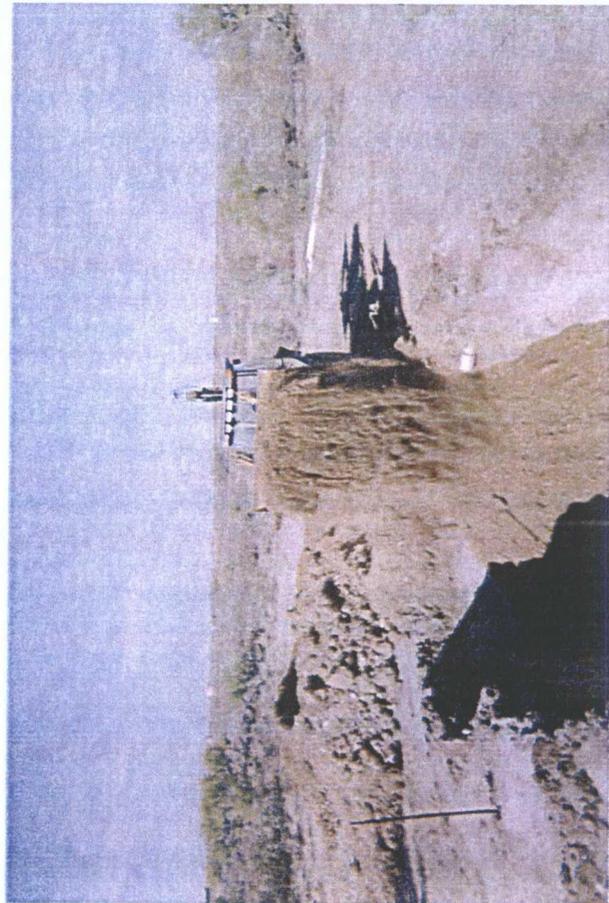
11/05/2009

Backfilling excavation

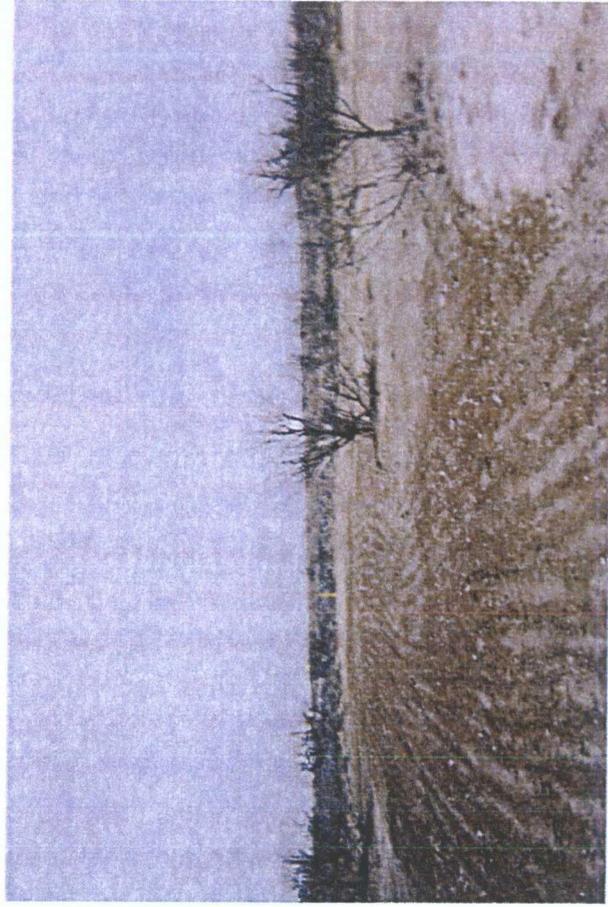
12/18/2009

Site complete

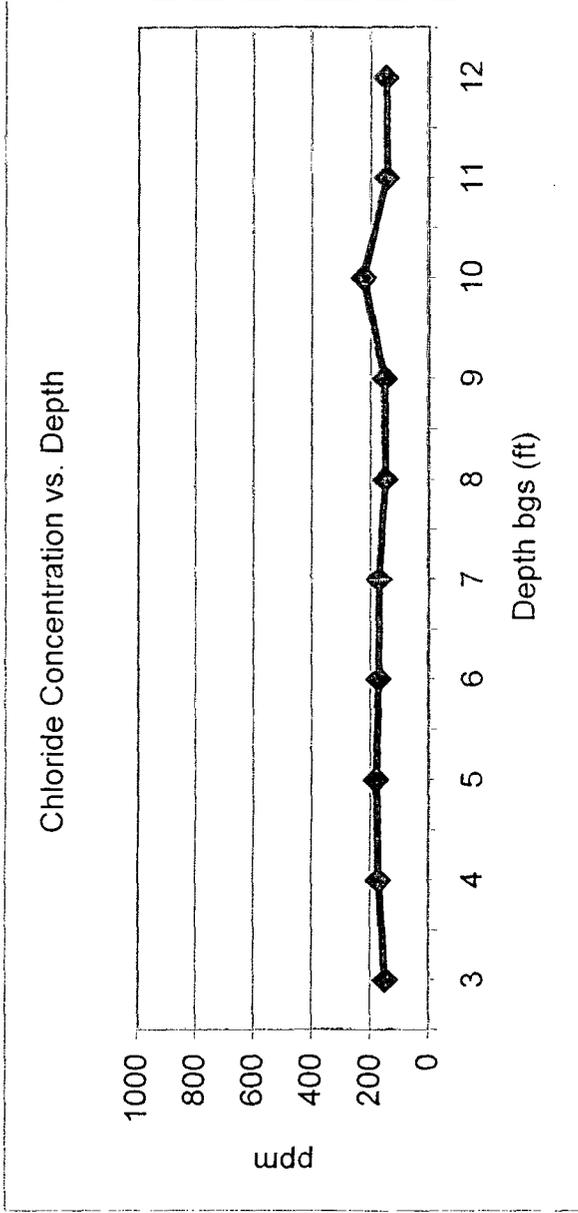
Backhoe samples at the junction (source)

Depth bgs (ft)	Cl ⁻ ppm
3	148
4	170
5	179
6	170
7	169
8	147
9	150
10	222
11	142
12	144

Groundwater = 34 ft.

LOCATION	DEPTH	mg/kg
4-wall comp.	n/a	145
bottom comp.	12'	147
blended backfill	n/a	204
background	6"	208
vertical delineation of the junction (source)	3'	148
	4'	170
	5'	179
	6'	170
	7'	169
	8'	147
	9'	150
	10'	222
	11'	142
	12'	144
