EME Jet G-21
2009

RICE OPERATING COMPANY
JUNCTION BOX FINAL REPORT

EME Jct. G-21

Unit G, Section 21, T21S, R36E

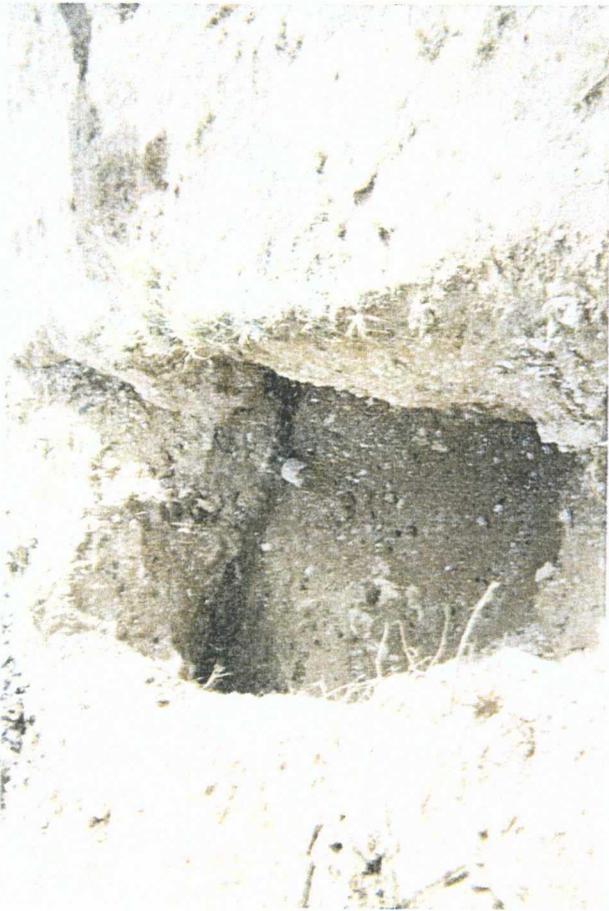
11/14/2008

site prior to excavation, facing east

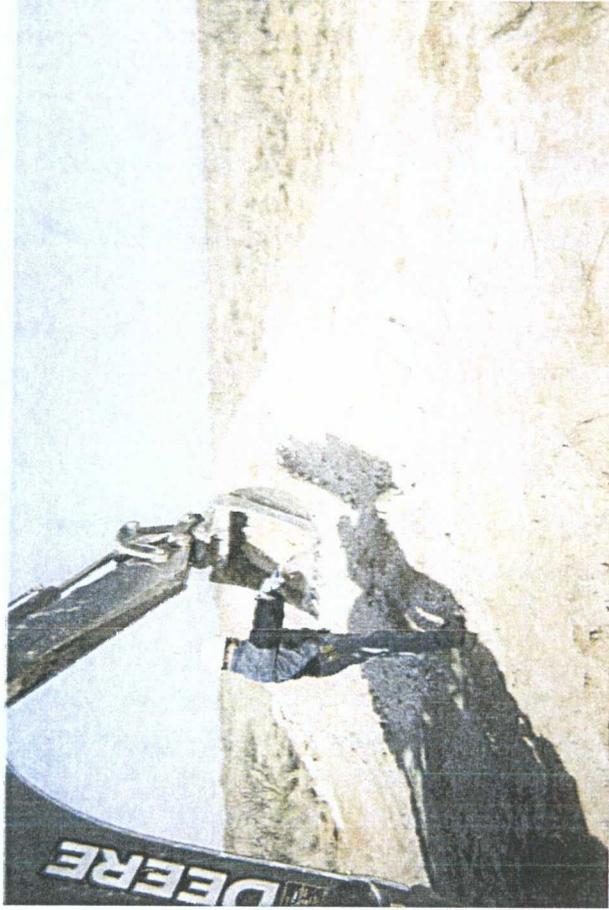
12/3/2008

collecting a soil sample, facing north

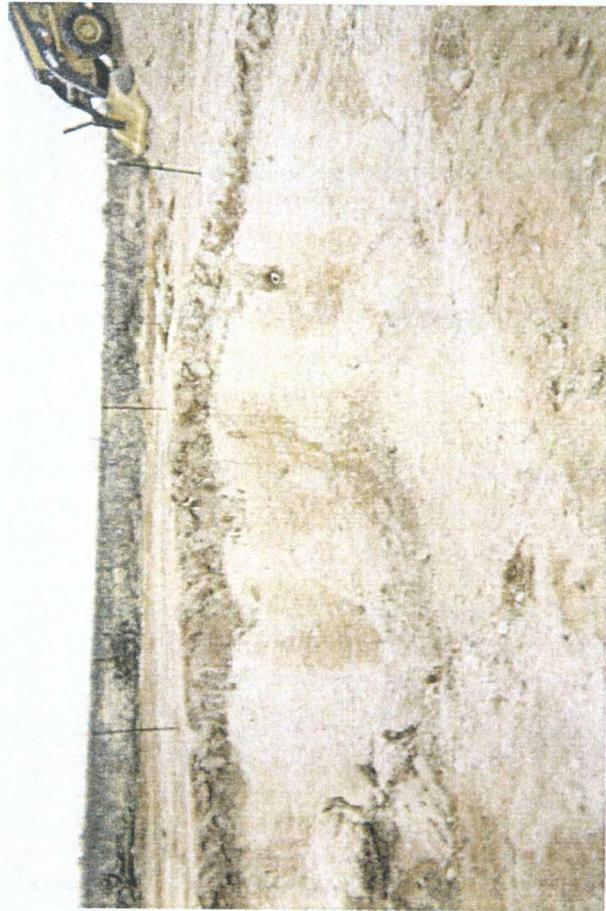
12/17/2008

final 30x30x12-ft excavation, facing north

General Description of Remedial Action: This junction box was eliminated during the pipeline replacement/upgrade program. After the former junction box was removed, an investigation was conducted using a backhoe to collect soil samples at regular intervals producing a 30x30x12-ft-deep excavation. Chloride field tests performed on each sample yielded generally low concentrations of chloride. Organic vapors were measured using a PID, which also yielded low concentrations. Representative composite samples were sent to a commercial laboratory for analysis of chloride and TPH which confirmed low concentrations. The excavated soil was blended on-site, returned to the excavation to ground surface, and contoured to the surrounding area. On 12/24/2008, the site was seeded with a blend of native vegetation and is expected to return to a productive capacity at a normal rate.

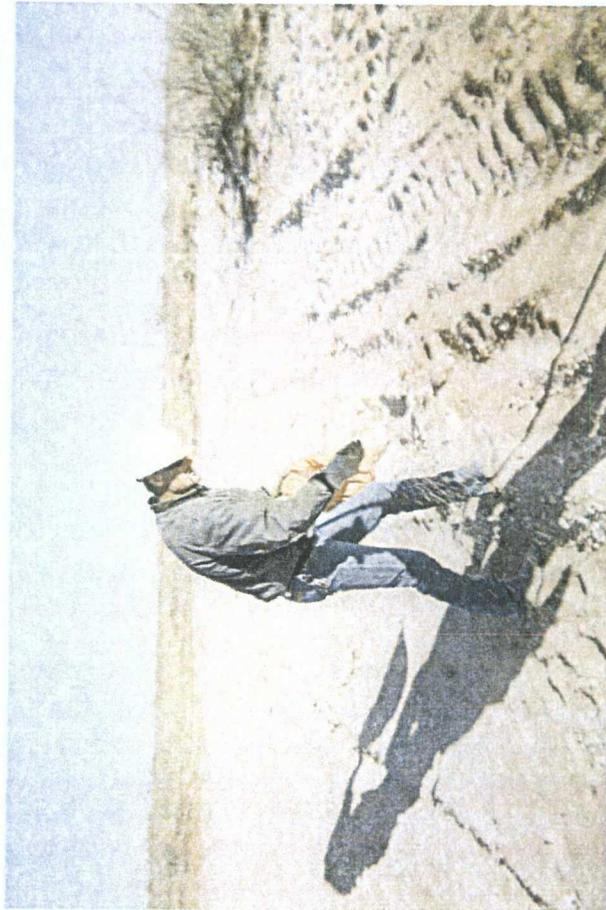
12/24/2008

seeding backfilled site, facing north

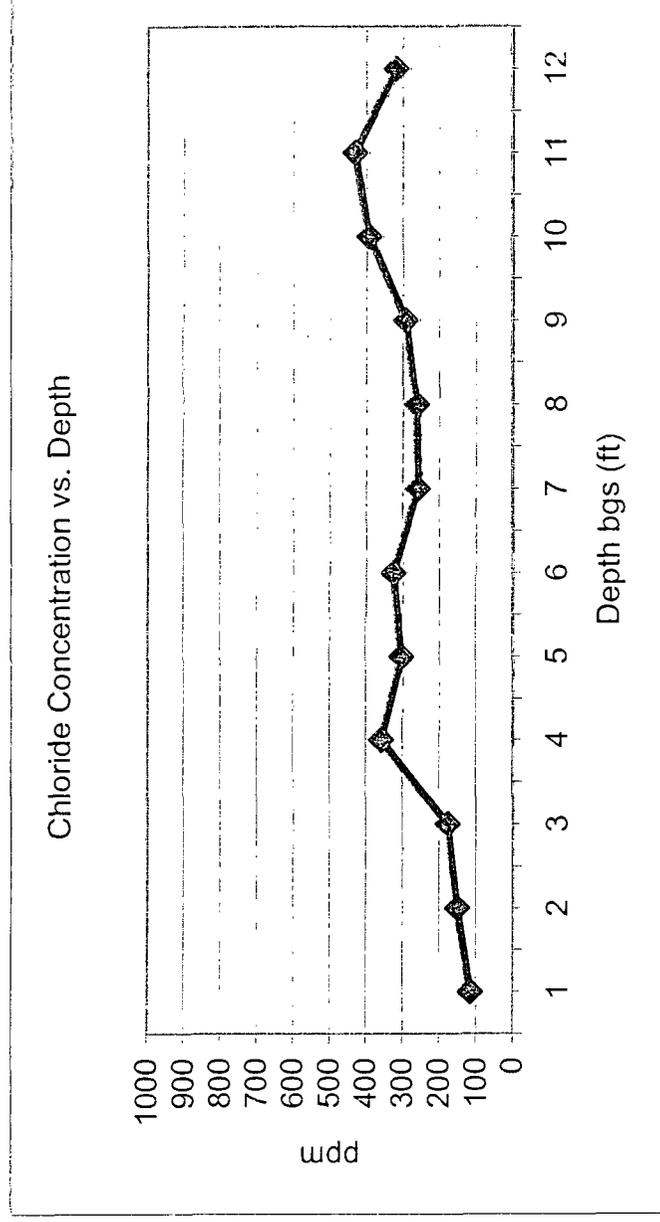
CHLORIDE CONCENTRATION CURVE

Backhoe samples at 5 ft north of the junction (source)

Depth bgs (ft)	[C] ppm
1	115
2	150
3	176
4	357
5	301
6	323
7	256
8	259
9	288
10	389
11	428
12	314

Groundwater = 162 ft
