RICE OPERATING COMPANY
JUNCTION BOX FINAL REPORT

SWD SYSTEM	JUNCTION	UNIT	SECTION	TOWNSHIP	RANGE	COUNTY	BOX DIMENSIONS - FEET		
							Length 5'	Width 12'	Depth 6'
Blinebry-Drinkard (BD)	P-34 EOL	P	34	21S	37E	Lea	eliminated

BD P-34 EOL

Unit P, Section 34, T21S, R37E

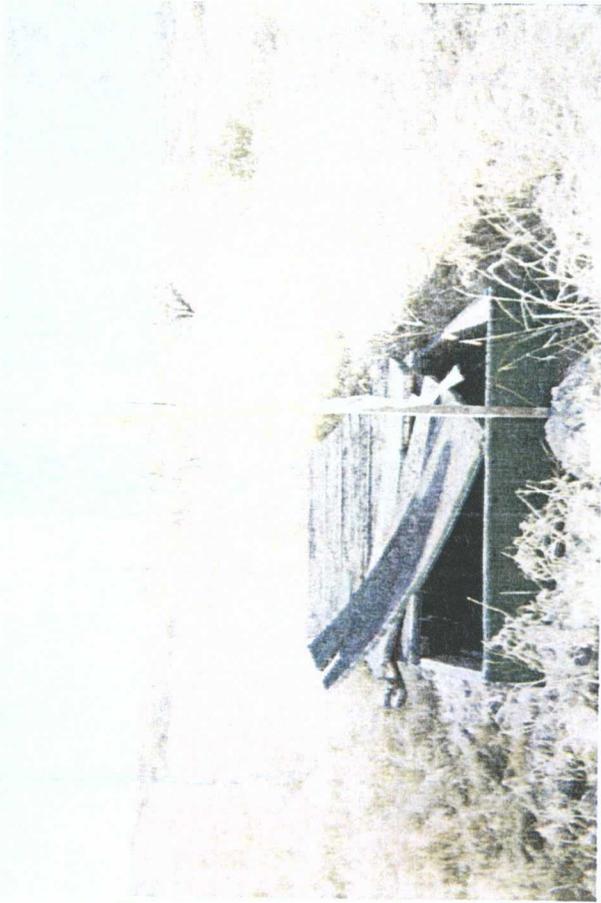
10/20/2009

site prior to excavation, facing south

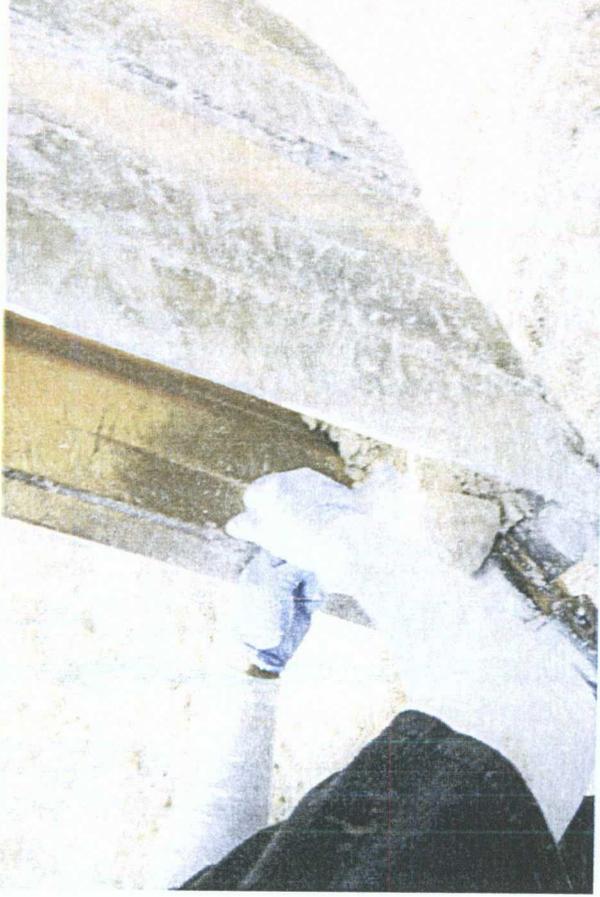
10/20/2009

collecting a soil sample, facing west

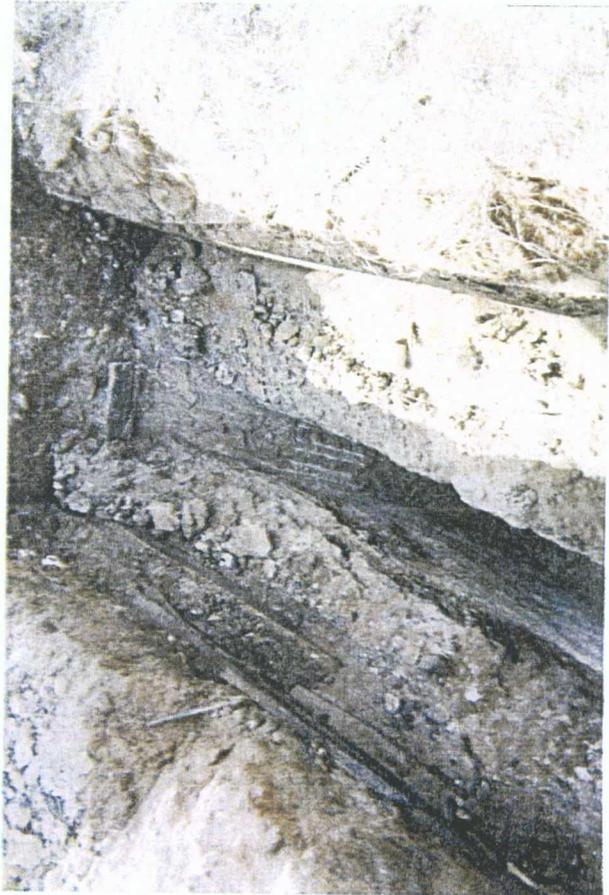
10/20/2009

excavation as the former junction box, facing east

General Description of Remedial Action: This junction was addressed during the pipeline replacement/upgrade program. After the former box was removed, an investigation was conducted using a backhoe to collect soil samples at regular intervals. Chloride field tests were performed on each sample which yielded low concentrations similar to that of the background. Organic vapors were measured using a PID which also yielded low concentrations. Laboratory analysis of the 9 ft BGS sample confirmed low concentrations of chloride and TPH. The excavated soil was returned to the excavation to ground surface and contoured to the surrounding area. On 11/6/2009, the site was seeded with a blend of native vegetation and is expected to return to a productive capacity at a normal rate.

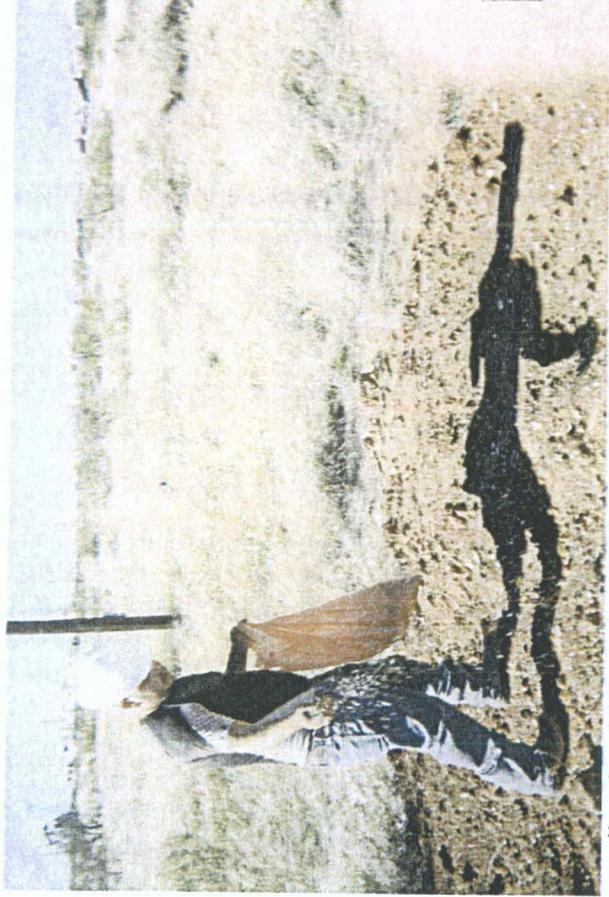
11/6/2009

seeding backfilled site, facing south

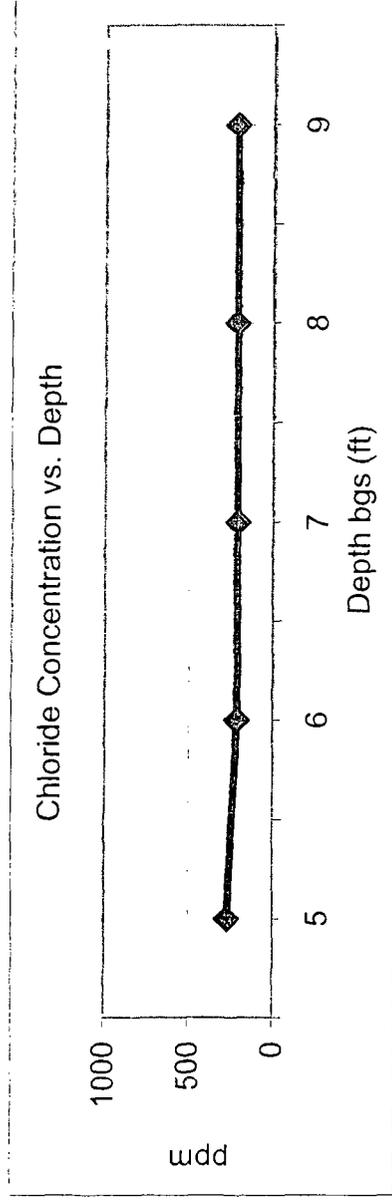
CHLORIDE CONCENTRATION CURVE

Backhoe samples at the junction (source)

Depth bgs (ft)	[Cl] ppm
5	270
6	211
7	209
8	212
9	210

Groundwater = 68 ft
