**BD Jct I-25  
2009**

RICE OPERATING COMPANY  
 JUNCTION BOX FINAL REPORT

# BD Jct. I-25

Unit I, Section 25, T21S, R36E

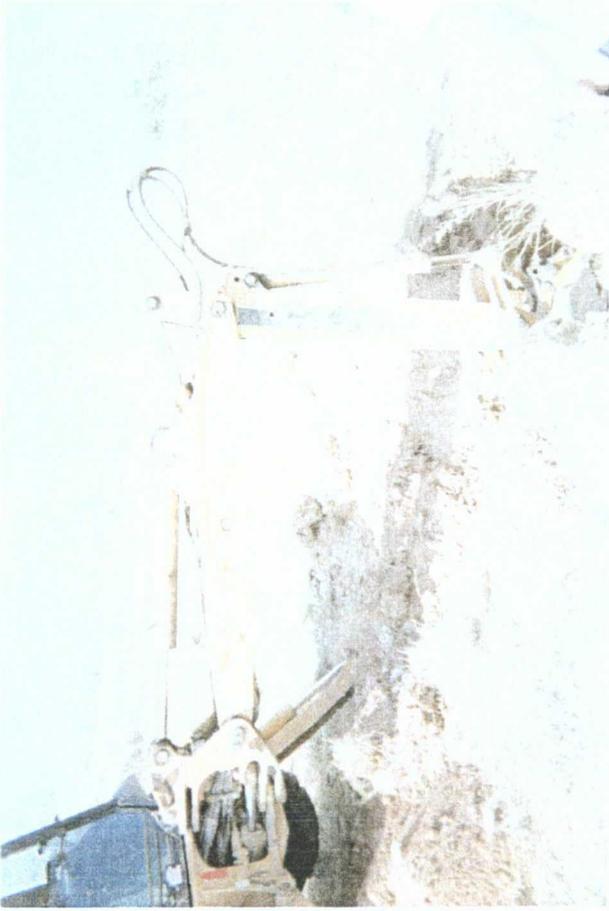
excavating the former junction box, facing north

8/31/2009

**General Description of Remedial Action:** This junction was eliminated during the pipeline replacement/upgrade program. After the former box was removed, an investigation was conducted using a backhoe to collect soil samples at regular intervals creating a 5x10x12-ft excavation. The excavation could not be extended any further to the south due to the close proximity of active lines and a lease road. Chloride field tests performed on each sample yielded low concentrations similar to that of the background. Organic vapors, measured using a PID, also yielded low concentrations. Laboratory analysis of the representative composite samples confirmed low concentrations of each. The excavated soil was blended on site and returned to the excavation to ground surface and contoured to the surrounding area. On 9/16/2009, the site was seeded with a blend of native vegetation and is expected to return to a productive capacity at a normal rate.

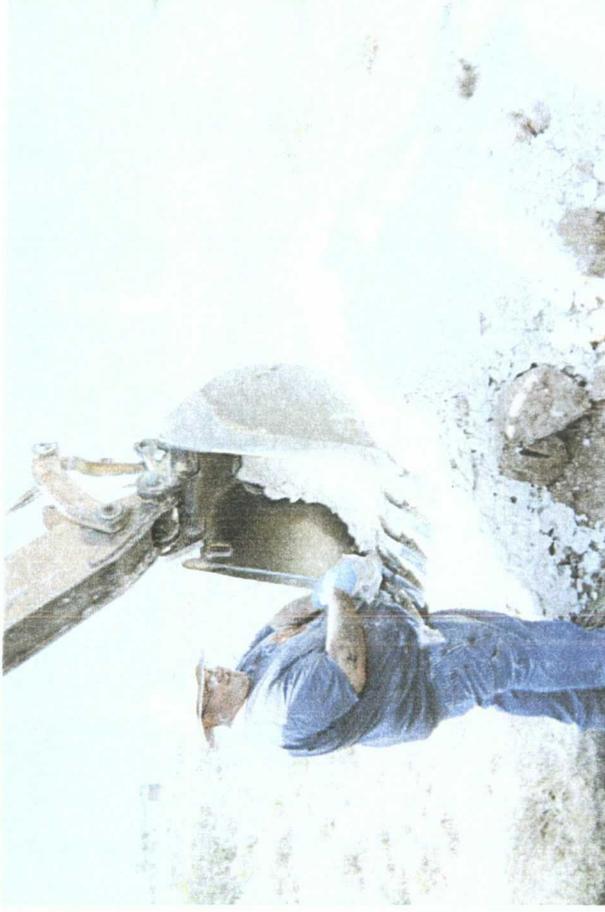
collecting a soil sample, facing north

8/31/2009

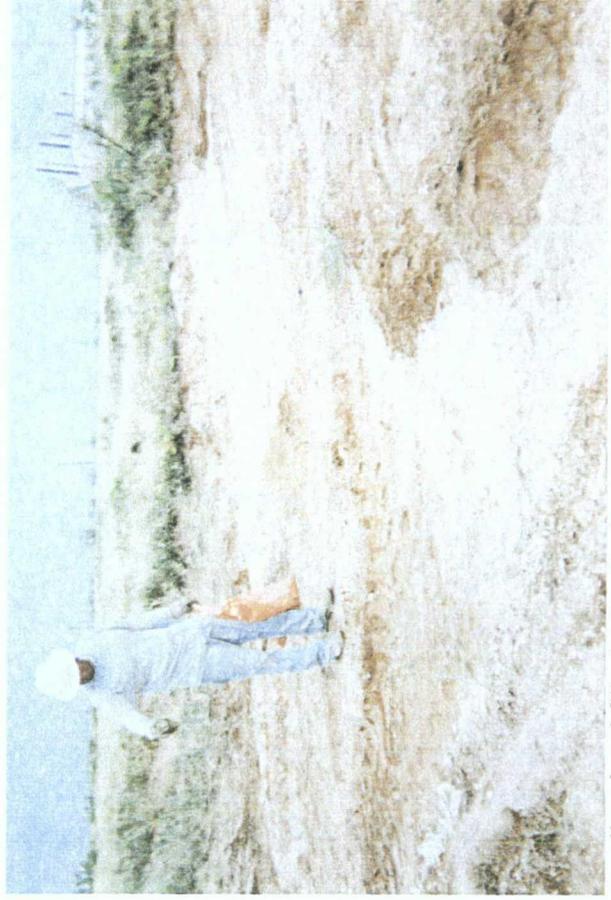
seeding backfilled site, facing west

9/16/2009

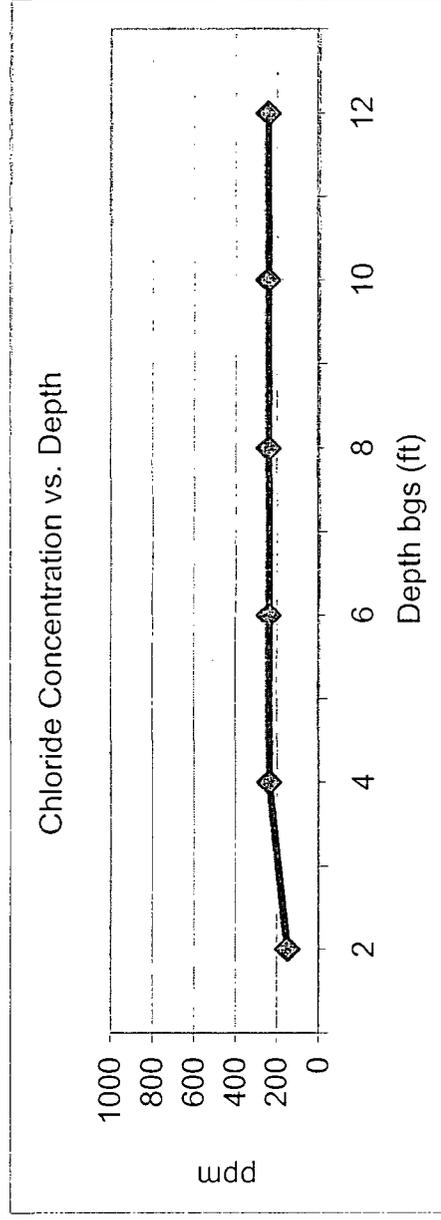
CHLORIDE CONCENTRATION CURVE

Backhoe samples at 5 ft West of the junction (source)

Groundwater = 148 ft

| LOCATION | DEPTH | mg/kg |
|---|---|---|
| vertical delineation trench at 5 ft West of the junction (source) | 2' | 149 |
