RICE OPERATING COMPANY
JUNCTION BOX FINAL REPORT

SWD SYSTEM	JUNCTION	UNIT	SECTION	TOWNSHIP	RANGE	COUNTY	BOX DIMENSIONS IN FEET		
							Length	Width	Depth
Blinebry-Drinkard (BD)	J-25 EOL	J	25	21S	37E	Lea	Eliminated

BD J-25 EOL

Unit J, Section 25, T21S, R37E

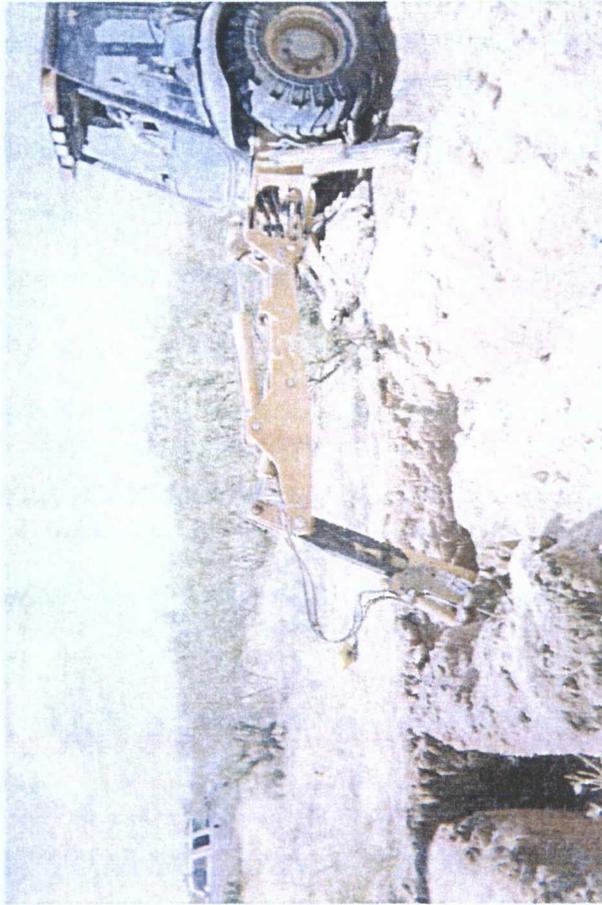
9/28/2009

Delineation trench at former junction box

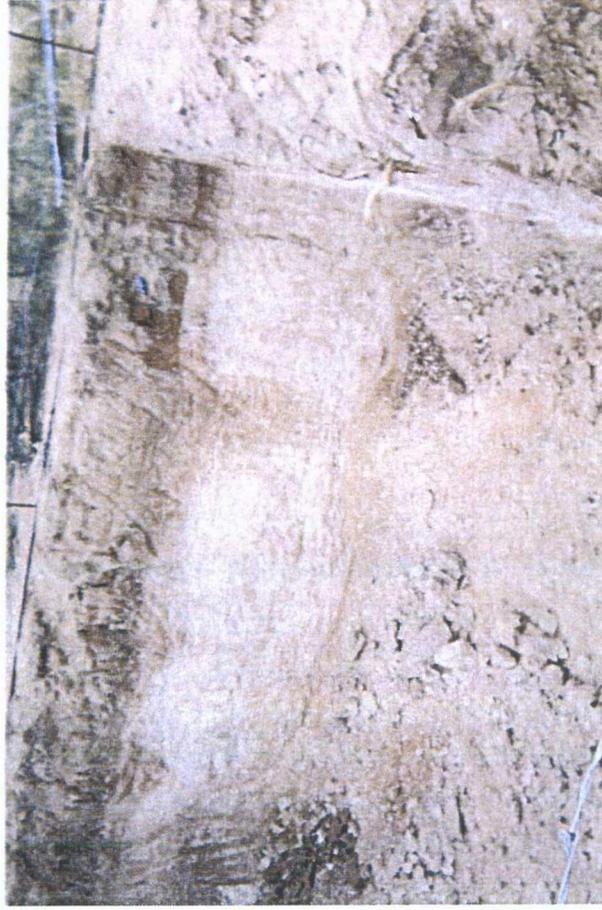
10/29/2009

Excavation complete

General Description of Remedial Action: This junction was eliminated under the pipeline replacement/upgrade program. After the former box was removed, an investigation was conducted using a backhoe to collect soil samples at regular intervals producing a 30x30x12-ft deep hole. Each sample was field tested for chlorides and organic vapors. Field chloride tests yielded elevated chloride concentrations that did not relent with depth. Representative composite samples were sent to a commercial laboratory for analysis. The excavated soil was then blended on site and returned to the excavation to 5 ft. BGS. A one foot thick clay layer was installed and compaction test performed. The remaining blended backfill was returned to the excavation to ground surface and contoured to the surrounding area. To further investigate the depth of chloride presence, a soil boring was initiated on 11/04/2009 10 ft. east of the former junction box site. The boring was advanced to 80 ft. BGS, while soil samples were collected every 3 ft and tested for chloride concentrations and organics. At 30 ft and 54 ft BGS, the soil samples were sent to a commercial laboratory for analysis. The groundwater data suggested that water would be encounter at approximately 35 ft. BGS. At 57 ft. BGS the soil lithology changed to chinle red bed clay and bore was advanced to 80 ft. BGS. The bore hole was left open and after 48 hrs no moisture content was detected when gauging bore hole. The entire bore hole was plugged with bentonite to ground surface. On 11/25/2009, site was seeded with a blend of native vegetation and is expected to return to a productive capacity at a normal rate.

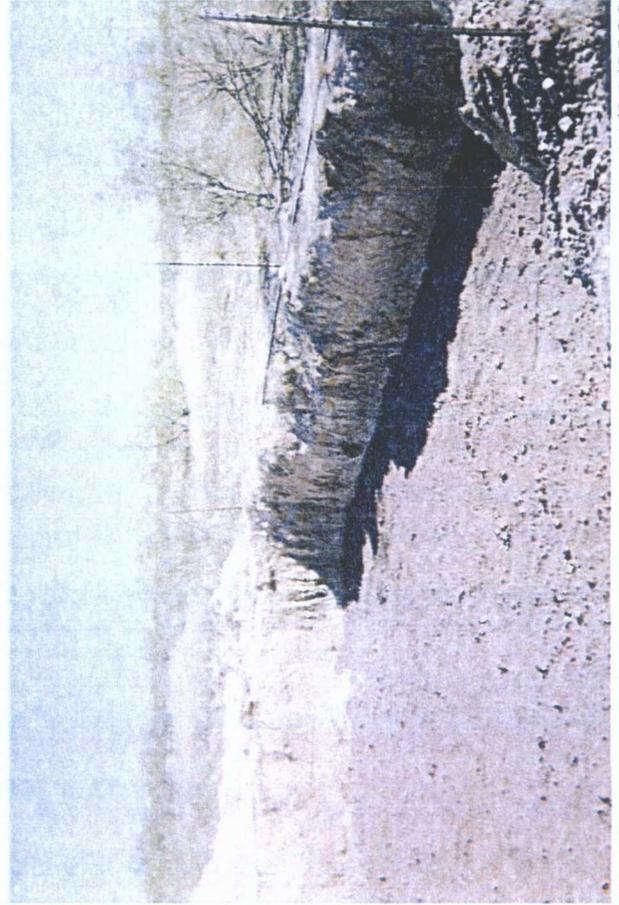
11/02/2009

Clay layer complete

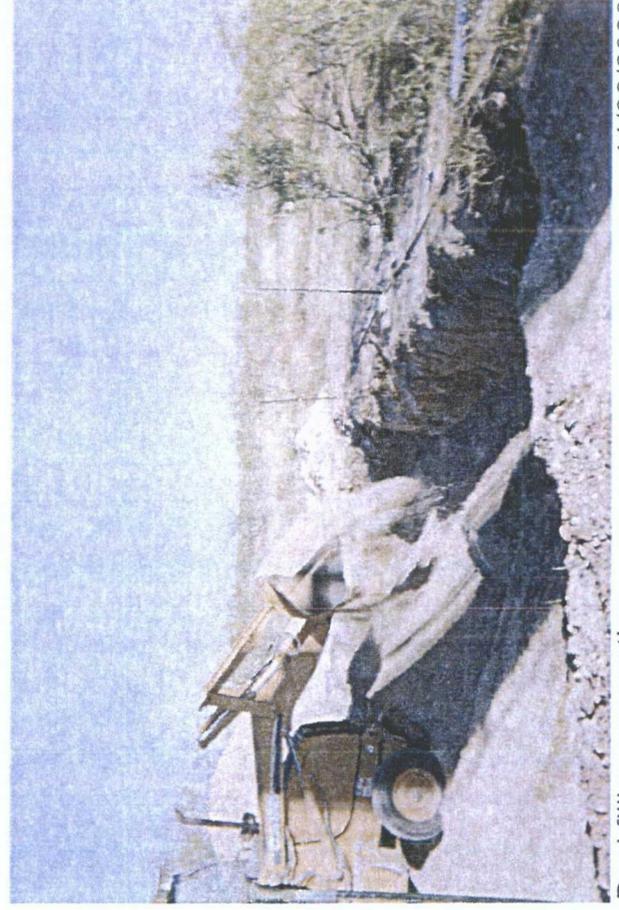
11/02/2009

Backfilling excavation

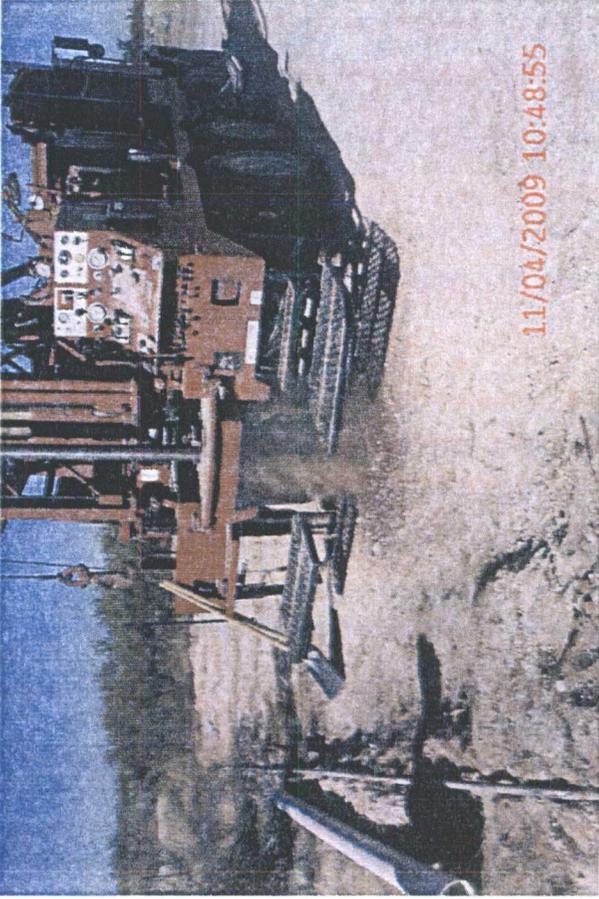
11/04/2009

Soil Bore # 1

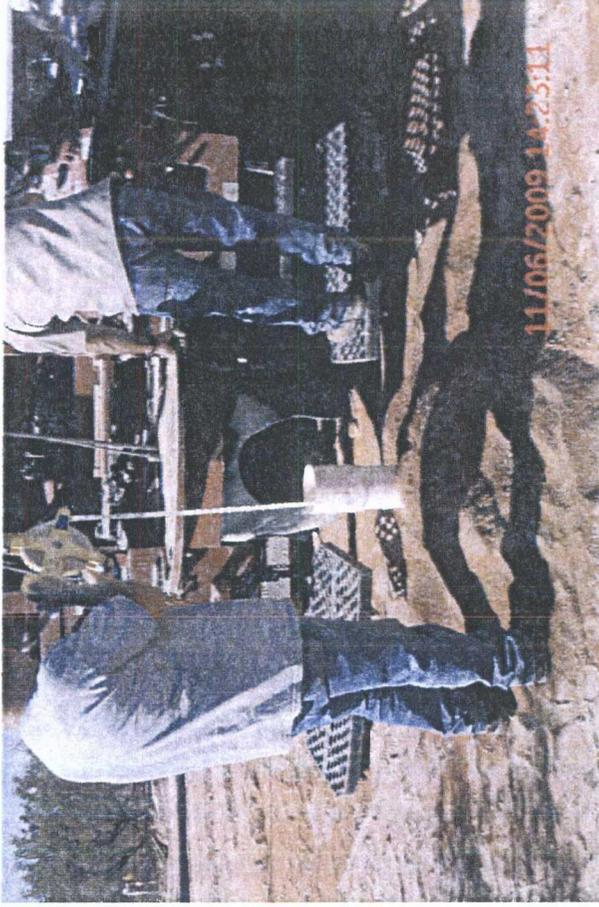
11/06/2009

Measuring for groundwater after 48 hrs.

On November 4, 2009, Harrison and Cooper were contracted by Rice Operating to drill and sample a soil boring at the subject site. The soil boring was drilled to approximately 80 feet in an effort to determine whether or not a saturated interval existed. After a forty-eight hour holdover time the moisture content at that depth was NON-detectable.

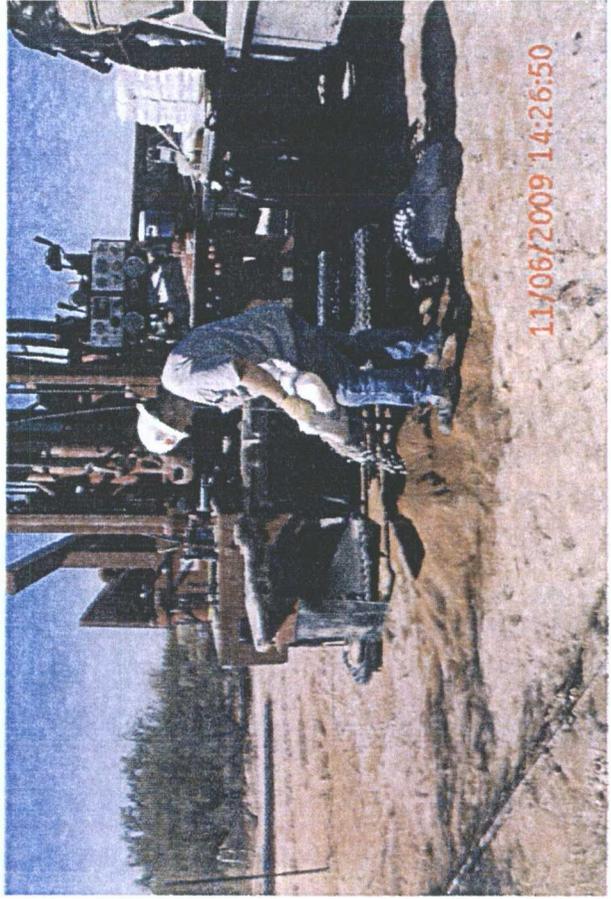
11/06/2009

Plugging soil bore with bentonite

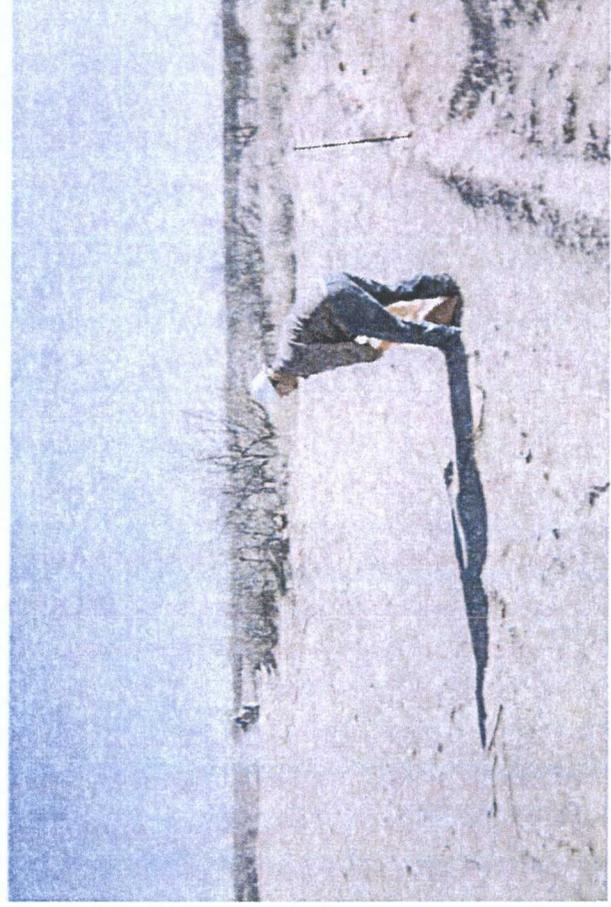
11/25/2009

Seeding site

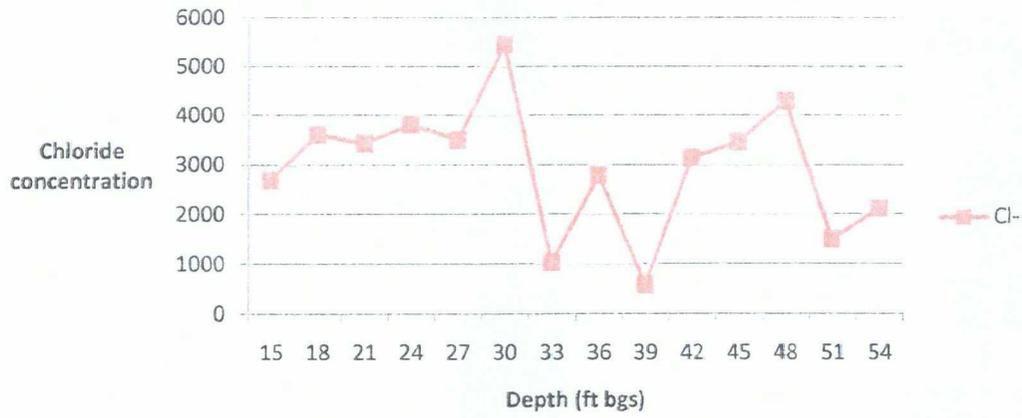
Chloride concentration versus depth

Depth (feet)	chloride field tests	LAB	PID	Description	Lithology	Well Construction
12 - 15 ft				VERY FINE TO FINE SAND; CALICHE & SANDSTONE light orangey brown, dry, no odor		
15	2706		1.9			
15 - 21 ft				VERY FINE TO FINE SAND; CALICHE & SANDSTONE orangey brown, dry, no odor		
18	3627		1.7			
21 - 24 ft				VERY FINE TO FINE SAND slight orangey brown, dry, no odor		
21	3446		2			
24 - 36 ft				VERY FINE TO FINE SAND; SANDSTONE light brown, dry, no odor		
24	3831		2.1			
27	3520		2.1			
30	5470	Cl 5-900 GRD <13.0 DRO <13.0	1.5			
33	1050		1.2

Depth (feet)	chloride field tests	LAB	PID	Description	Lithology	Well Construction
36	2802		1.8			
39	600		3.4			
42	3169		1.8	36 - 57 ft VERY FINE TO FINE SAND; SANDSTONE reddish orange, dry, no odor		
45	3471		2.2			
48	4305		2.9			
51	1506		0.7			
54	2127	CI-8300	1.4			
		GRD				
		<10.0				
		DRO				
		<10.0				
57				57 - 80 ft CLAY Chinle red bed clay		
80

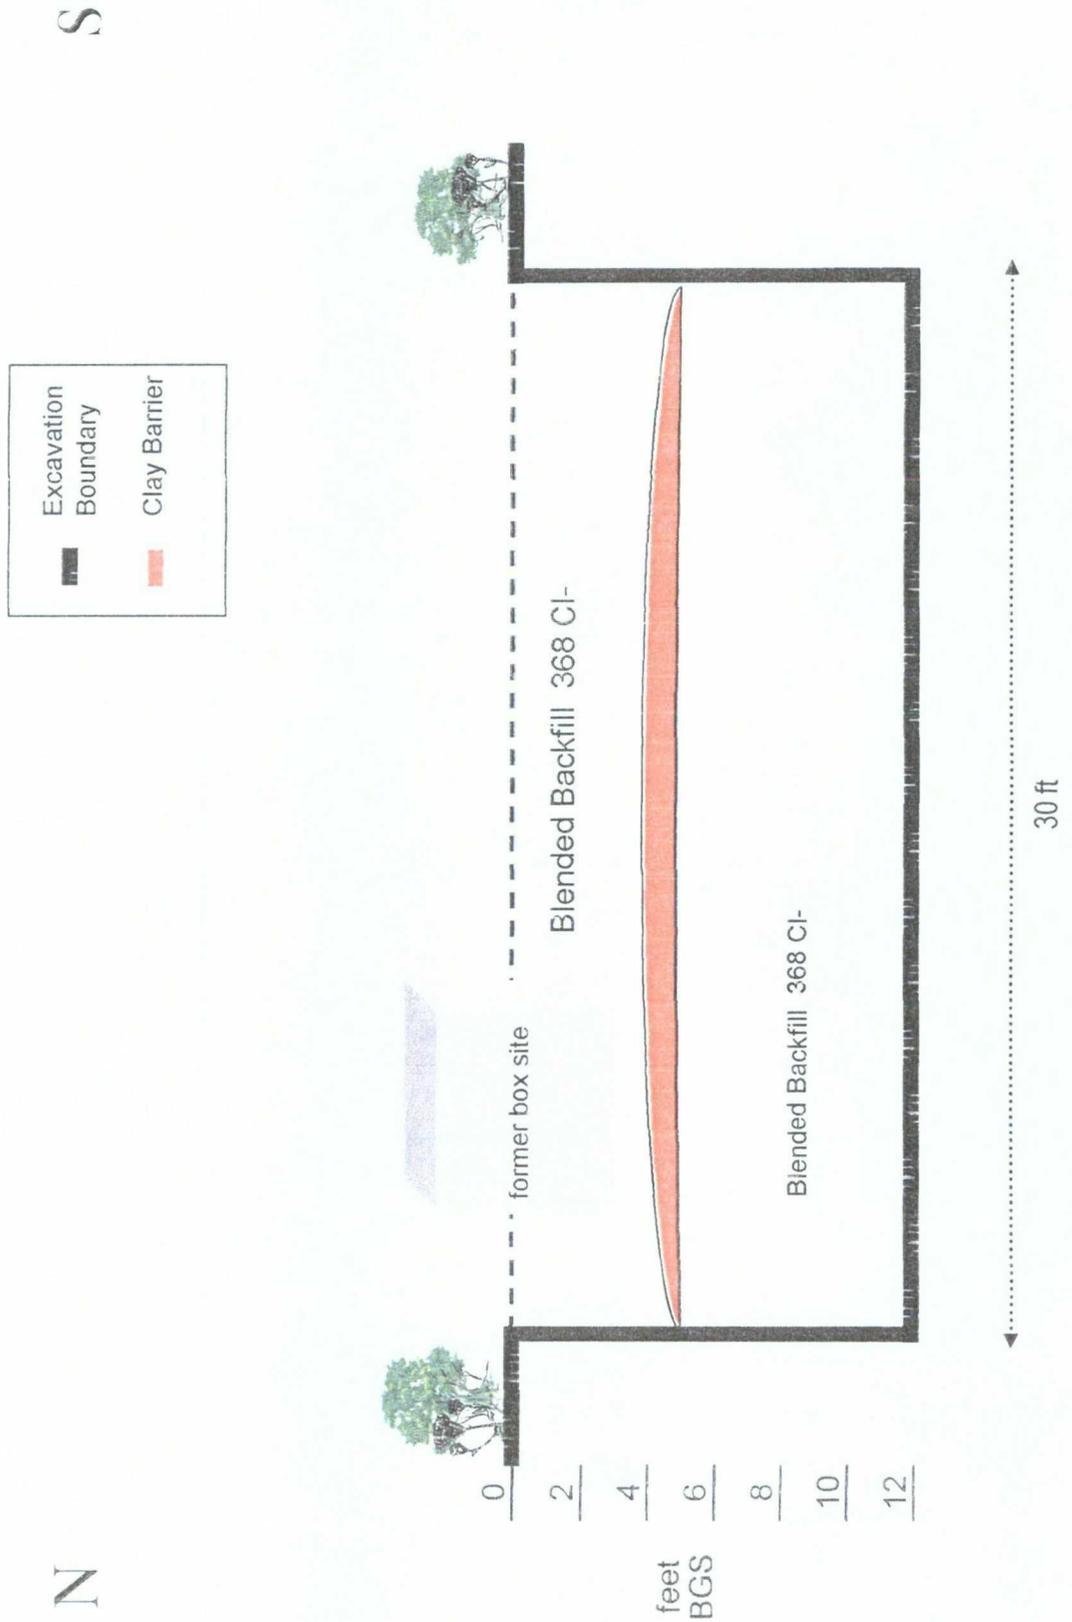
Excavation Cross-Section

BD J-25 EOL
Unit 'J', Sec. 25, T21S, R37E

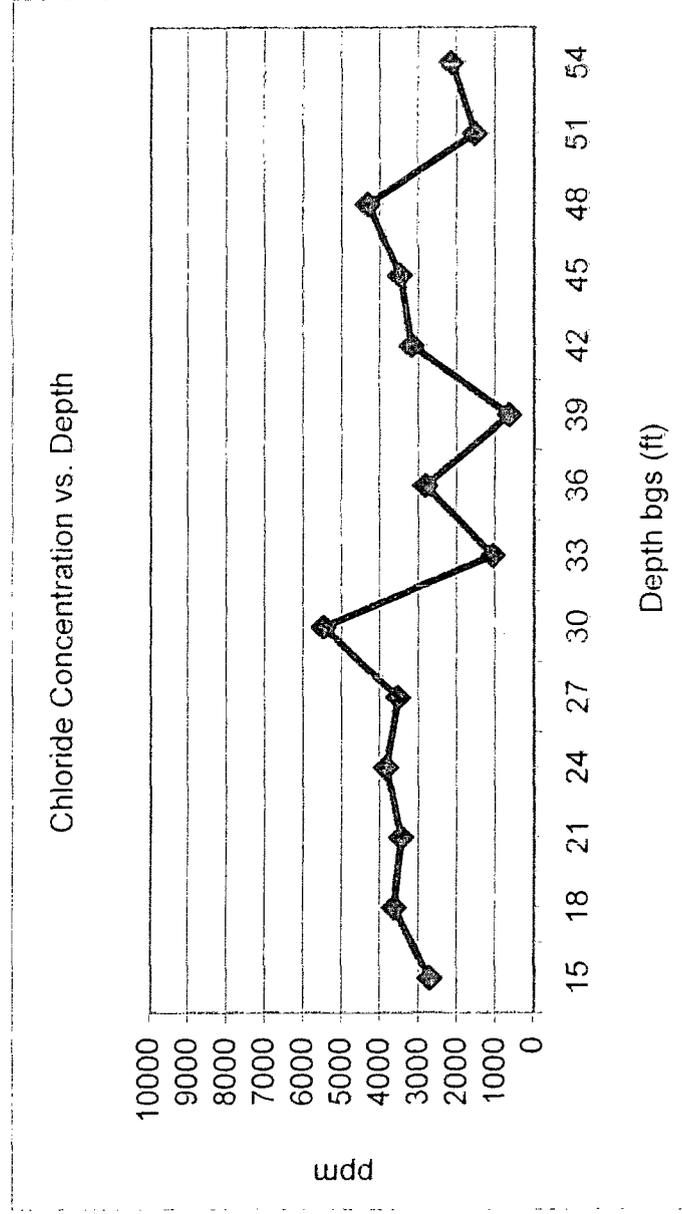
CHLORIDE CONCENTRATION CURVE

Soil bore samples 10 ft. east of former junction box

Depth bgs (ft)	Cl ppm
15	2706
18	3627
21	3446
24	3831
27	3520
30	5470
33	1050
36	2802
39	600
42	3169
45	3471
48	4305
51	1506
54	2127

Groundwater = none
