CLOSURE

RICE OPERATING COMPANY
JUNCTION BOX FINAL REPORT

BD A-17 EOL

Unit A, Section 17, T22S, R37E

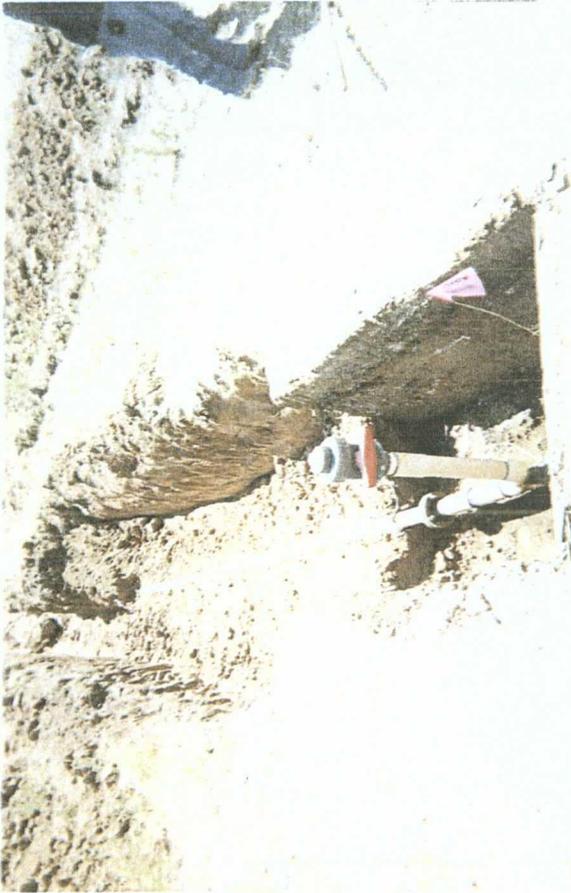
9/23/2009

Site prior to delineation

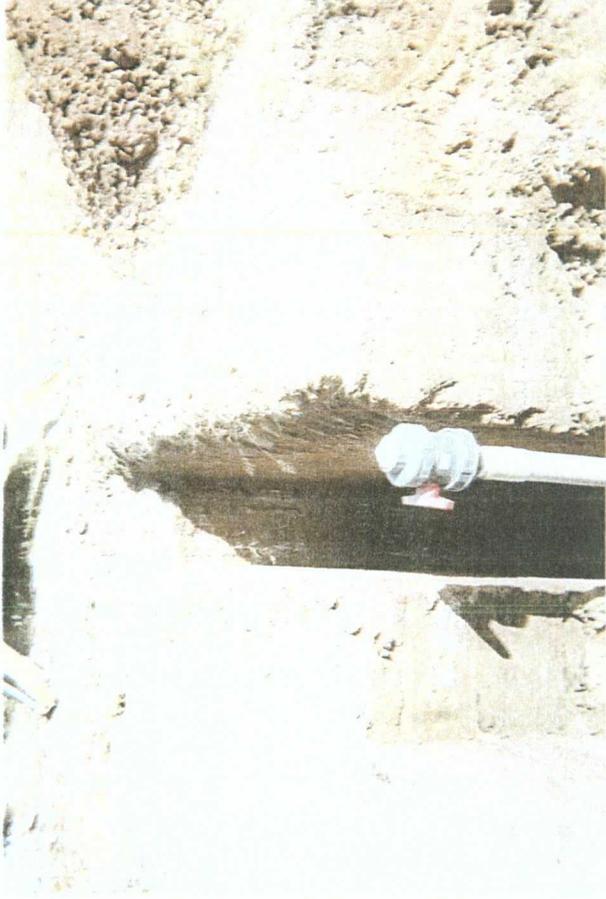
9/23/2009

Delineation trench at former junction site

LOCATION	DEPTH	mg/kg
background	6	150
vertical delineation trench at the junction (source)	4'	1751
	5'	1311
	6'	1363
	7'	1320
	8'	1110
	9'	570
	10'	598
	11'	300
	12'	208
