Jct  
BD K-25 EOL  
^ 2009

RICE OPERATING COMPANY  
JUNCTION BOX FINAL REPORT

SWD SYSTEM	JUNCTION	UNIT	SECTION	TOWNSHIP	RANGE	COUNTY	BOX DIMENSIONS - FEET		
							Length	Width	Depth
Blinebry-Drinkard (BD)	Jct. K-25 EOL	K	25	21S	37E	Lea	Eliminated

# BD K-25 EOL

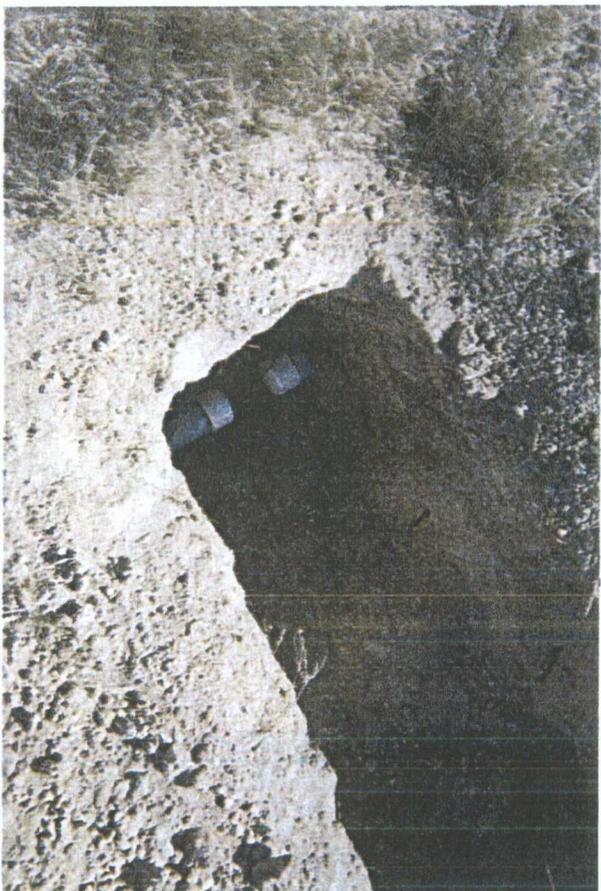
Site prior to excavation

12/18/2009

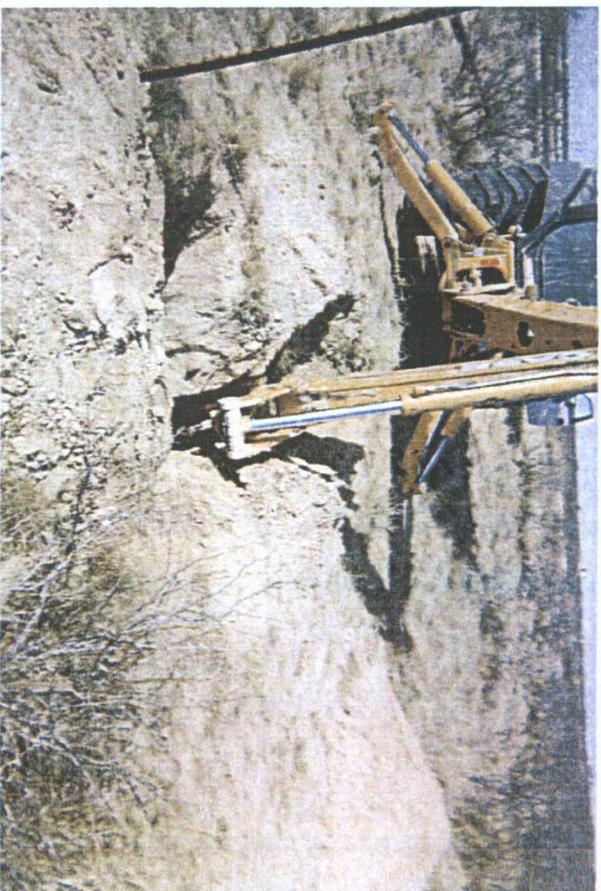
Delineation trench being excavated

12/18/2009

**General Description of Remedial Action:** This junction was eliminated during the pipeline replacement/upgrade program. After the former junction box was removed, an investigation was conducted using a backhoe to collect soil samples at regular intervals creating a 5x3x8-ft deep excavation. Chloride field tests were performed on each sample which yielded low concentrations. Organic vapors were measured using a PID, which also yielded low concentrations. The deepest sample, 8 ft BGS, was sent to a commercial laboratory for analysis of chloride and TPH. Lab analysis confirmed low concentrations of each. The excavated soil was returned to the excavation and contoured to the surrounding area. On 12/31/2009, site was seeded with a blend of native vegetation and is expected to return to a productive capacity at a normal rate.

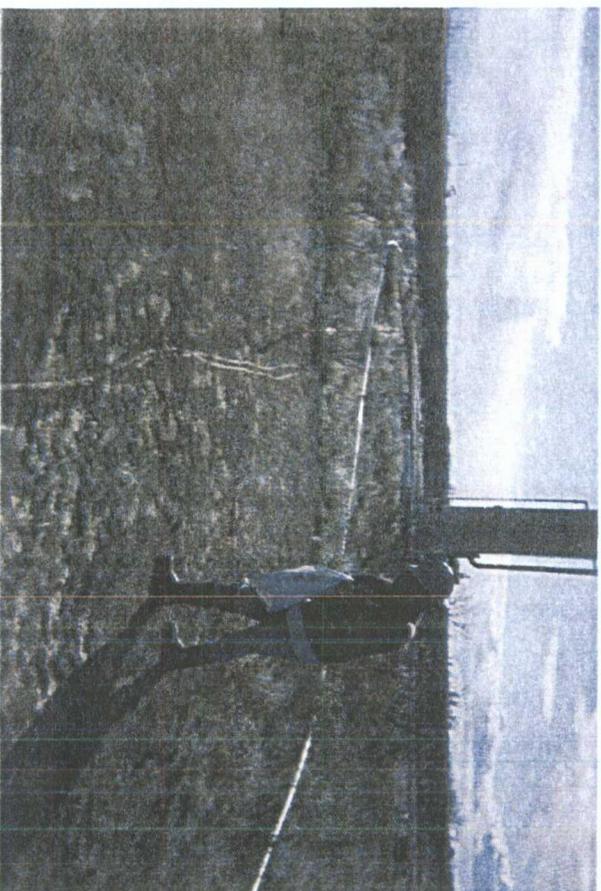
Seeding site

12/31/2009

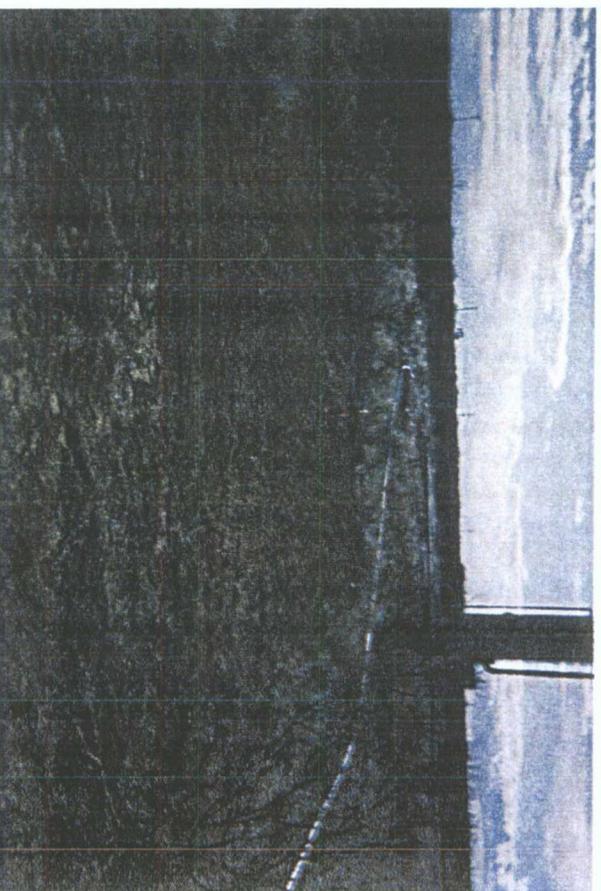
Site complete

12/31/2009

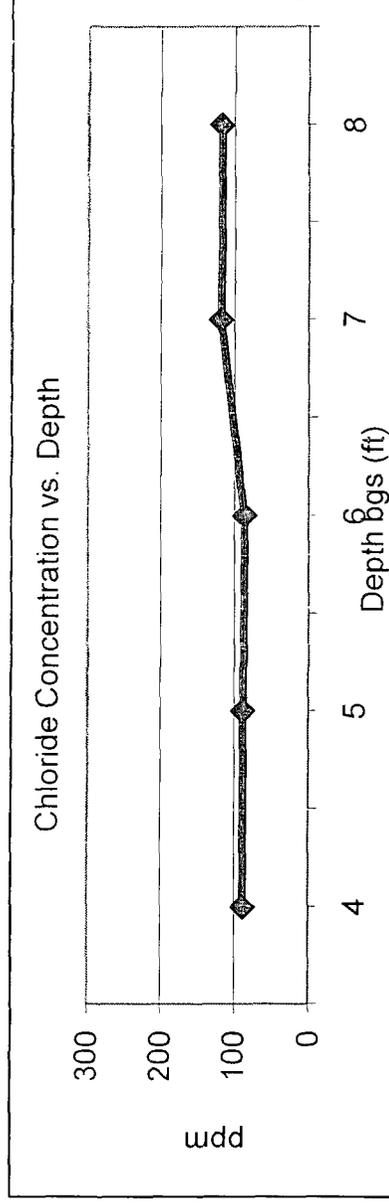
# CHLORIDE CONCENTRATION CURVE

Backhoe samples at the junction (source)

Depth bgs (ft)	[Cl] ppm
4	88
5	88
6	86
7	118
8	117

Groundwater = 42 ft

LOCATION	DEPTH	mg/kg
vertical delineation trench at the junction (source)	4'	88
	5'	88
	6'	86
	7'	118
	8'	117
