RICE OPERATING COMPANY
JUNCTION BOX FINAL REPORT

SWD SYSTEM	JUNCTION	UNIT	SECTION	TOWNSHIP	RANGE	COUNTY	BOX DIMENSIONS - FEET		
							Length	Width	Depth
Brinebry-Drinkard (BD)	P-24 EOL	P	24	21S	36E	Lea	4'	4'	3'
							Eliminated

BD P-24 EOL

Unit P, Section 24, T21S, R36E

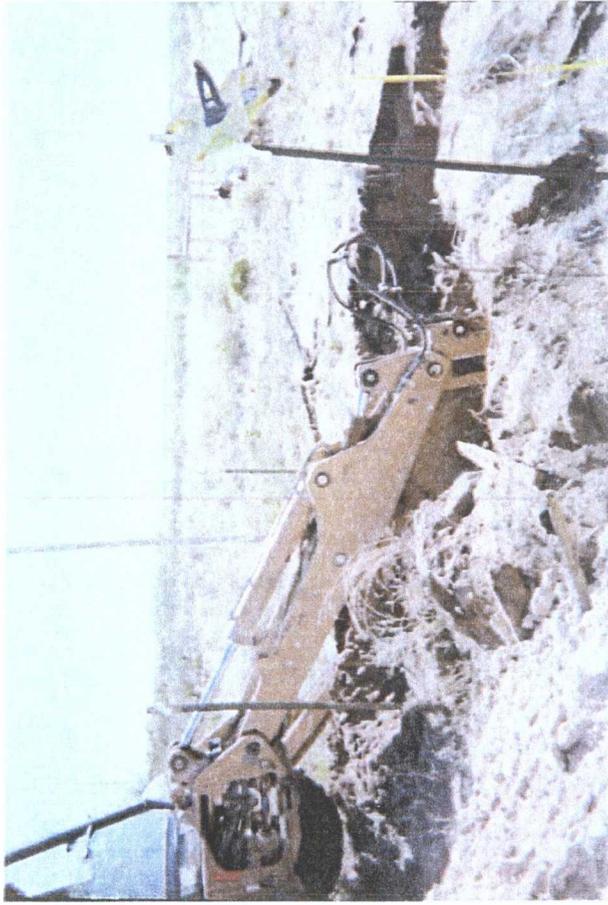
11/03/2009

Delineation trench at former junction box

General Description of Remedial Action: This junction was eliminated under the pipeline replacement/upgrade program. After the former junction was removed, an investigation was conducted using a backhoe to collect soil samples at regular intervals. Chloride field tests were performed on each sample, which concentrations decreased with depth. Organic vapors were measured using a PID, which also yielded low concentrations. The deepest sample, 11 ft BGS, was sent to a commercial laboratory for analysis, which confirmed low concentrations of chloride and organics. The excavated soil was returned to the excavation to ground surface and contoured to the surrounding area. On 11/30/09, the site was seeded with a blend of native vegetation and is expected to return to a productive capacity at a normal rate.

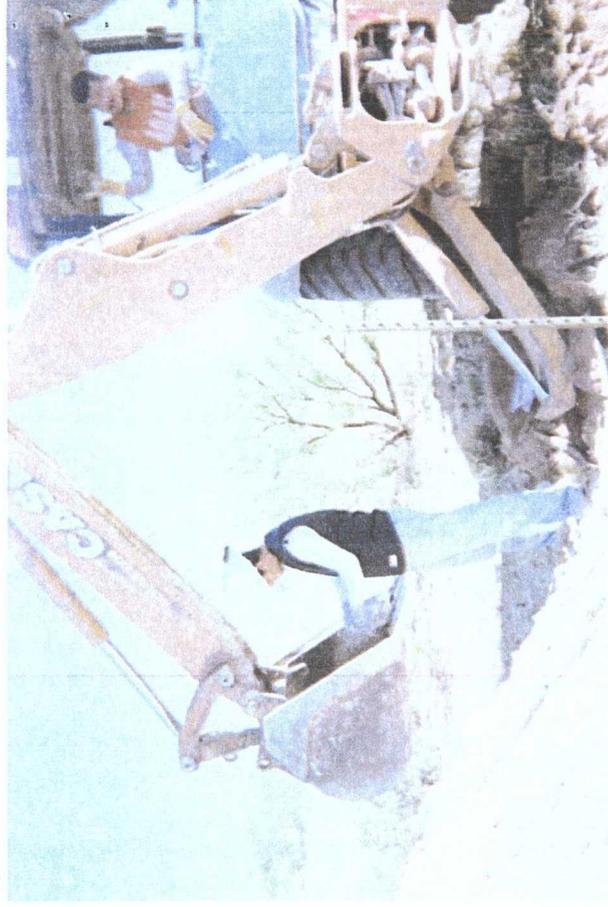
11/03/2009

Sample being taken

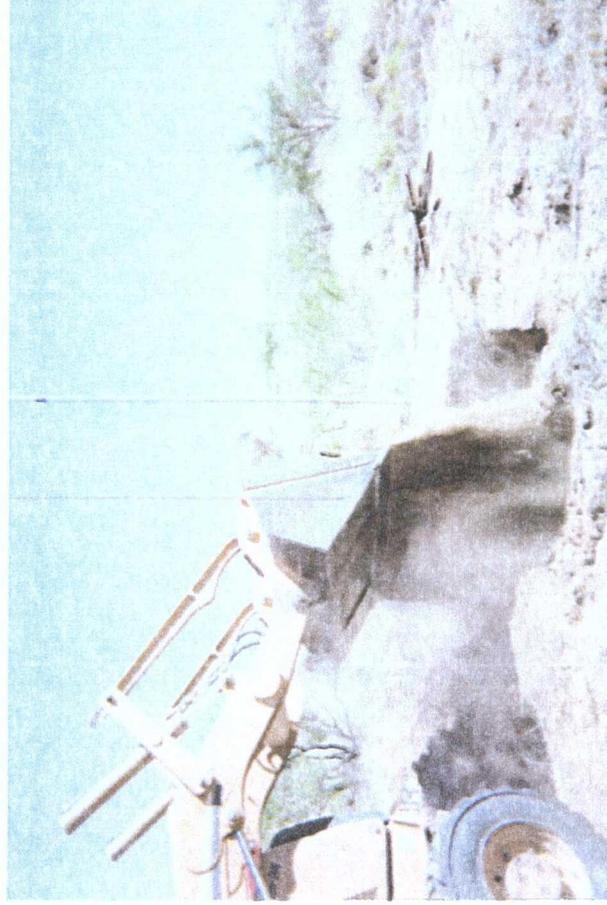
11/03/2009

Backfilling excavation

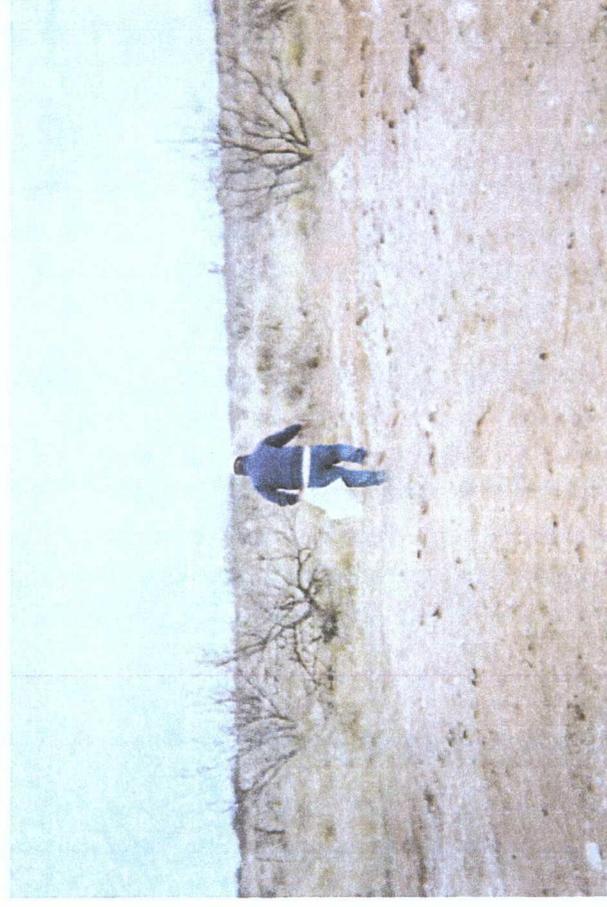
11/30/2009

Seeding site

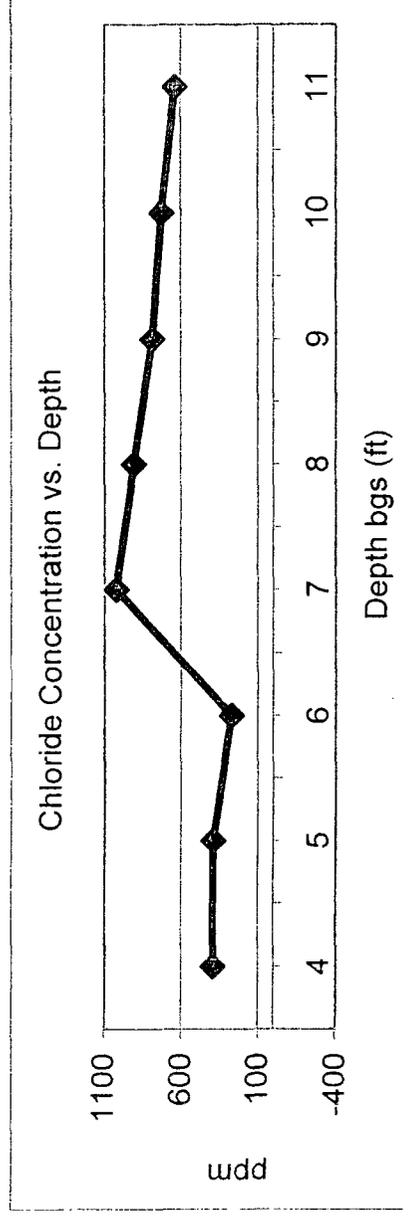
CHLORIDE CONCENTRATION CURVE

Backhoe samples at the junction (source)

Depth bgs (ft)	[Cl] ppm
4	394
5	390
6	270
7	1016
8	900
9	780
10	720
11	630

Groundwater = 136 ft.

LOCATION	DEPTH	mg/kg
background	6"	90
vertical delineation trench at the junction (source)	4'	394
	5'	390
	6'	270
	7'	1016
	8'	900
	9'	780
	10'	720
	11'	630
