RICE OPERATING COMPANY  
JUNCTION BOX DISCLOSURE\* REPORT

BOX LOCATION									
SWD SYSTEM	JUNCTION	UNIT	SECTION	TOWNSHIP	RANGE	COUNTY	BOX DIMENSIONS - FEET		
Blinebry-Drinkard (BD)	Jct. B-1 (3 boxes)	B	1	22S	36E	Lea	Length	Width	Depth
							moved 30 ft east

# BD Jct. B-1

Unit B, Section 1, T22S, R36E

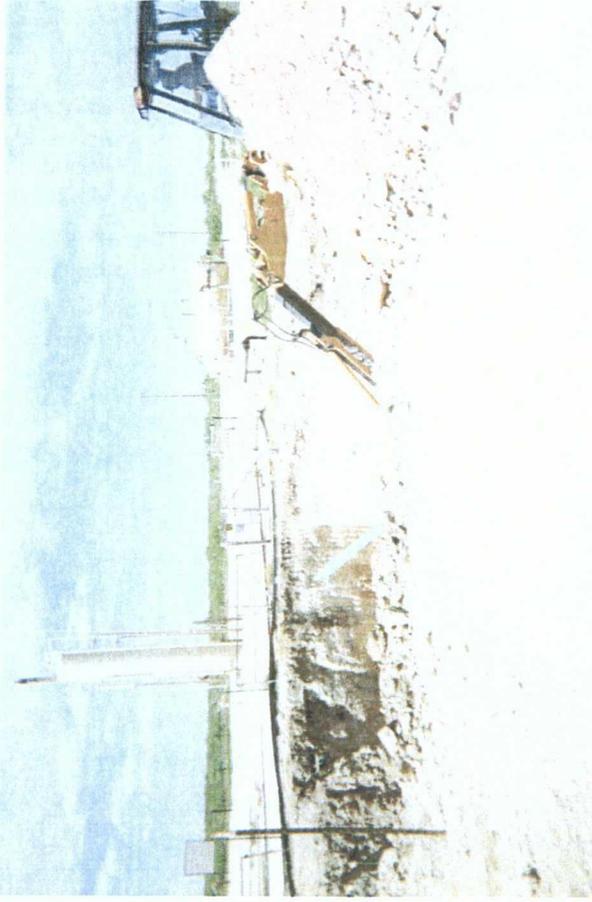
excavating the former junction box site, facing south 7/8/2009

**General Description of Remedial Action:** These junction boxes were addressed during the pipeline replacement/upgrade program. After the former junction boxes were removed, an investigation was conducted using a backhoe to collect soil samples at regular intervals producing a 30x40x12-ft deep excavation. Chloride field tests were performed on each sample and yielded elevated concentrations that did not relent with depth. Organic vapors were measured using a PID which yielded some elevated concentrations. The excavated soil was blended on site with clean, imported soil. Representative composite samples were collected from the blended excavated soil, the bottom of the excavation, and the excavation walls. Laboratory analysis of the representative samples confirmed elevated concentrations of chloride. The blended excavated soil was returned to the excavation up to 5 ft below ground surface (BGS). At 5-4 ft BGS, a 1-ft thick clay barrier was installed with a compaction test performed on 7/16/2009. The remaining backfill was blended with clean, imported soil and used to backfill the excavation to ground surface and to contour to the surrounding area. A new, watertight junction box was built 30 ft east of the former. On 9/9/2009, the site was seeded with a blend of native vegetation and is expected to return to a productive capacity at a normal rate. To further investigate depth of chloride presence, a soil bore was initiated on 9/28/2009 at 8 ft west of the former junction boxes. The boring was advanced to depth of 115 ft BGS with soil samples collected every 5 ft and field tested for chloride and organic vapors. Laboratory analysis of the 25 ft and 115 ft samples confirmed elevated concentrations of chloride that decreased with depth and low concentrations of TPH. The entire bore hole was plugged with bentonite to the ground surface. NMOCD was notified of potential groundwater impact on 2/26/2010.

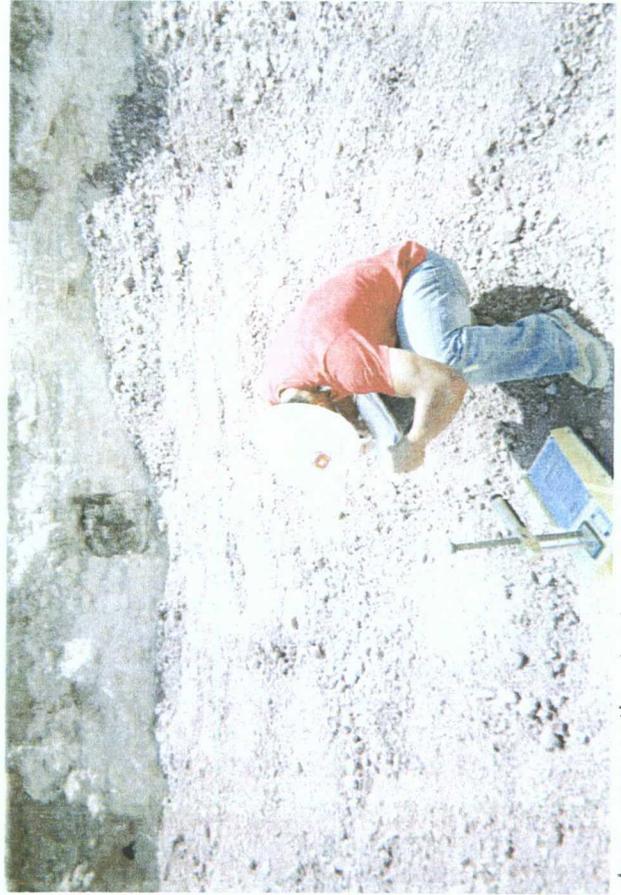
clay compaction test

Test No.	Location	Dry Density % Max	% Moisture	Depth
SG 16	BD - JCT B-1 - 15' E. & 65' S. of NW Corner of Junction Box	90.7	17.8	5' Below Surface

**Required Compaction:** 90 - 95%

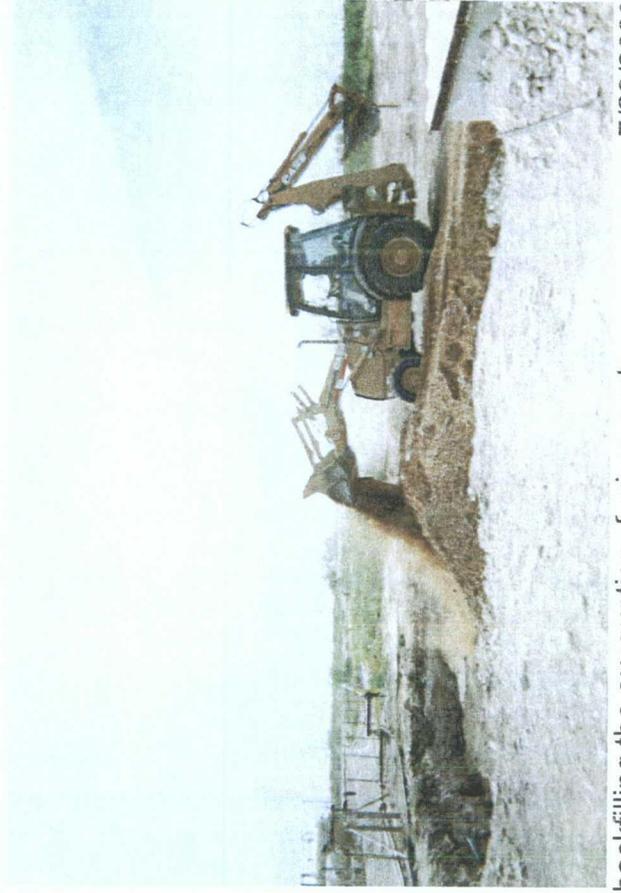
backfilling the excavation, facing west

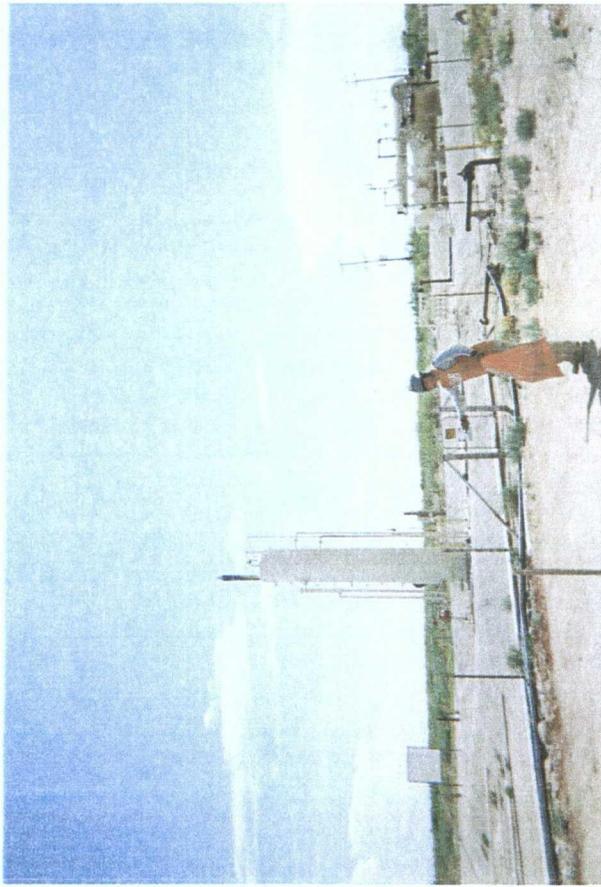
seeding the backfilled site, facing west

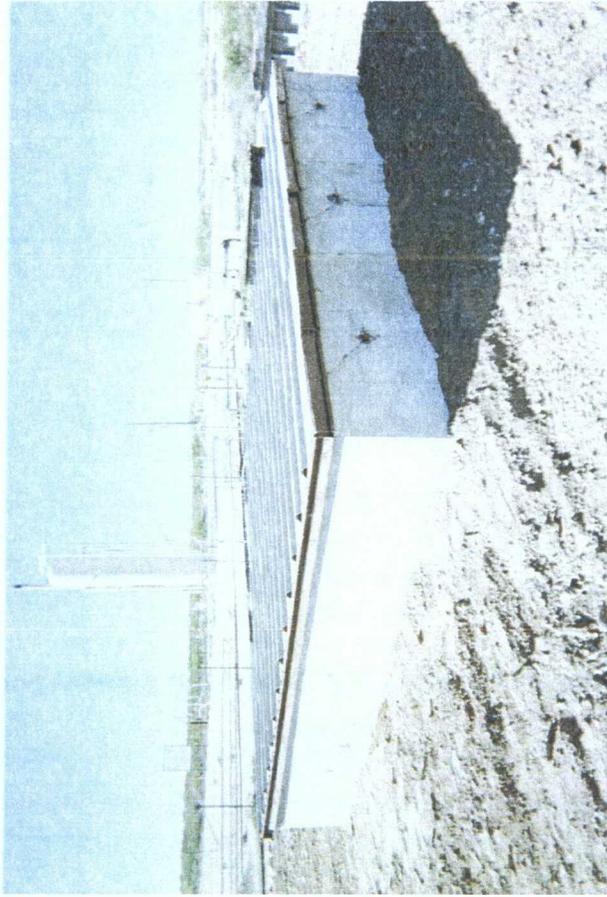
new, watertight junction box 30 ft east

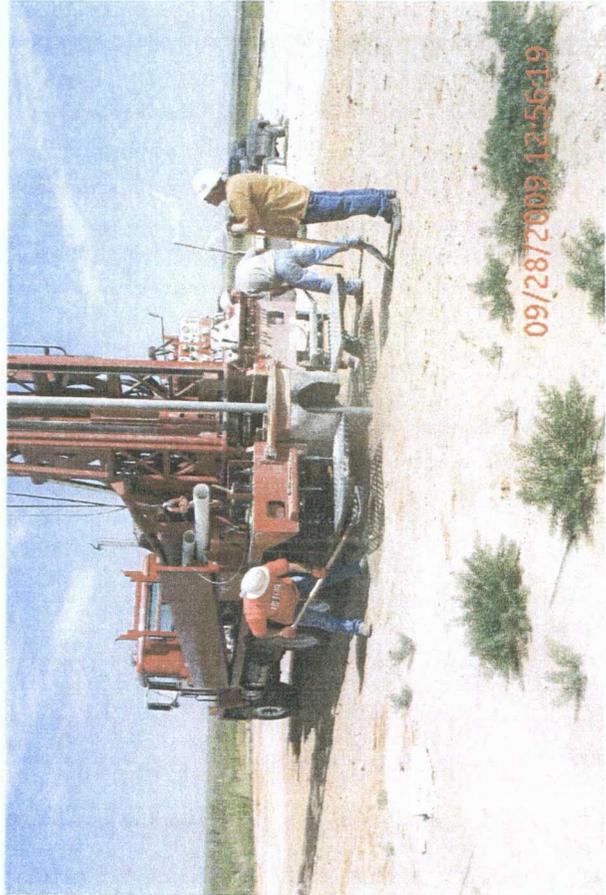
drilling SB #1

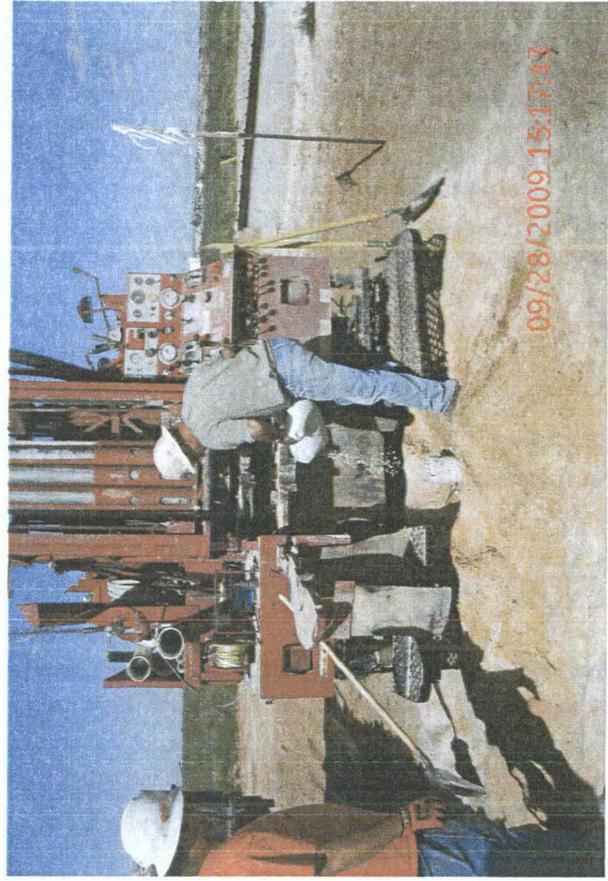
plugging SB #1 with bentonite

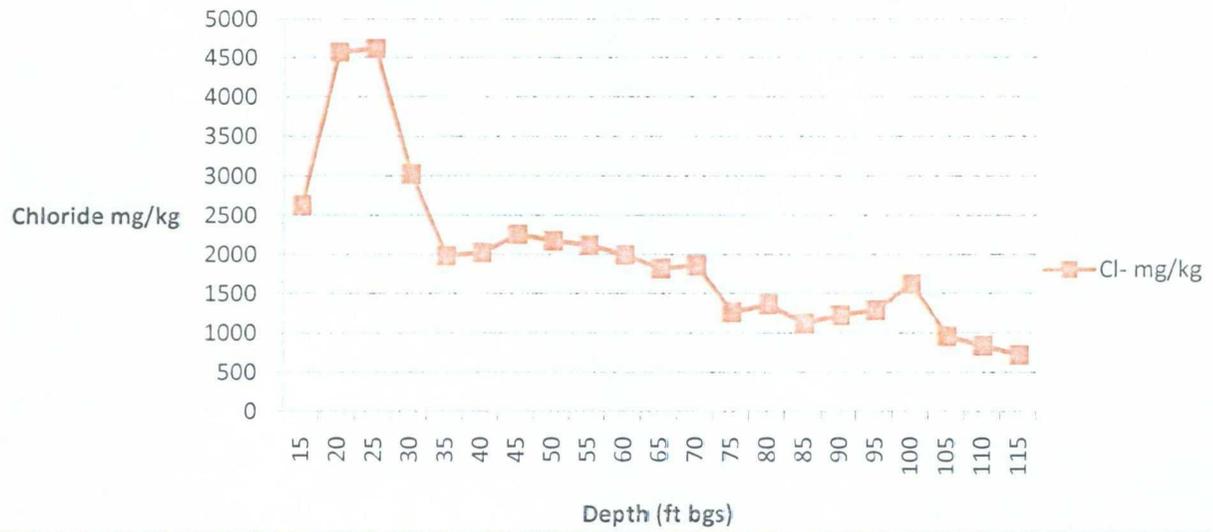
## Chloride Concentration versus Depth

Depth (feet)	chloride field tests	LAB	PID	Description	Lithology	Well Construction
15	2636		4.8	10 - 25 ft VERY FINE TO FINE SAND WITH CONSOL. ROCK light brown, dry, slight hydrocarbon odor		
20	4574		1.9			
25	4618	Cl- 4640 GRO <10.0 DRO <10.0	0.8			
30	3027		0.1			
35	1985		0	25 - 55 ft VERY FINE TO FINE SAND orangey-brown, dry, no odor		
40	2028		0.5			
45	2260		0.1			
50	2178		0			
55	2124		0

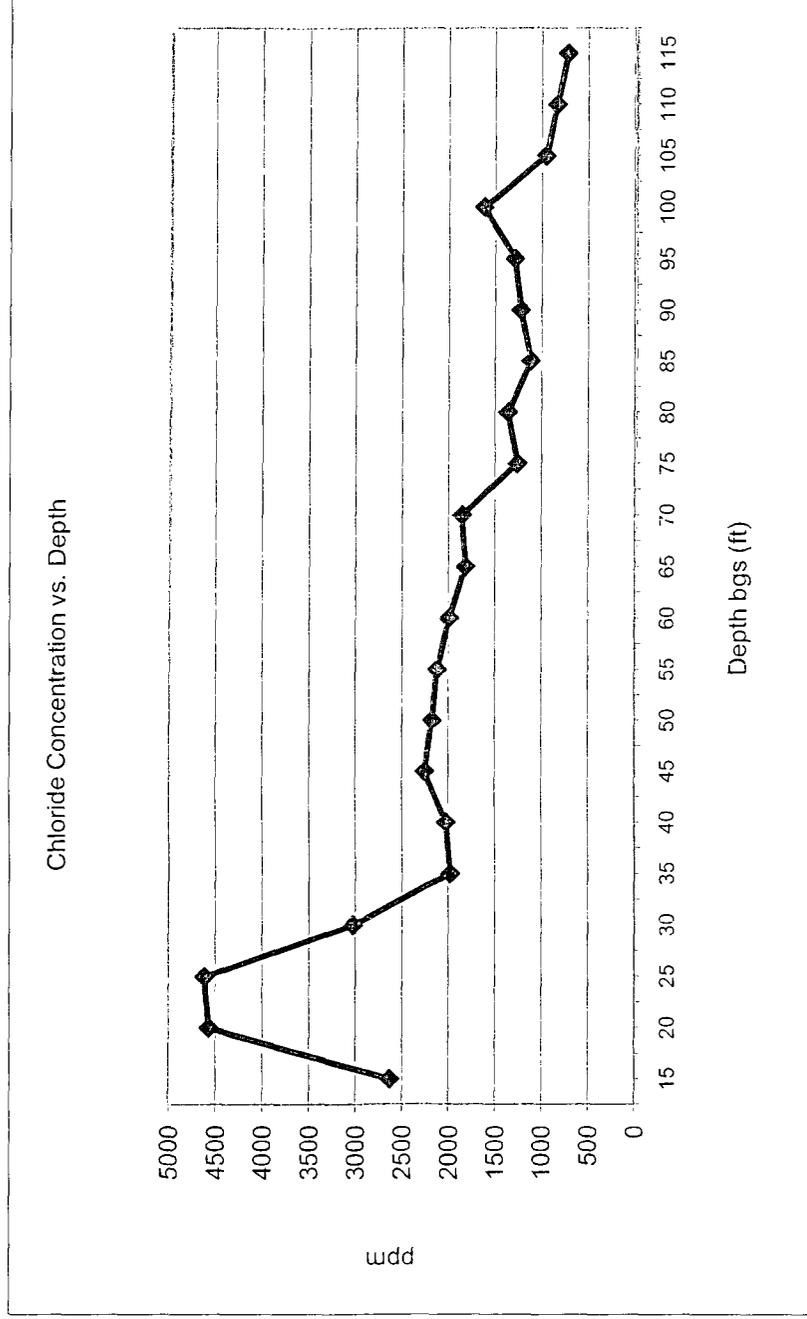
CHLORIDE CONCENTRATION CURVE

SOIL BORE samples at 8 ft west of the junction (source)

Depth, bgs (ft)	Cl <sup>-</sup> , ppm
15	2636
20	4574
25	4618
30	3027
35	1985
40	2028
45	2260
50	2178
55	2124
60	1998
65	1823
70	1859
75	1264
80	1363
85	1121
90	1228
95	1292
100	1623
105	960
110	841
115	723

Groundwater = 137 ft
