Corrective Action Plan Report and Termination Request
Eunice Monument Eumont (EME) Jct. F-18, NMOCD Case #1R 427-168
T20S, R37E, Section 18, Unit F, Eunice, Lea County, New Mexico

Project Number	MT000911.0001
Drawing Date	9/16/09
Figure	1

RICE OPERATING COMPANY
EUNICE MONUMENT EUMONT (EME) JCT. F-18
INFILTRATION BARRIER
EXTENSION
Eunice, Lea County, New Mexico

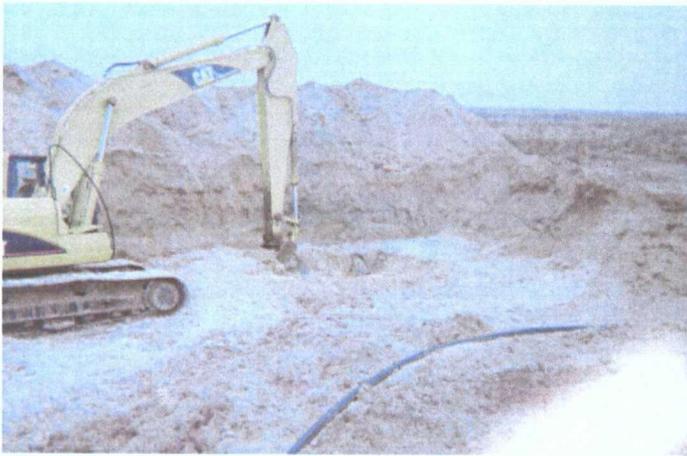
Excavating EME Jct. F-18

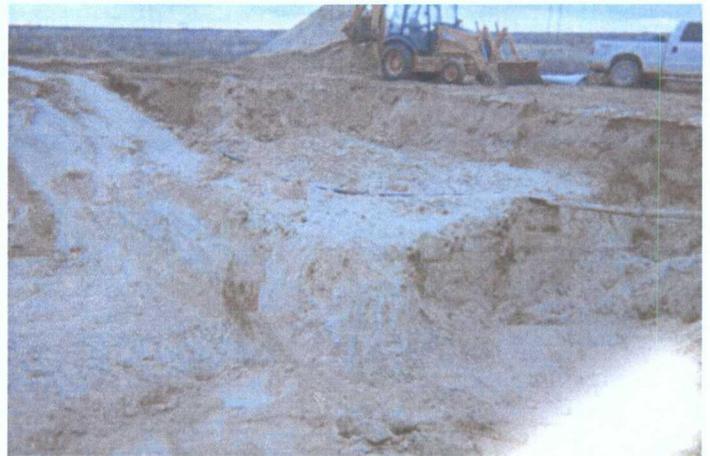
Final excavation to 5 ft BGS and 12 ft BGS on the North and East portion of the site

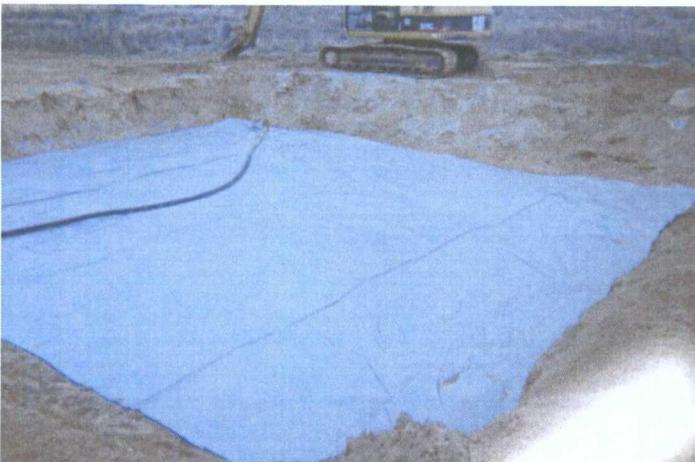
Placement of the liner

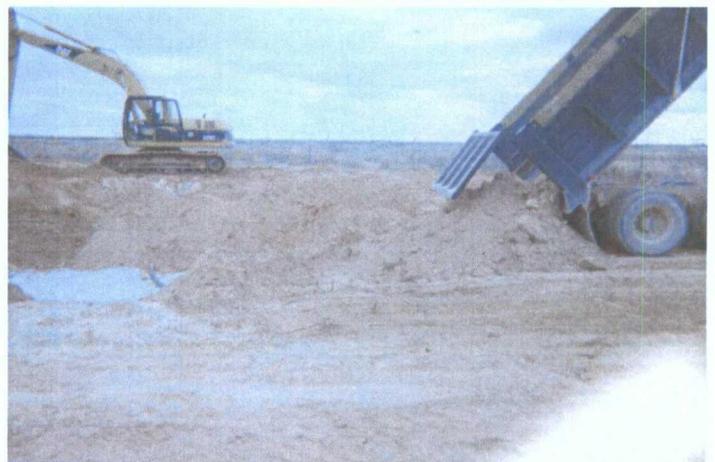
Backfilling the site

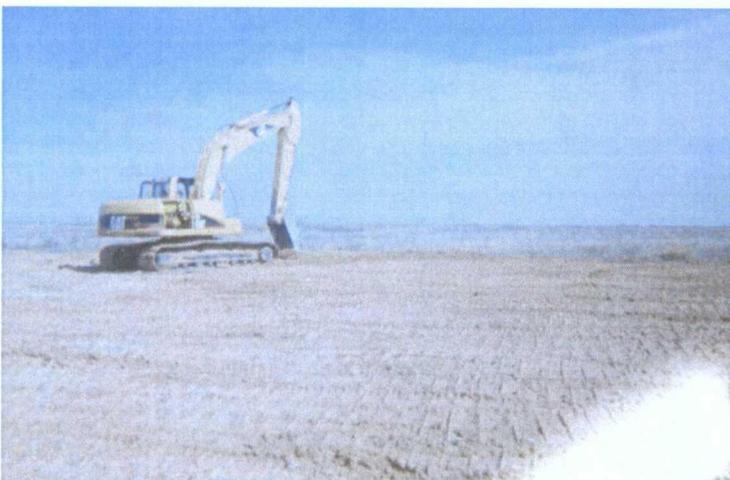
Site after being backfilled

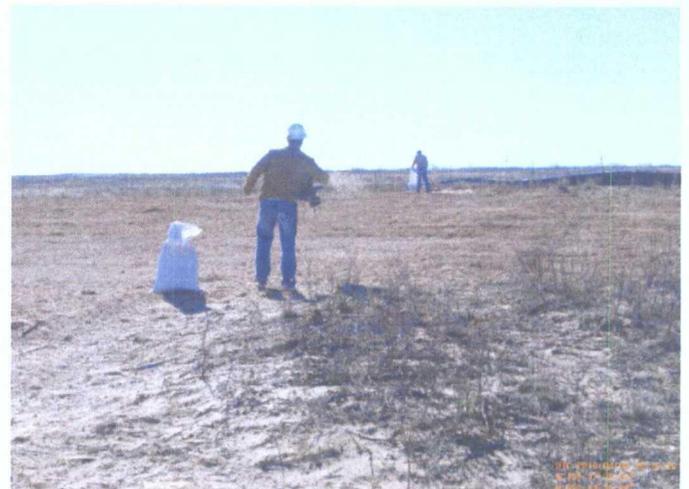
Seeding the site

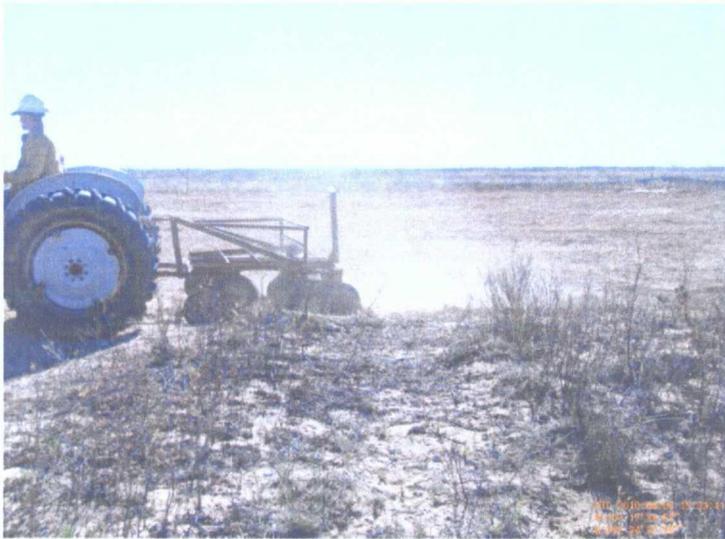
Tilling the seed into the soil
