1R426-259

# RICE OPERATING COMPANY JUNCTION BOX DISCLOSURE REPORT

## BD Jct. N-11 Boot

Unit N, Section 11, T22S, R37E

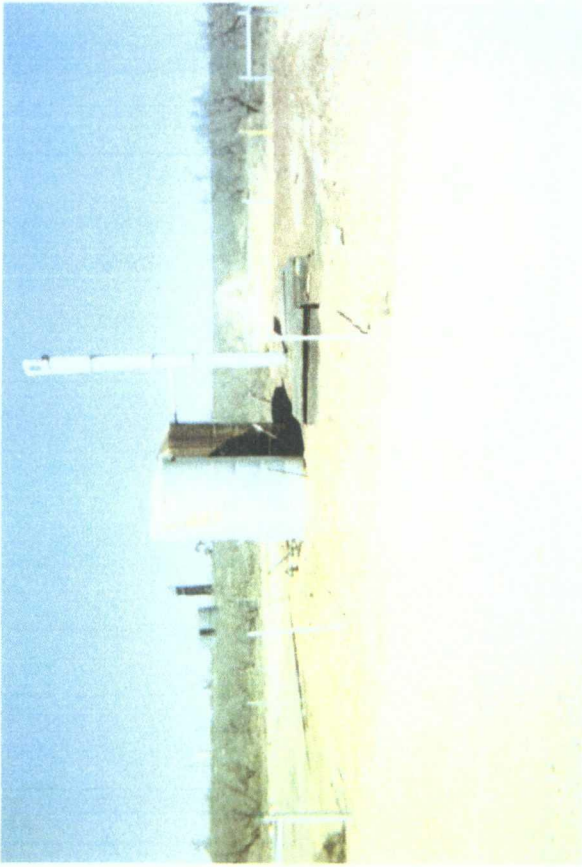
Site prior to excavating

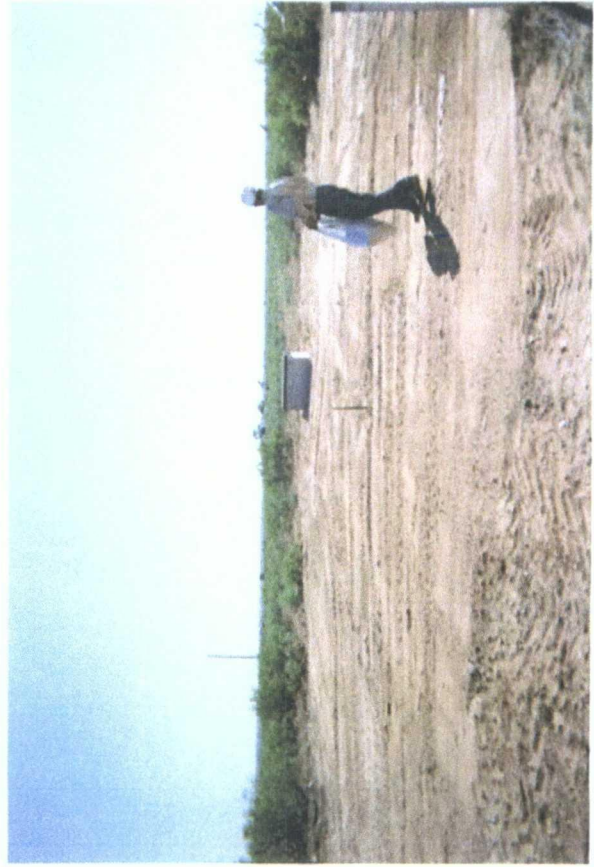
Compaction test

Seeding excavation

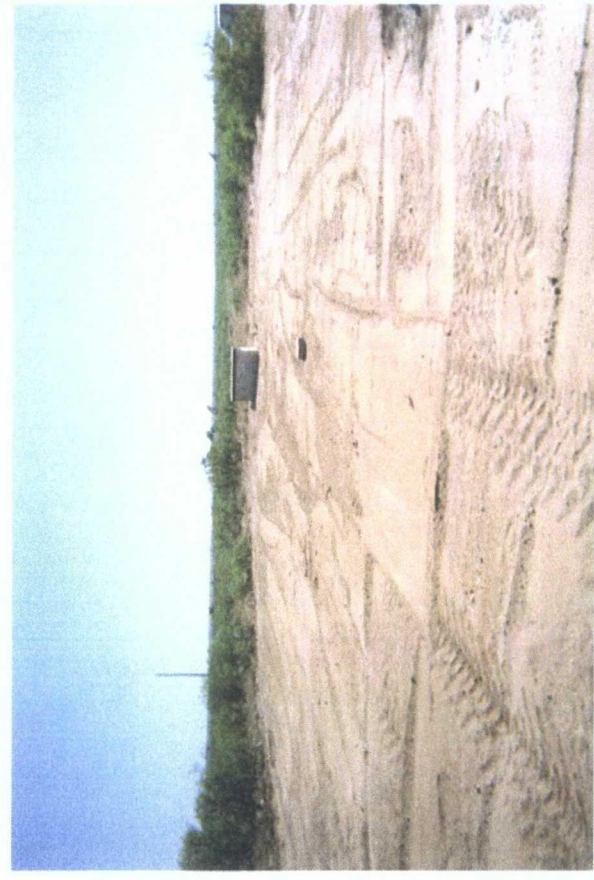
Excavation complete
