RE: **Termination Request**
Hobbs Jct. O-13 Site: NMOCD CASE #: 1R428-72
Township 18S, Range 37E, Section 13, Unit O

On behalf of Rice Operating Company (ROC), R.T. Hicks Consultants, Ltd. is submitting this Termination Request for the Hobbs Jct. O-13 regulatory file. The investigation demonstrated that neither chloride nor hydrocarbons are present in the vadose zone in quantities that represent a threat to ground water quality.

ICP Field Program Results, Hobbs O-13

Attachment B
Laboratory Reports
Backhoe Delineation

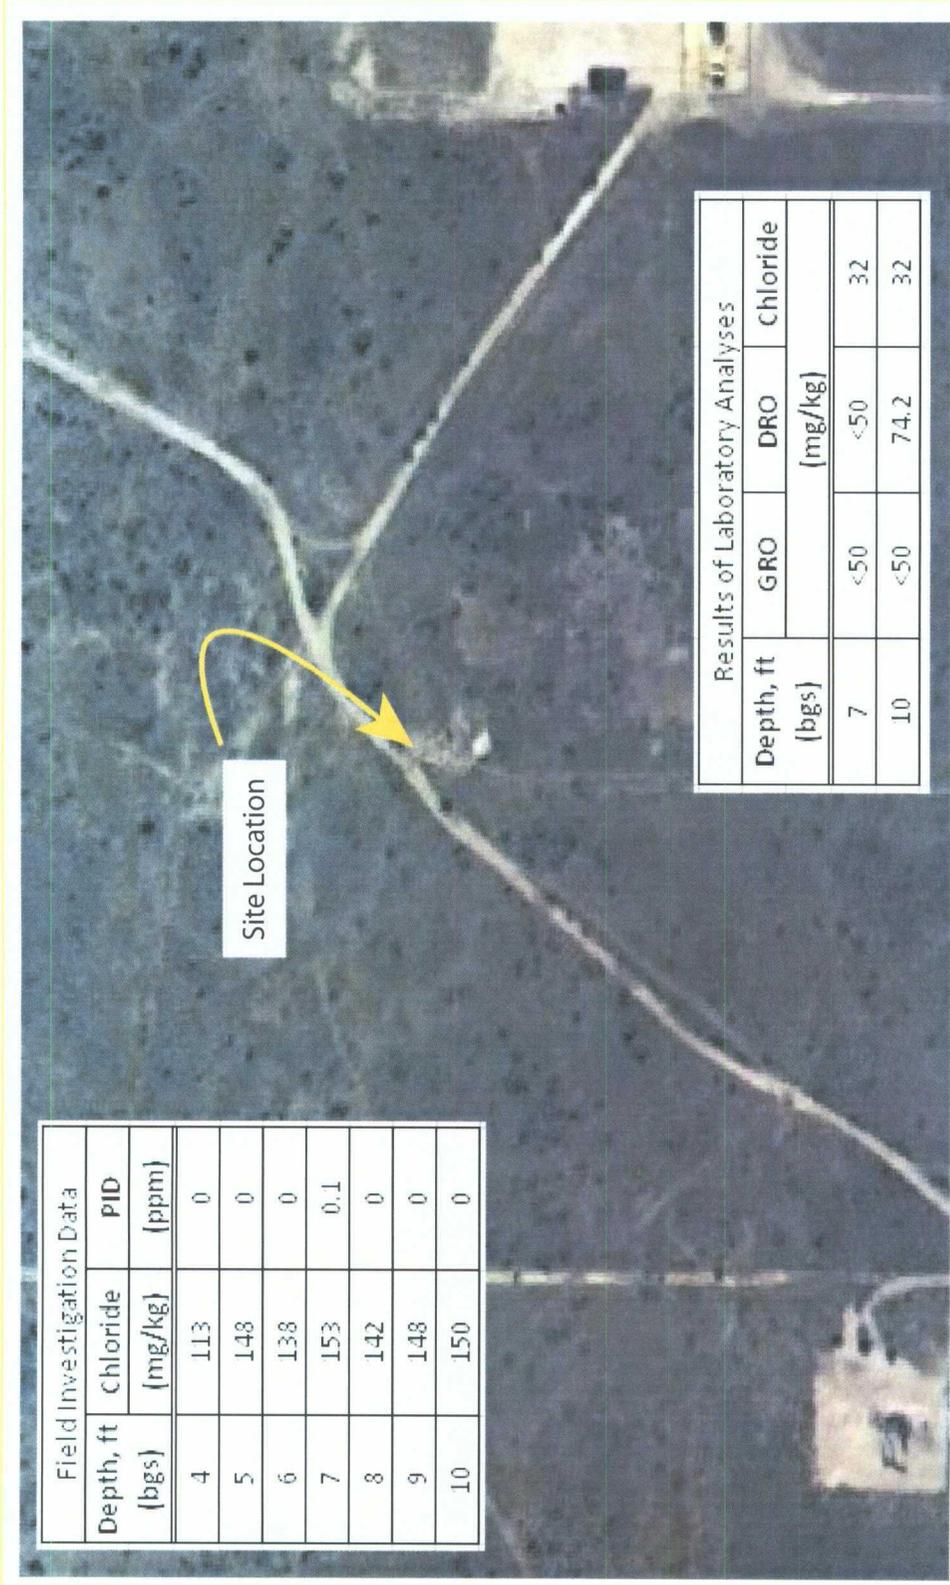
Field Investigation Data		
Depth, ft (bgs)	Chloride (mg/kg)	PID (ppm)
4	113	0
5	148	0
6	138	0
7	153	0.1
8	142	0
9	148	0
10	150	0

Results of Laboratory Analyses		
Depth, ft (bgs)	GRO	Chloride
	(mg/kg)	
7	<50	32
10	<50	32

Aerial Photo: 2005/06 Source: RGIS

Confirmation laboratory analysis for chloride was performed on the 7- and 10-foot samples; both showed chloride concentrations of 32 mg/kg. The laboratory results and chain-of-custody as well as the field documentation of the backhoe excavation are provided in Attachment B. Plate 1 shows the site on a recent aerial photograph and presents all the field screening and laboratory verification results.

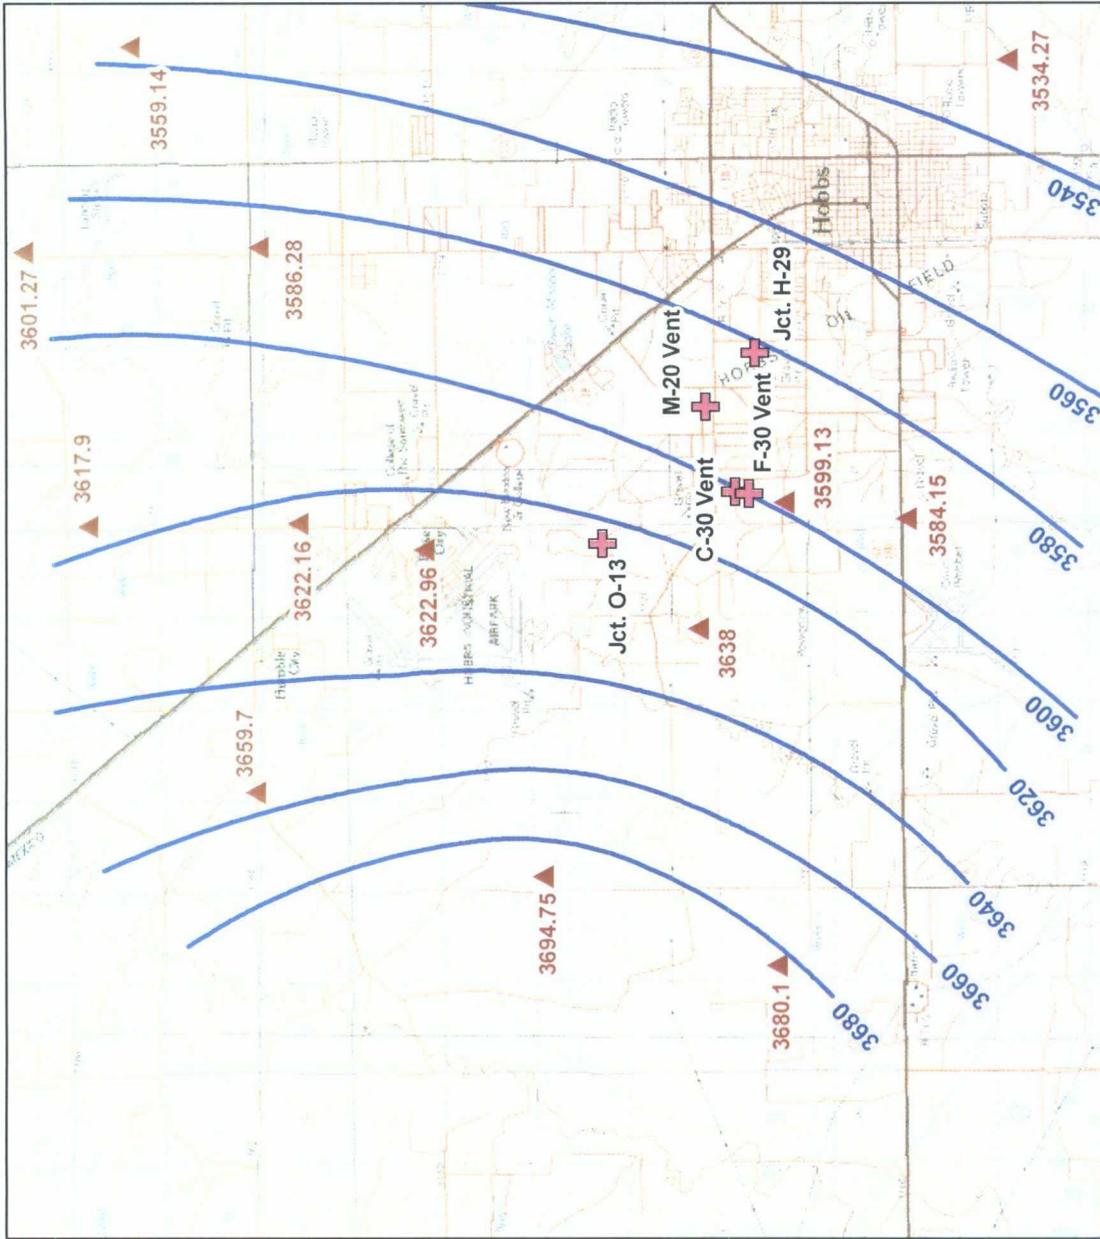
Plate 2
 February 2010

- + ROC Site
- USGS gauging station (2007)
[ground water elevation (ft)]
- Potentiometric surface (ft. amsl)
(derived from USGS 2007)

2007 Potentiometric Surface Map
 C-30 Vent, F-30 Vent, Jct. H-29, Jct. O-13, M-20 Vent
 Rice Operating Company
 2010 Hobbs Investigation and Characterization Plan

On behalf of Rice Operating Company (ROC), R.T. Hicks Consultants, Ltd. is pleased to submit this Investigation & Characterization Plan (ICP) for the Hobbs Jct. O-13 site. Plate 1 is a map showing the site relative to major roads in the area. Plate 2 shows the site, nearby USGS monitoring wells, and a regional potentiometric surface map.

- c. Soil boring to capillary fringe should neither (a) or (b) apply.
8. If the boring penetrates the capillary fringe, a monitoring well will be completed with a 2 or 4" diameter casing down gradient from confirmed impact for use during possible corrective actions. Ground water will be analyzed for chloride, sulfate, TDS and BTEX if warranted. Plate 2 presents a potentiometric surface map for the site area.

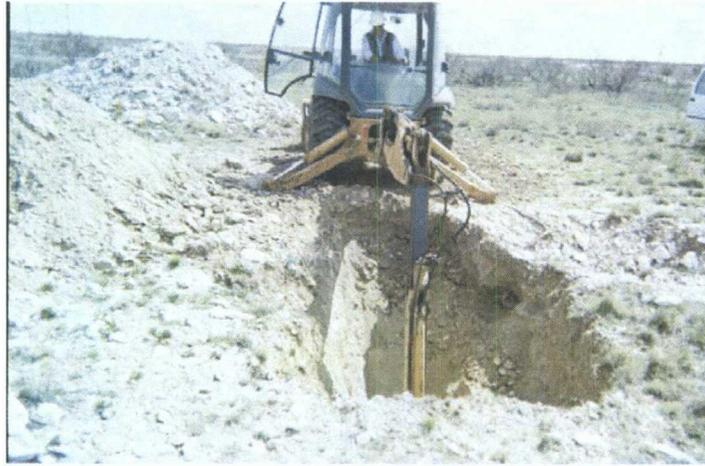
excavating the source trench

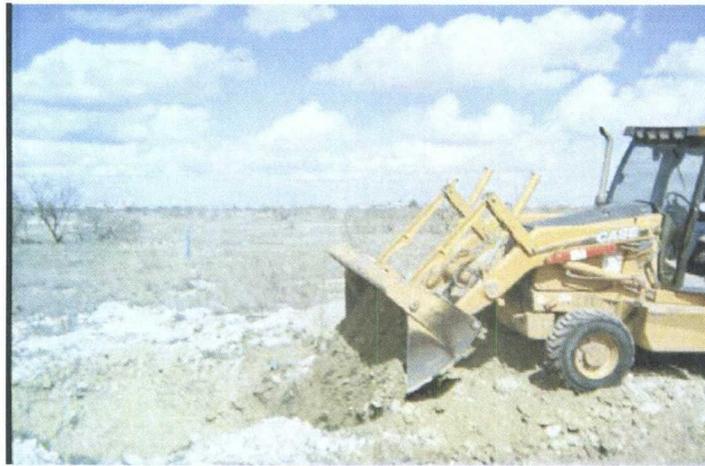
backfilling the source trench

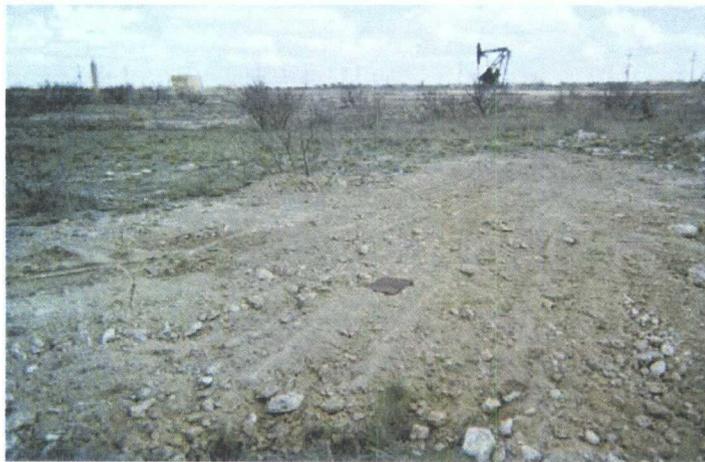
site complete

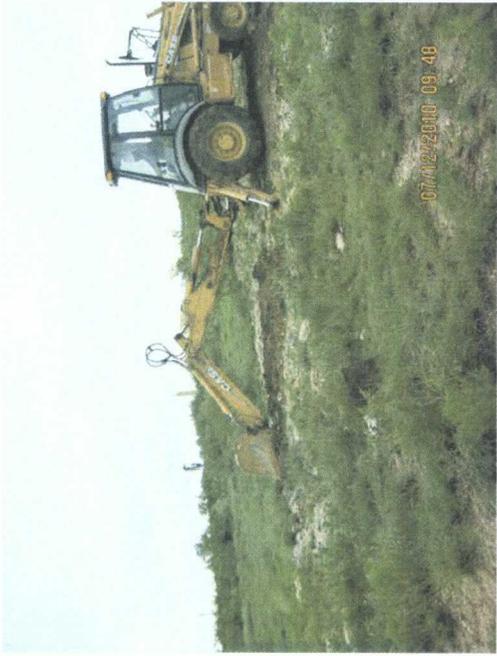
Removing rock from area

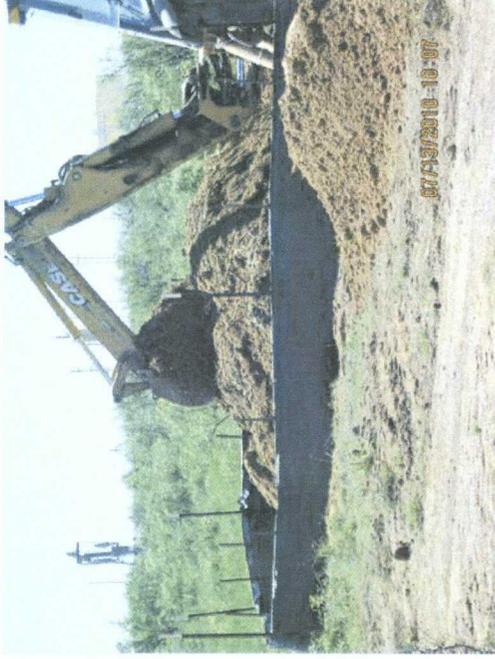
Blending hay with imported soil

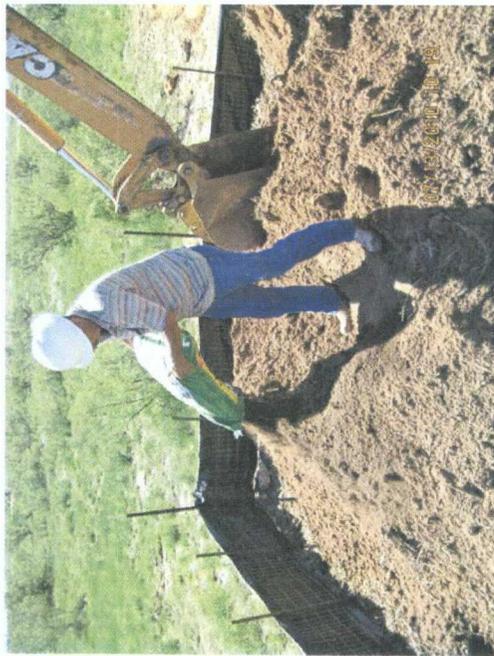
Adding amendments (Peat Moss)

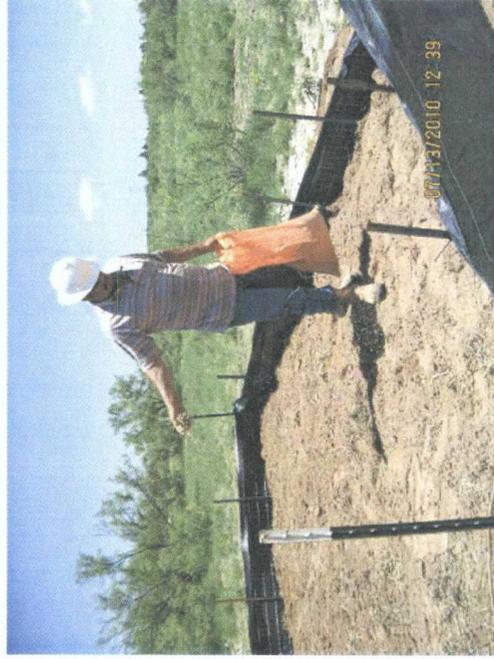
Seeding site

Attachment C presents documentation of filling in the excavation at the site, installation of imported soil, grading to match the surroundings and seeding the site with native plant seeds. On July 13, 2010, ROC prepared the surface and seeded the site with 3 lbs. of Pecos Mix, ½ lbs. Blue Grama and 3 lbs. Horseshoe Oats. The area surrounding the site is well vegetated, as shown in Attachment C.
