RE: CAP Report and Termination Request, Rice Operating Company, Blinebry Drinkard (BD) Saltwater Disposal System (SWD) O-17-1 Vent, Unit O, Section 17, T-21-S, R-37-E, Lea County, New Mexico, NMOCD CASE #1R426-12.

Tetra Tech, Inc. (Tetra Tech) submits the following CAP Report and Termination Request for the Rice Operating Company (ROC), Blinebry Drinkard (BD) Salt Water Disposal (SWD) System O-17-1 Vent, NMOCD Case #1R426-12. ROC is the service provider (agent) for the BD SWD System and has no ownership of any portion of the pipeline, well or facility. The BD SWD system is owned by a consortium of oil producers, System Parties, who provide all operating capital on a percentage ownership/usage basis. The site is shown on Figures 1 and 2.

BD O-17-1 vent (1R426-12)
Unit O, Section 17, T-21-S, R-37-E

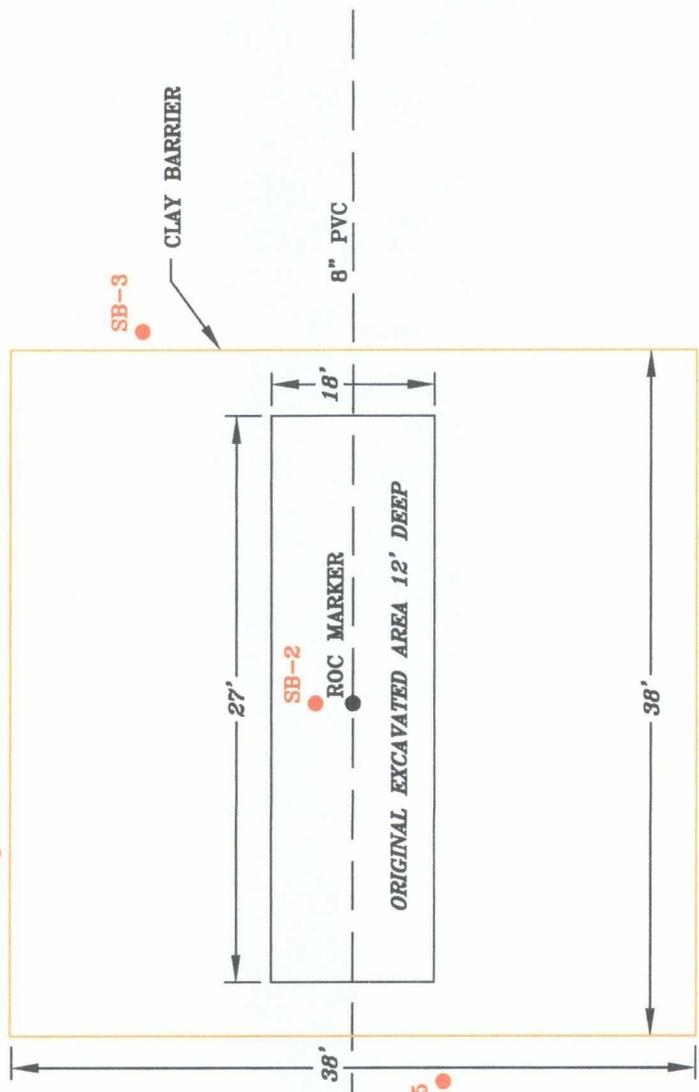
FIGURE NO. 2

JCT. BOX
BD 0-17-1

LEA COUNTY, NEW MEXICO
 RICE OPERATING COMPANY
 BD 0-17-1
 PROPOSED CLAY LINER
 TETRA TECH, INC.
 MIDLAND, TEXAS

● SOIL BORING LOCATIONS

1. As per the CAP, an area measuring 38 feet wide by 38 feet long by 6 feet deep was excavated and a 1 foot compacted clay liner was installed in the bottom of the excavation. Upon completion of the liner the site was backfilled with blended and clean soils, and brought up to surface grade with excavated soils blended with hay. The site was fenced and reseeded with native vegetation.
2. Approximately 372 cubic yards of soil was hauled to the NMOCD approved Sundance facility for disposal

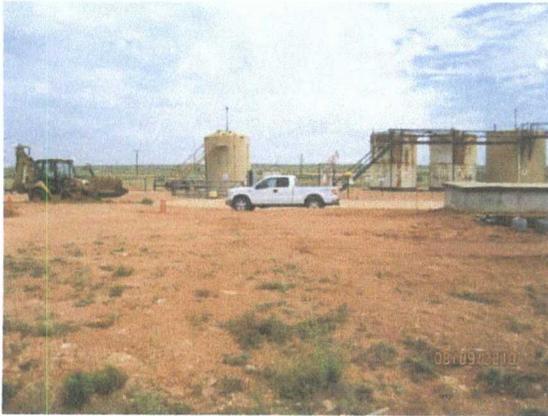
site prior to excavation, facing north

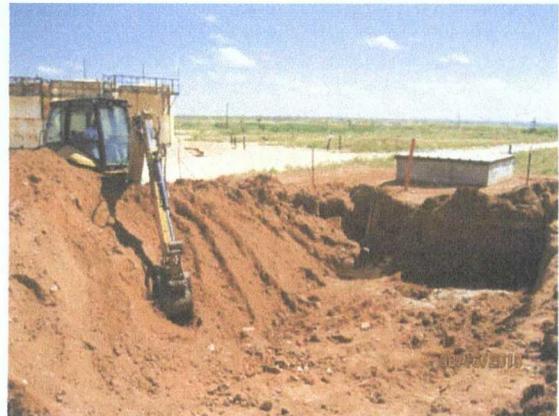
excavating a 38'x38' area, facing northeast

As part of the Corrective Action Plan (CAP), ROC was onsite August 9, 2010 through August 18, 2010, to excavate chloride impacted soils from the K-4 release area. An area measuring 38 feet wide by 38 feet long by 6 feet deep was excavated. Two feet of topsoil was removed and stockpiled onsite. The site was excavated further and a total of 372 cubic yards of soil were disposed of at the NMOCD approved Sundance facility. A topsoil composite sample (PID reading 3.3ppm) was collected on August 17, 2010 and analyzed by Cardinal Laboratory, with the resulting chloride concentration of 352 mg/Kg, GRO <10 mg/Kg and DRO 126 mg/Kg. A total of seven (7) loads of red clay and six (6) loads of blow sand were hauled in from Wallach Concrete. Upon completion of the excavation, a clay barrier was installed and compacted from 5'-6' in the bottom of the excavation. The blow sand was blended with the stockpiled soils and a backfill composite sample (PID reading 3.5 ppm) was analyzed by Cardinal Laboratory resulting in a chloride concentration of 336 mg/Kg, GRO of <10 mg/Kg and DRO of 99.5 mg/Kg. Between September 10 and September 14, 2010, clean offsite soils blended with peanut hay were brought to the site to continue backfilling. The site was brought up to surface grade. (See Appendix A – Laboratory Data for analysis on the topsoil and blended excavated soils and soil compaction testing data). The site was fenced and on September 16, 2010, the site was reseeded with 8 pounds of Lea County mix and 10 pounds of rye. (See Appendix B – Site Photographs)

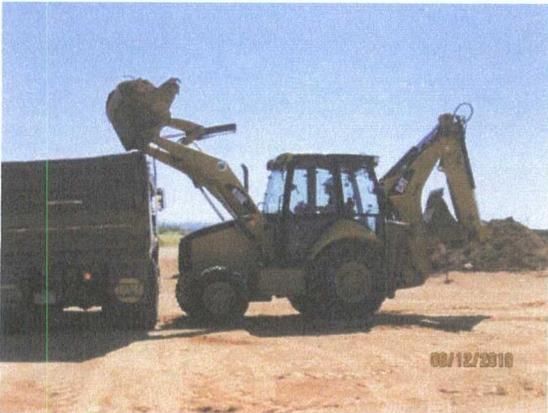
hauling off excavated soil, facing east

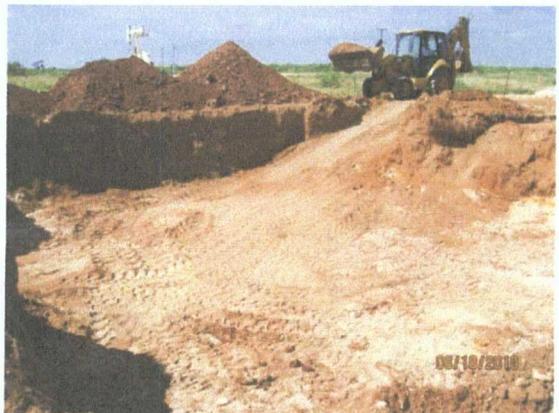
final excavation, facing southwest

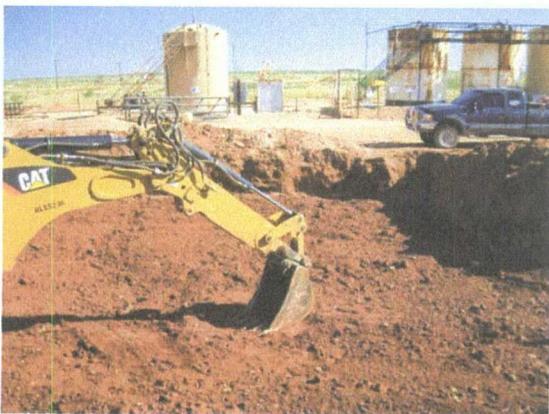
installing clay barrier, facing north (8/18/2010)

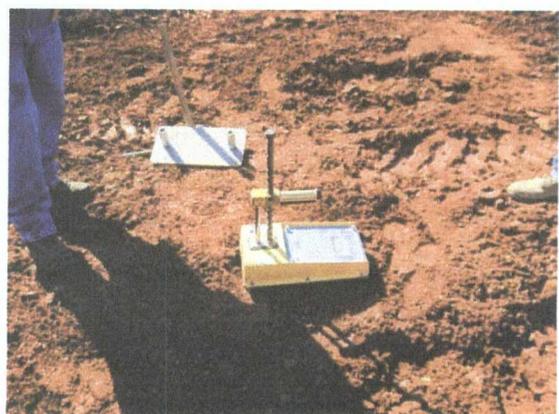
clay compaction test (8/19/2010)

Test No.	Location	*Dry Density % Max	% Moisture	Depth
SG 1	15' N. & 12' W. of SE Corner	83.1	24.0	5' Below FSG Natural Ground
RT SG 1	15' N. & 12' W. of SE Corner	87.4	27.8	5' Below FSG Natural Ground
2RT SG 1	15' N. & 12' W. of SE Corner	93.1	21.5	5' Below FSG Natural Ground

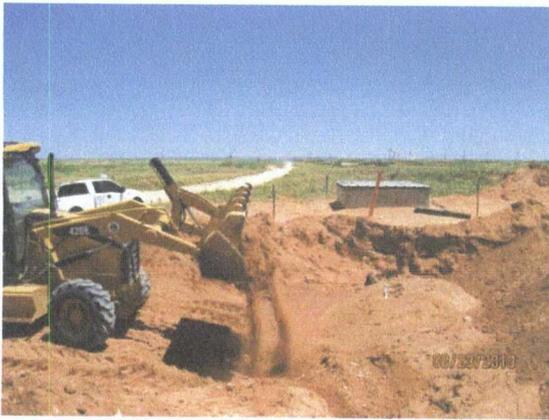
backfilling the excavation, facing east

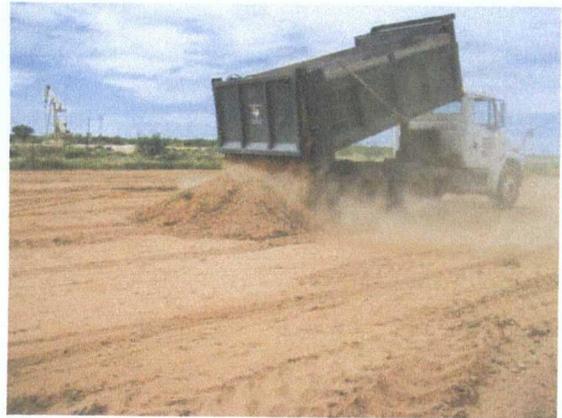
hauling in clean soil blended with hay, facing southwest (9/14/2010)

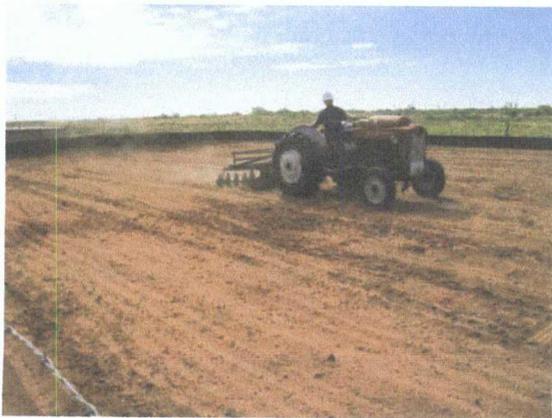
tilling in the clean soil blended with hay, facing southeast (9/16/2010)

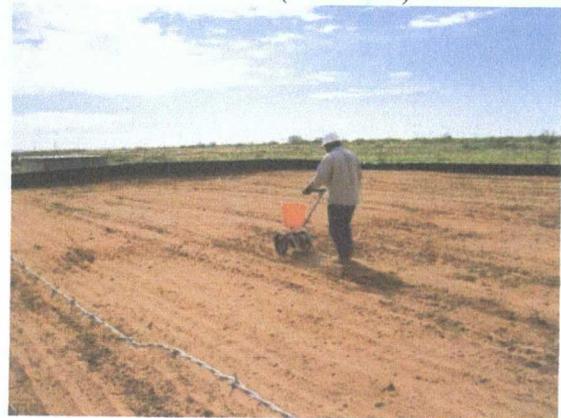
seeding the backfilled site, facing southeast (9/16/2010)

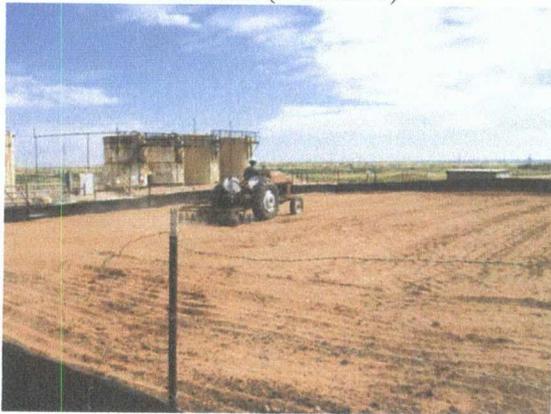
tilling in seed, facing northeast (9/16/2010)

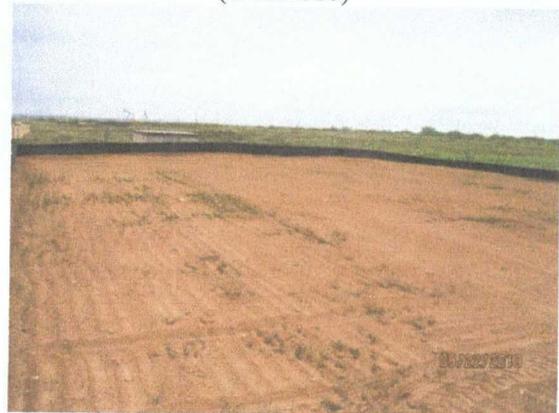
site complete with vegetation beginning to grow, facing east
