Release Notification and Corrective Action

Closure Report

LAT A-9
Lea Co., NM

Re: Lateral A-9 (1RP-2585)

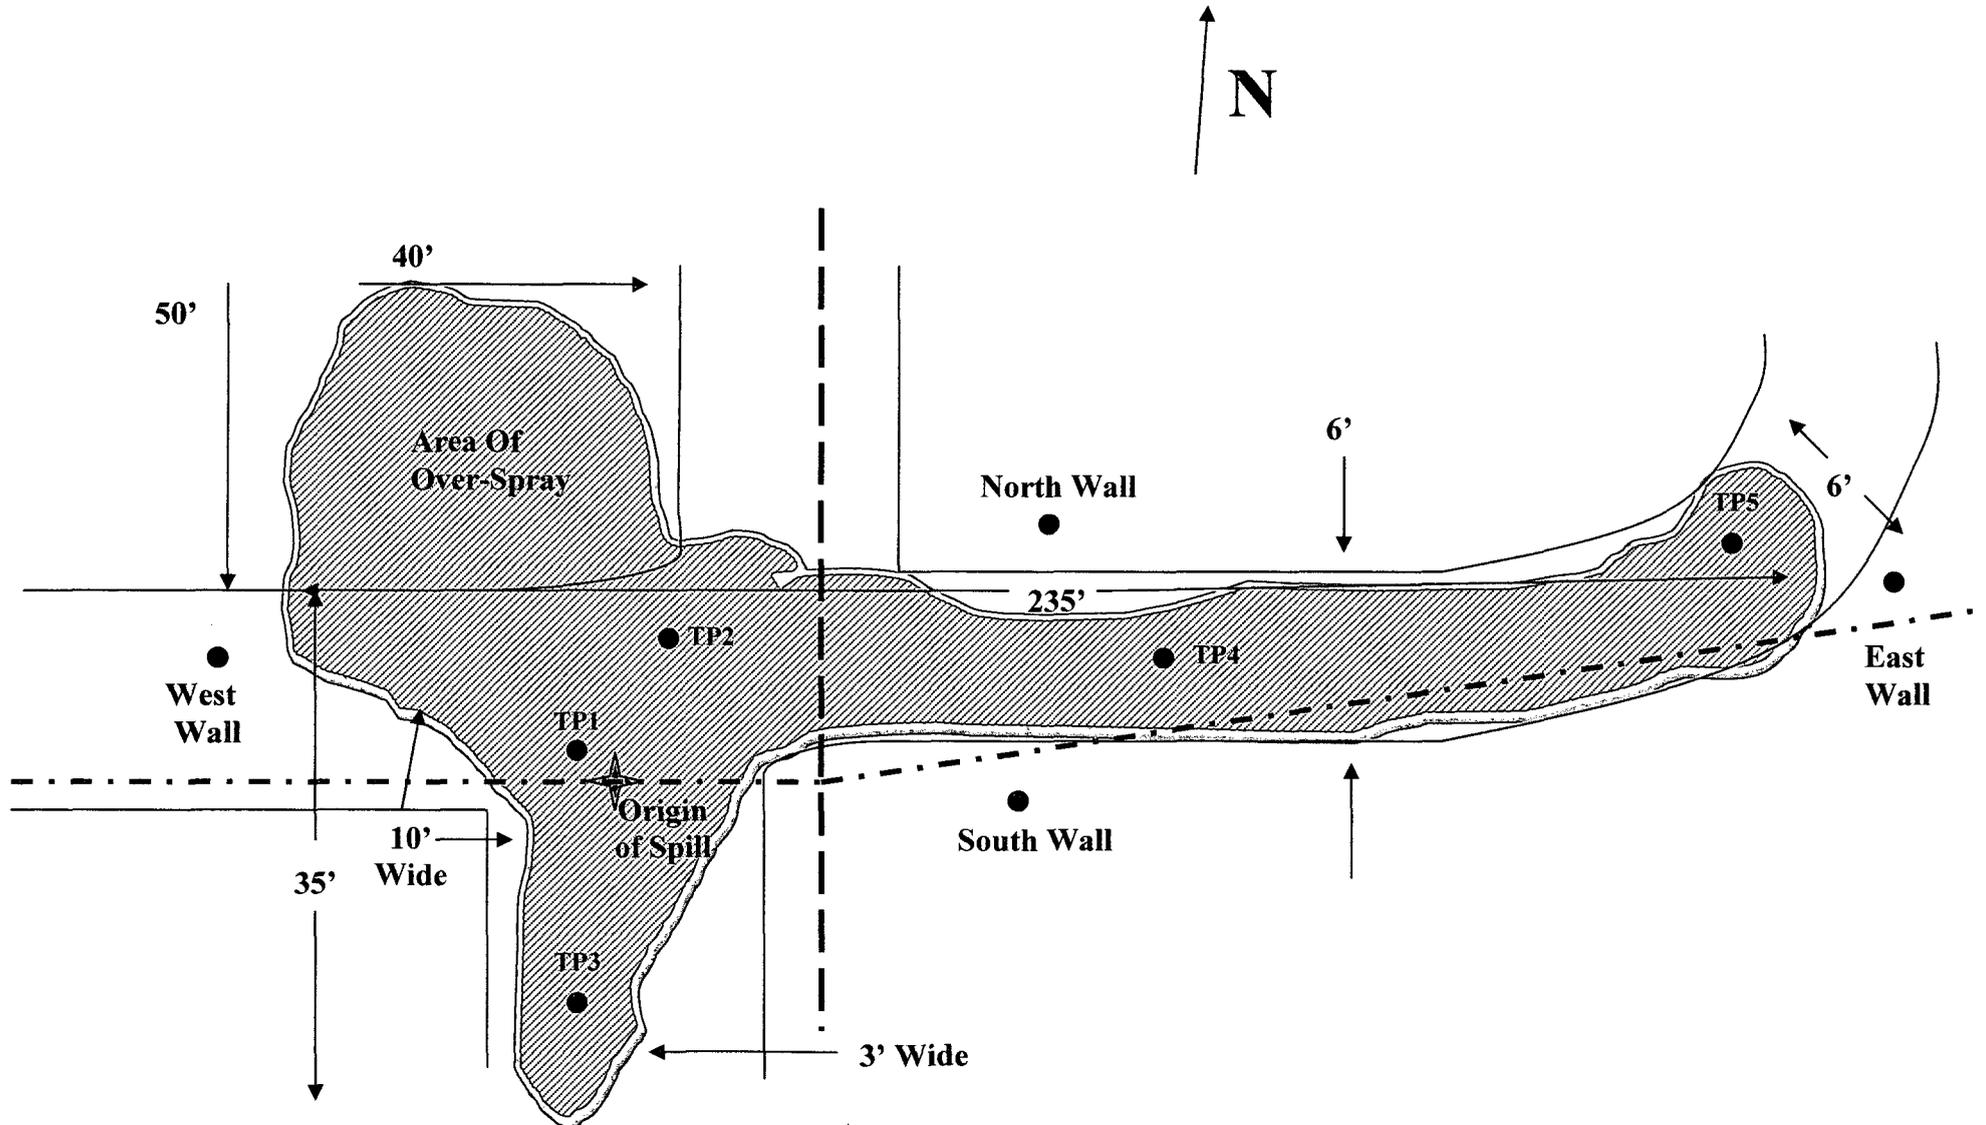
Plat Map

Southern Union Gas Services
Line # Lat A-9 Leak

@ 24", TP 2 @ 24", TP 3 @ 27", TP 4 @ 24" and TP 5 @ 24") were collected. A site map is attached and depicts the locations of the soil samples. The soil samples were field screened using a Photo-Ionization Detector (PID), a TPH analyzer (Method 418.1) and a chloride field test kit (EPA 4500 Cl-), prior to submission to the laboratory for confirmation analysis. The soil samples were analyzed for concentration of benzene, toluene, ethyl benzene and xylene using EPA Method 8021b, total petroleum hydrocarbons using EPA Method SW-846 8015M and chloride using EPA 300.1. The analytical results indicated chloride concentrations exceeded the NMOCD clean-up standards in areas represented by soil samples TP 1 @ 24" and TP 5 @ 24".

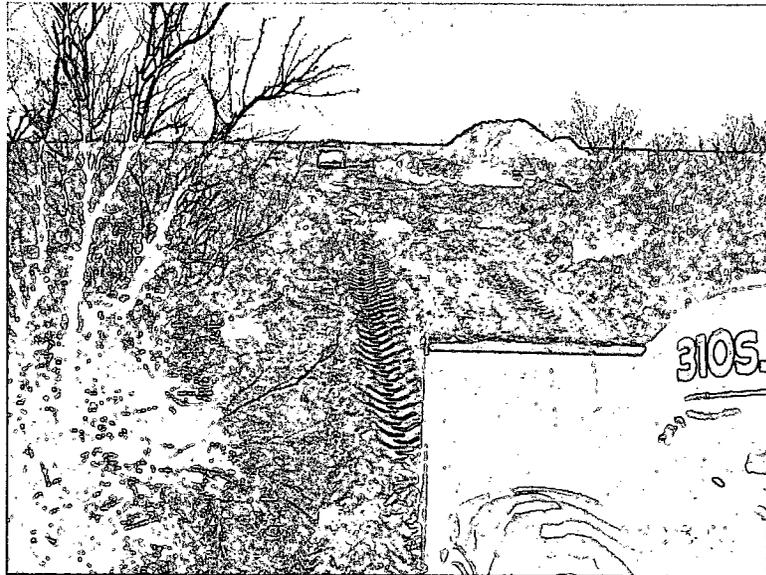
Excavation of spill which traveled East

On July 14, 2010, initial excavation of the release began; impacted soil was stockpiled adjacent to the release on plastic. The initial depth of excavation was approximately twenty-four (24) to twenty-seven (27) inches bgs. Following initial excavation activities, five (5) soil samples (TP 1

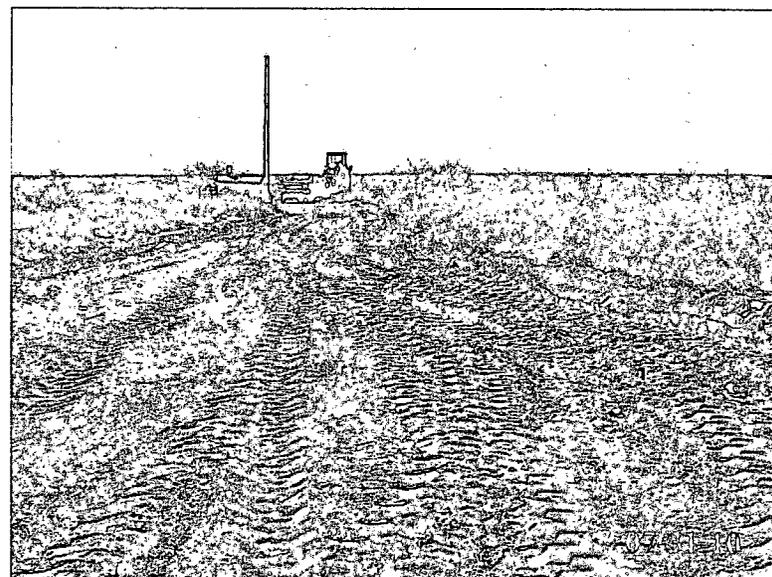
Test Point 1 after backfill

An additional soil sample was collected from the blended stockpile and submitted for analysis. The analytical results indicated the concentrations of the constituents were less than the NMOCD clean-up levels and the blended stockpile soil was placed in the excavation.
