# REMEDIATION PROPOSAL

## NEW MEXICO "S" STATE TANK BATTERY #5

EPI REF: #190041  
NMOCD: 1RP-10-4-2489

UL-F (SE¼ OF THE NW¼) OF SECTION 02, T22S, R37E  
~3.0 MILE SOUTHEAST OF EUNICE,  
LEA COUNTY, NEW MEXICO

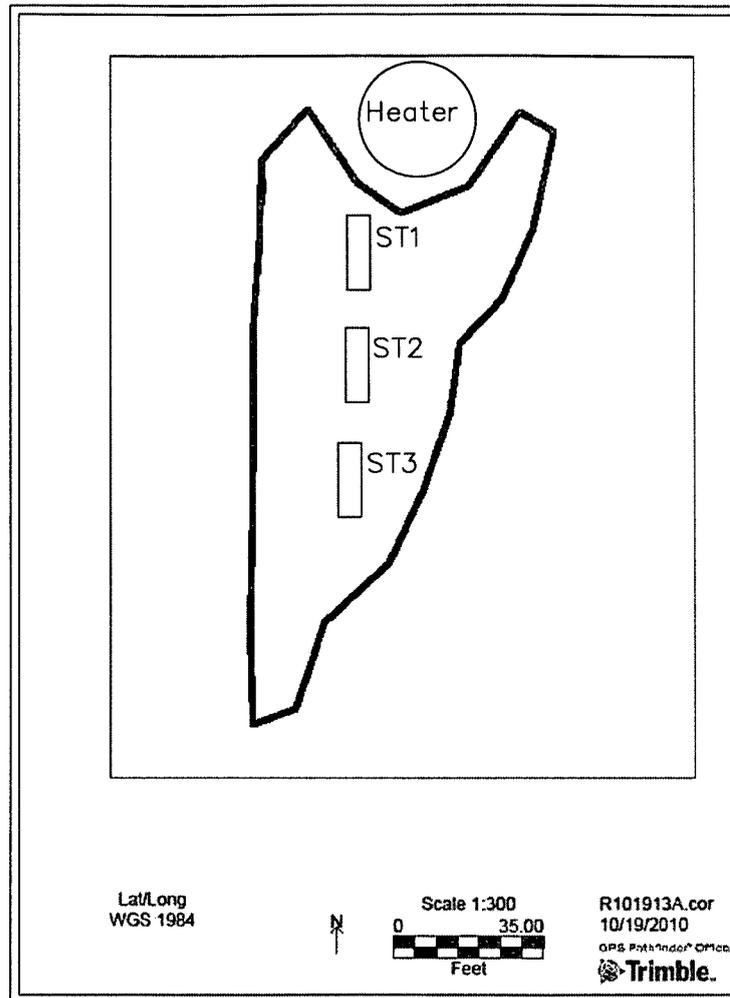
Figure 4  
 Sample Trench Site Map  
 ExxonMobil  
 NM S State TB #5

On May 21, 2010 EPI mobilized at the Site to delineate the release area via sample trenches (ST). ST-1 was excavated to a depth of 6-feet and ST-2 to a depth of 11-feet bgs. Soil samples were collected at 1-foot intervals to total depth of each ST. On July 29, 2010 EPI mobilized to the site and excavated ST-3 a total depth of 10-feet bgs. Soil samples were collected at selected intervals (2-, 3.5-, 5-, 7- and 10-feet bgs) for field analyses and laboratory analytical test.

In viewing the physical location of the release area, it would require a very large excavation to remove all chloride impacted soil to approximately eleven (11) vertical feet. The northern end is blocked by an active heater treater while the west side is confined by the lease road. Excessive excavation around the heater treater would endanger the base on which it is located. Removal of impacted material from the lease road would require a detour and closure of the main north-south route. In lieu of this, EPI proposes to excavate the release area a maximum of six (6) vertical feet. While not eliminating all, it will remove the bulk of chloride impacted material. Excavation of the north end will commence five (5) feet south of the heater treater and continue in a southerly direction until soil free of impacted material is reached. Excavation in a westerly direction will continue until it abuts east edge of existing north-south lease road. Sidewalls on the east side of the release area will be excavated to whatever distance is necessary for removal of chloride impacted material above 250 mg/Kg.

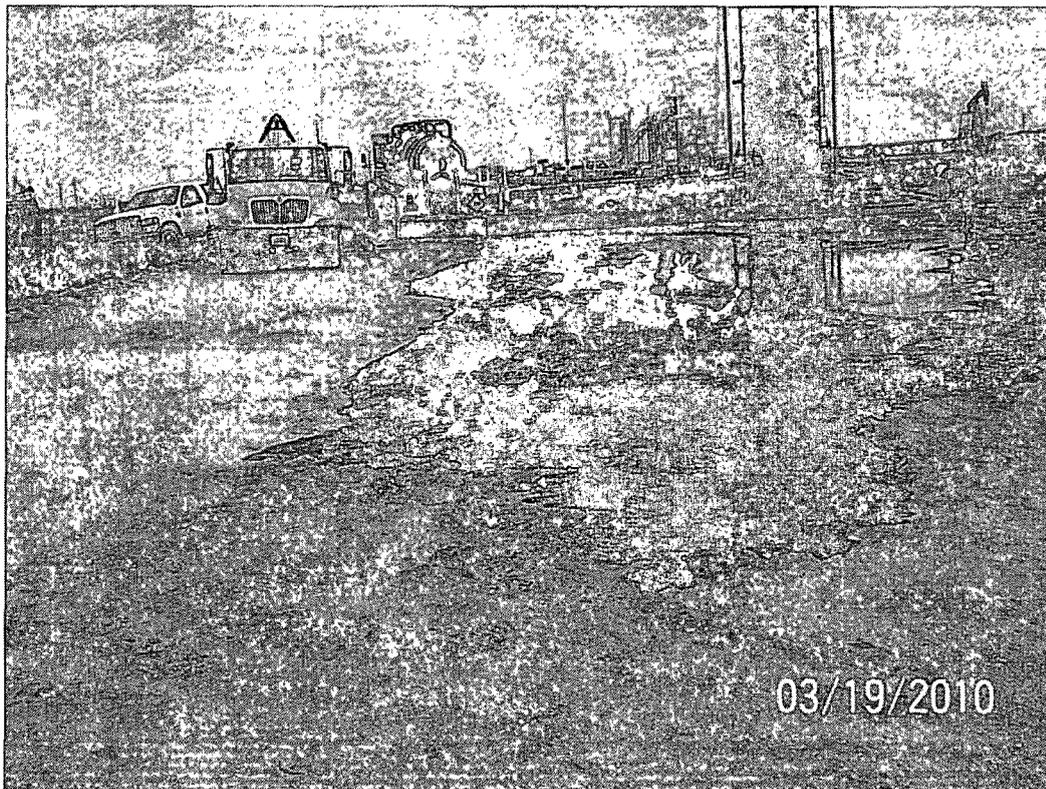
Photograph No. 2 – Looking northerly at release area and cleanup effort

Describe Area Affected and Cleanup Action Taken.\*  
A vacuum truck was called out to pick up free fluid. Emergency on call was put in and contaminated soil was excavated. Site will be delineated and remediated according to NM guidelines.

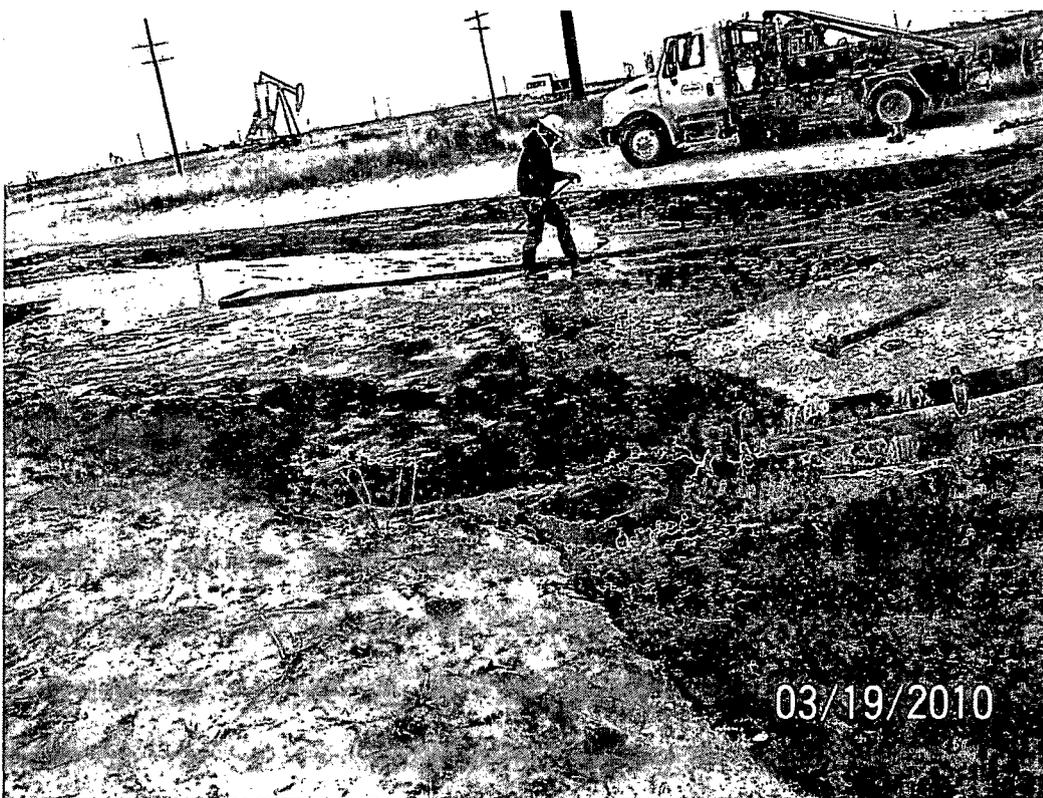
Photograph No. 4 – Looking southerly at release area and cleanup efforts
