**XTO Energy, Inc.  
EMSU-B #923  
Township 20 South, Range 36 East, Section 24  
Lea County, New Mexico**

**Closure Report**

**November 1, 2010**

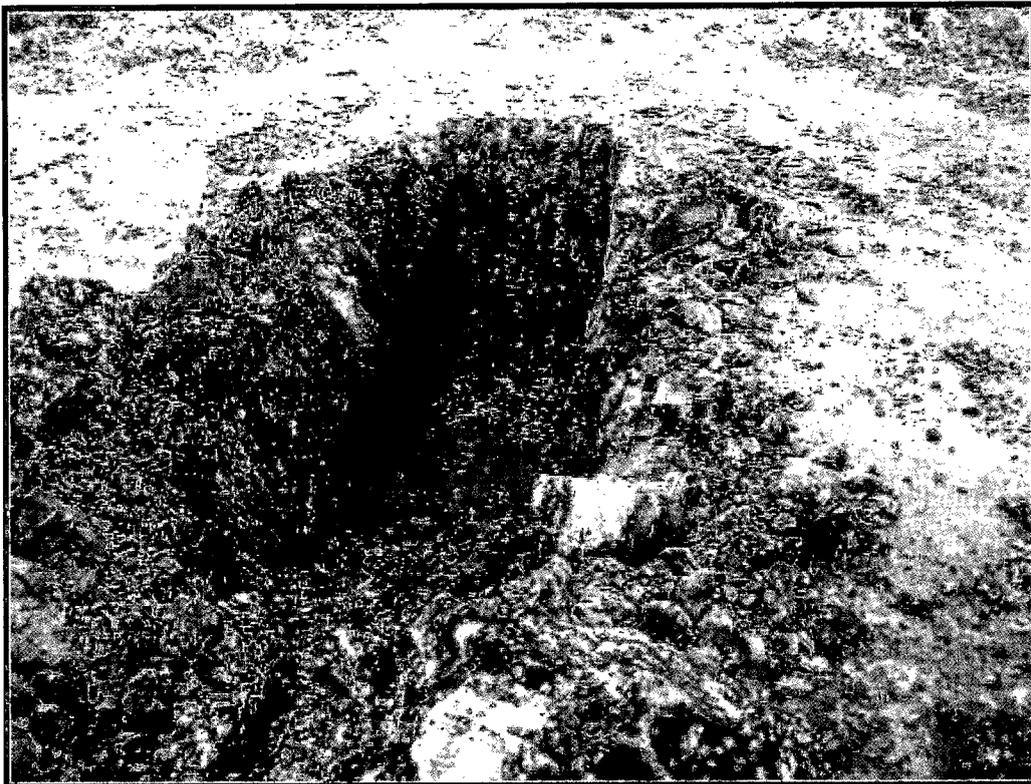
Test trench #1 8'

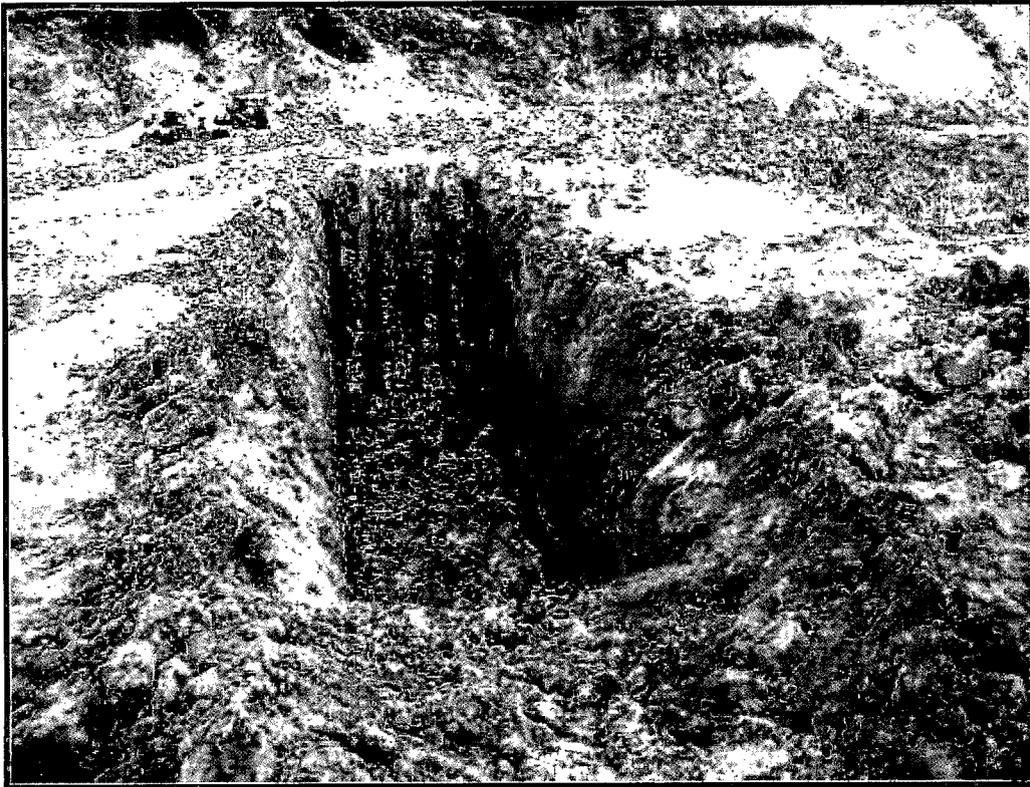
Test Trench #2 9'

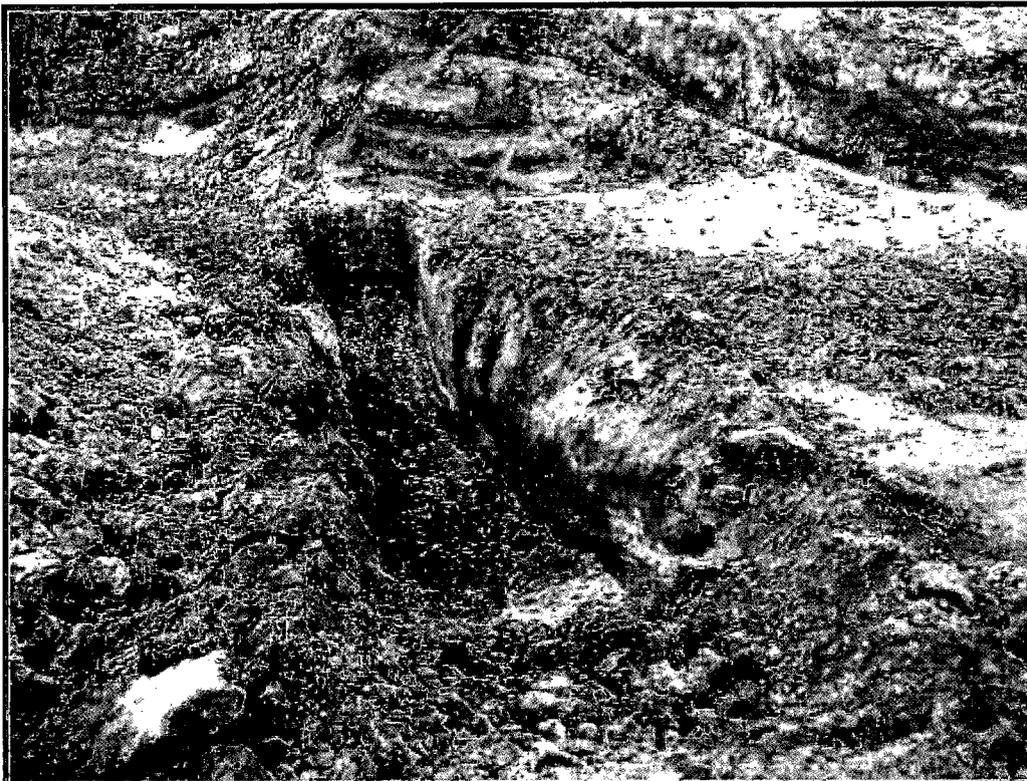
Test trench #3 10'

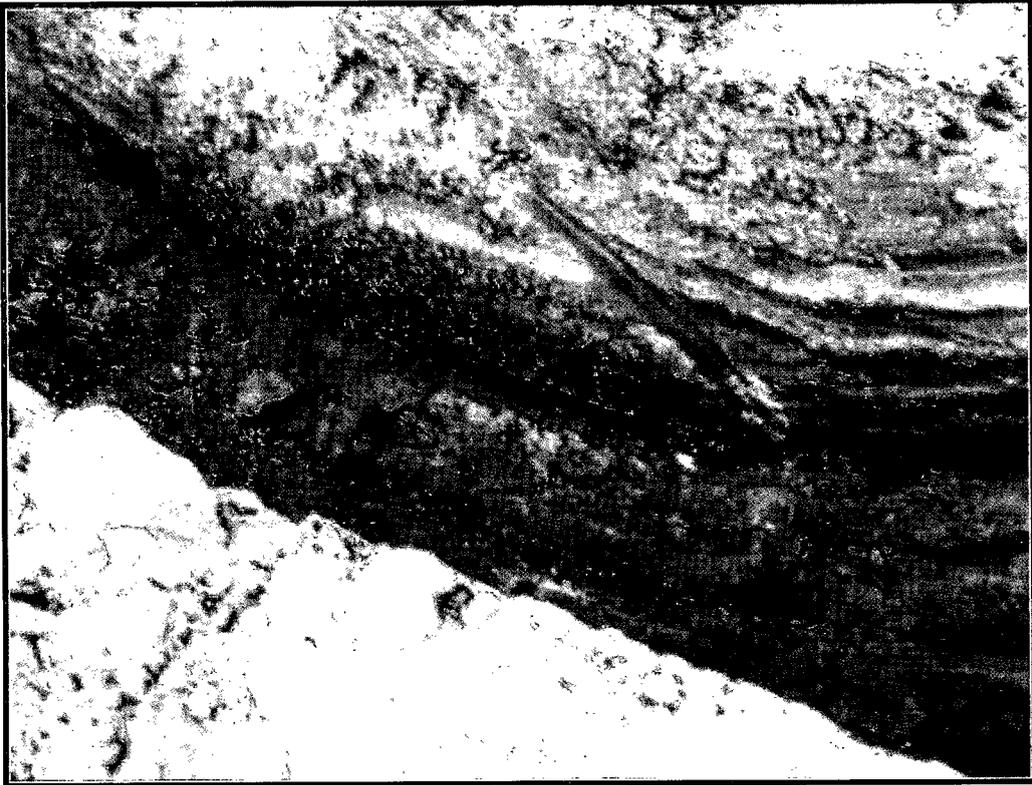
Test Trench #4 11'

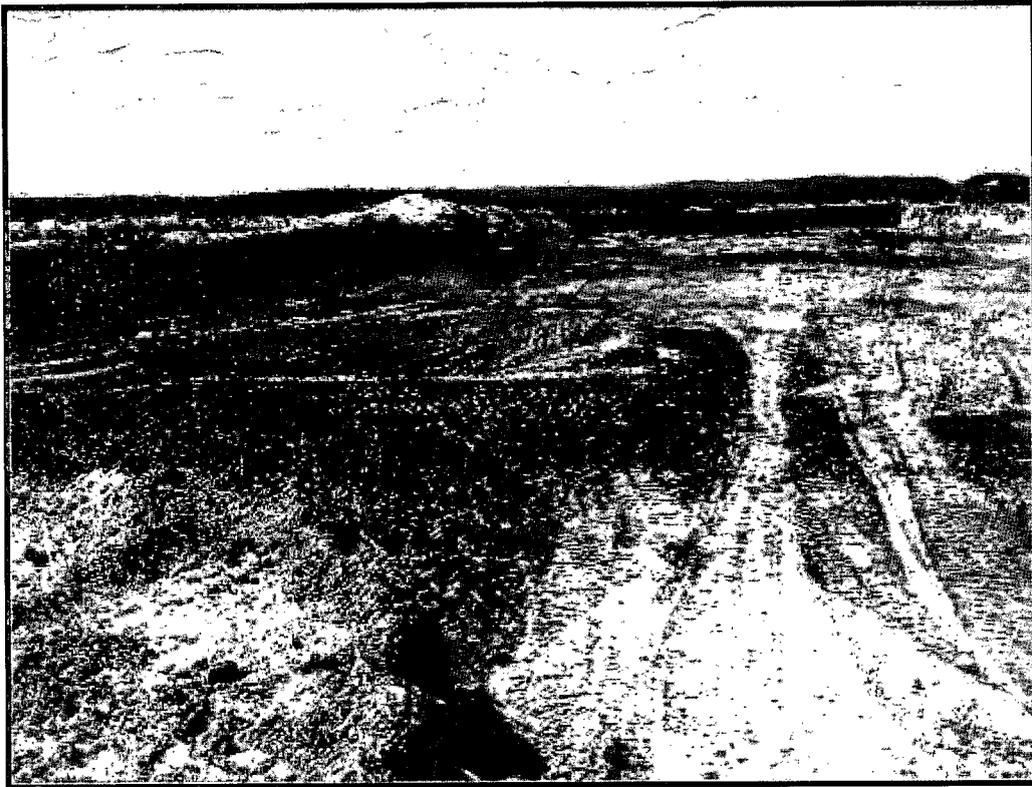
Test Trenches backfilled facing southwest

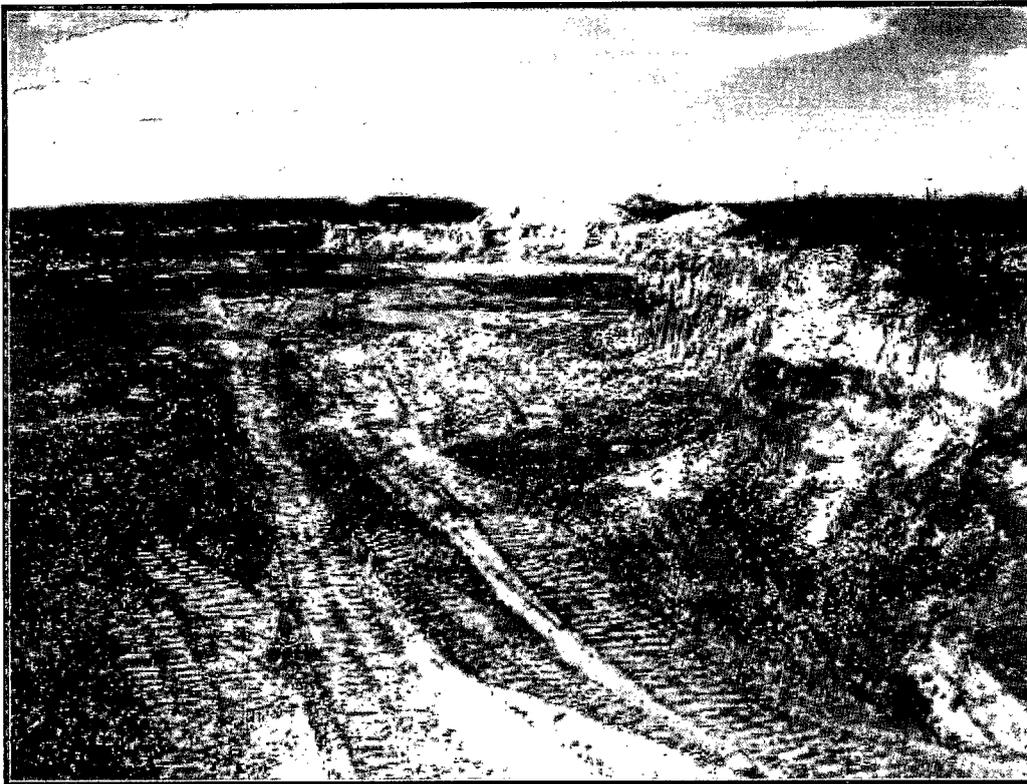
Test Trenches backfilled facing northwest

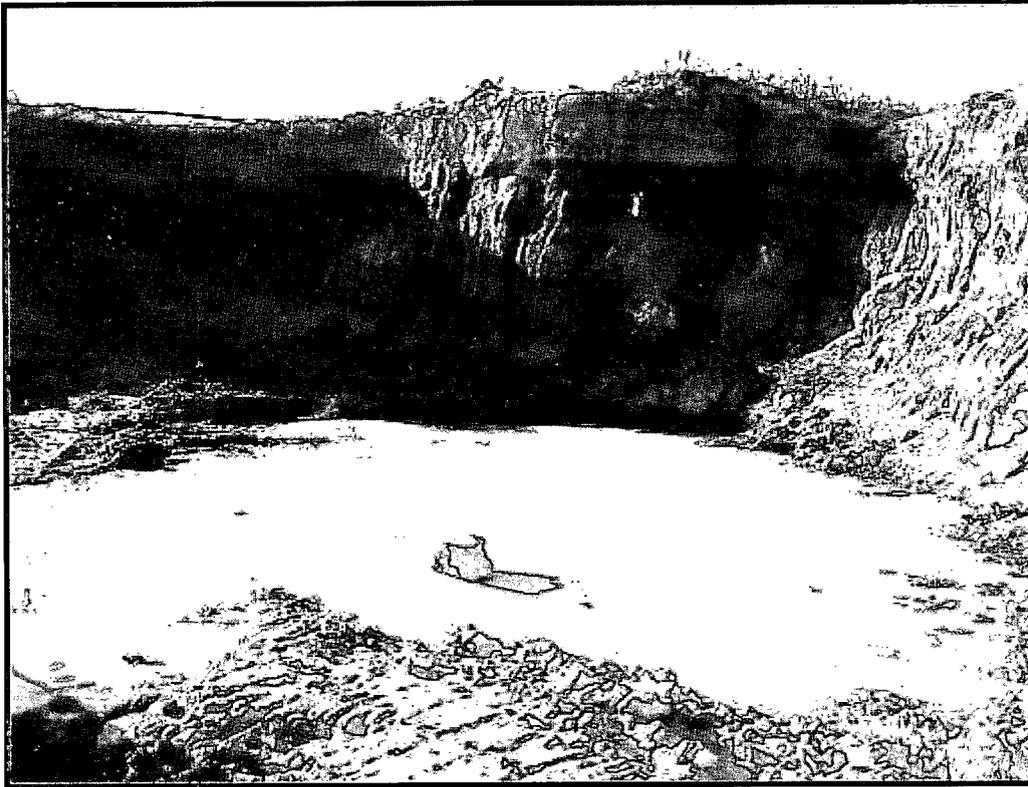
Southeast corner with rain water facing south

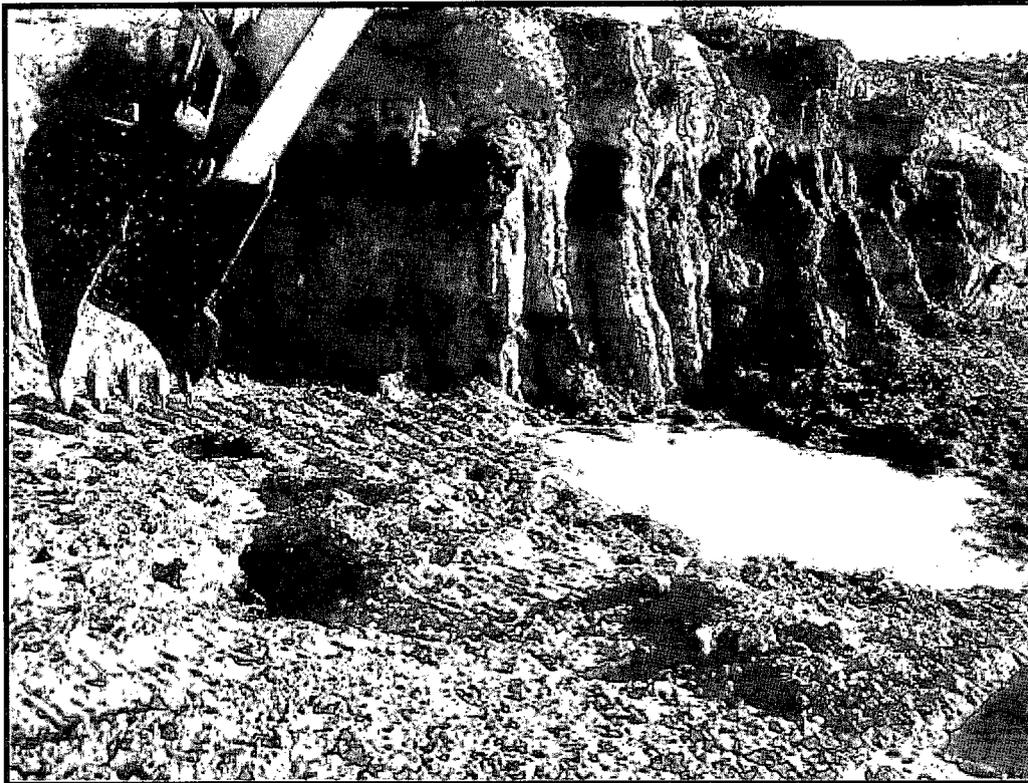
Northeast corner with rain water facing northeast

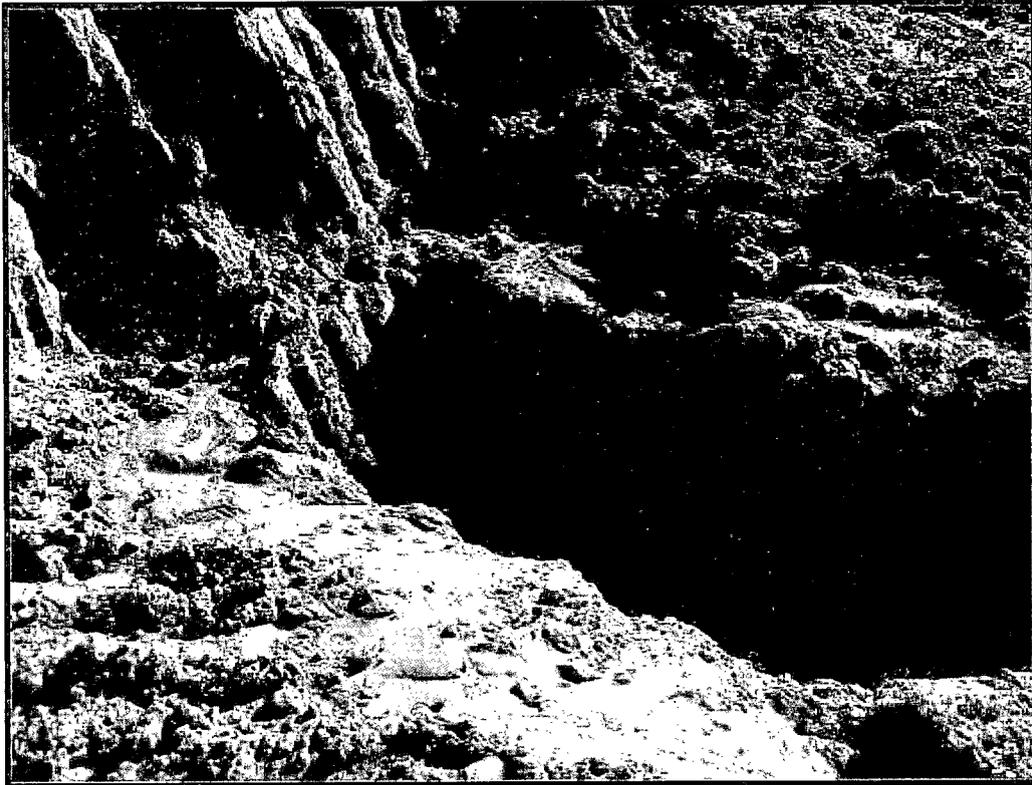
Northeast corner with rain water on top facing east

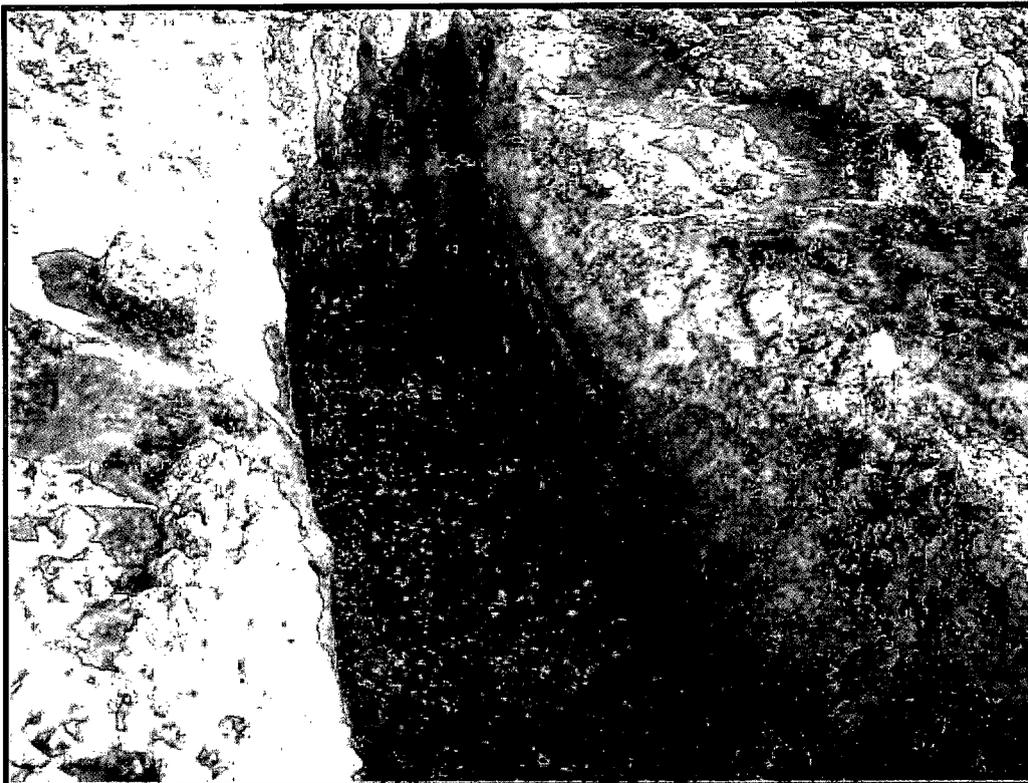
Northeast corner at 3 1/2' dry facing north

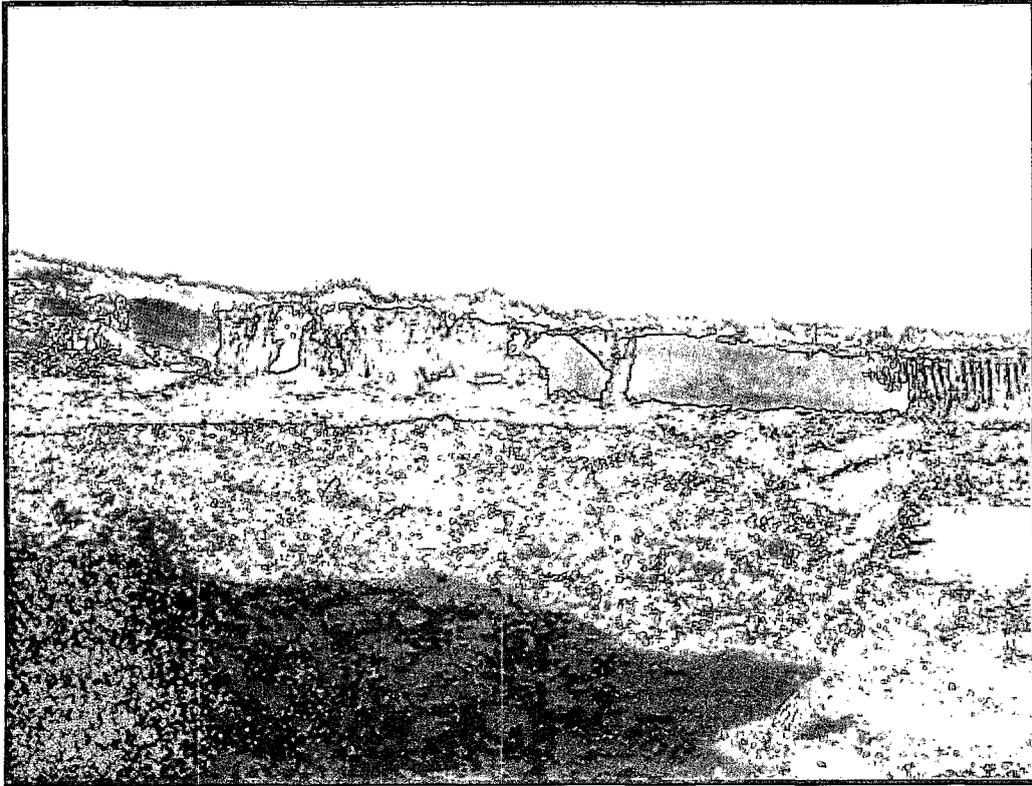
Test Trench #4 backfilled facing west

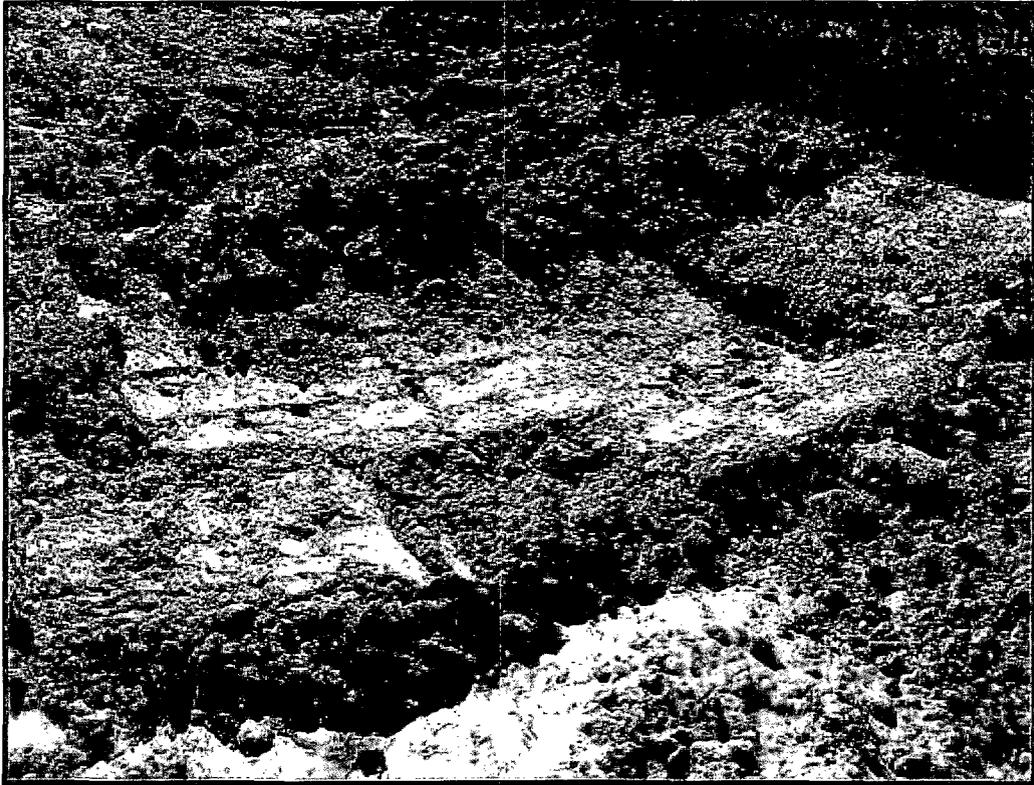
Northeast corner backfilled facing east

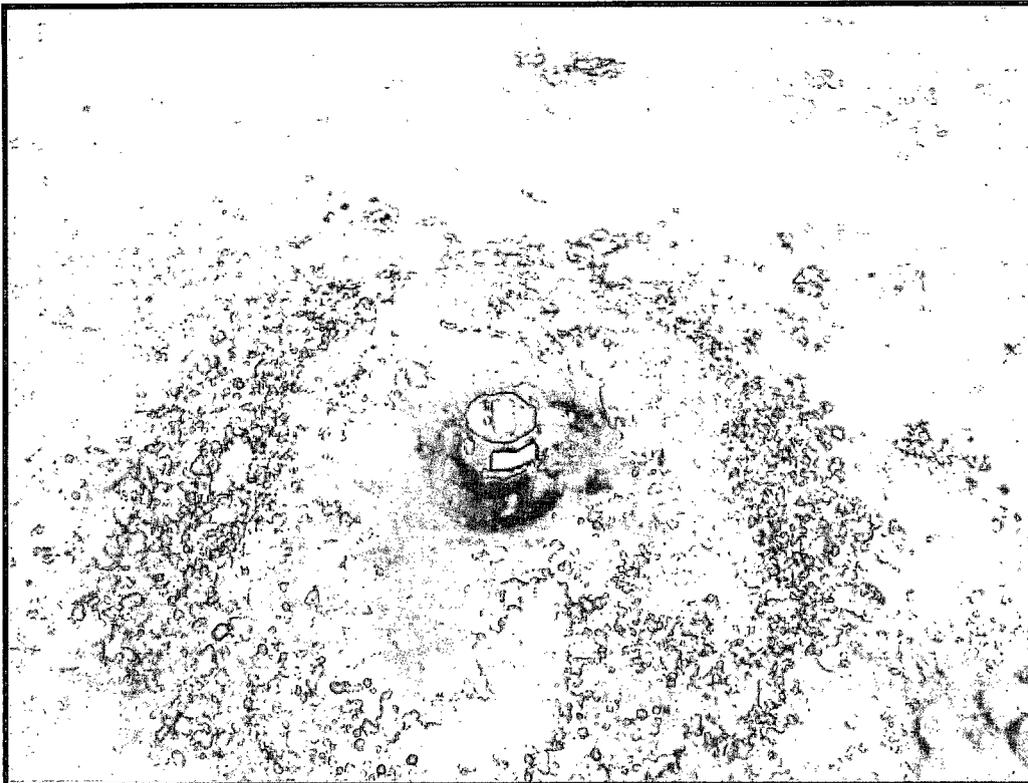
Monitor well undisturbed

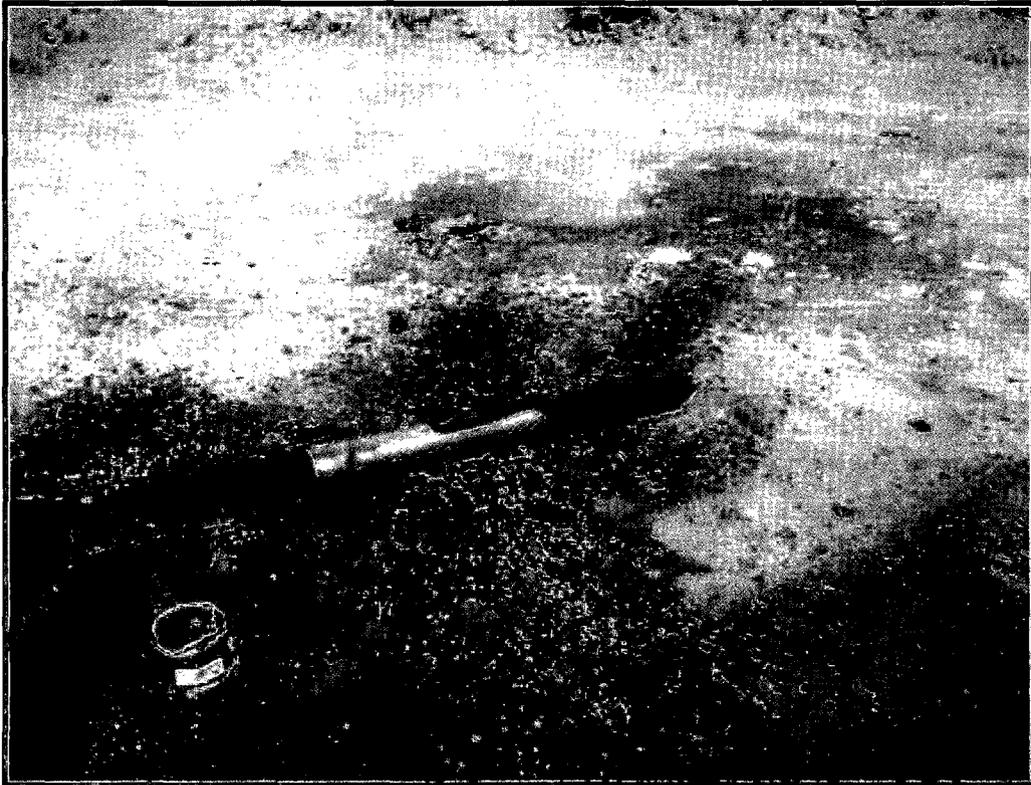
Measurement at bottom of well with no water

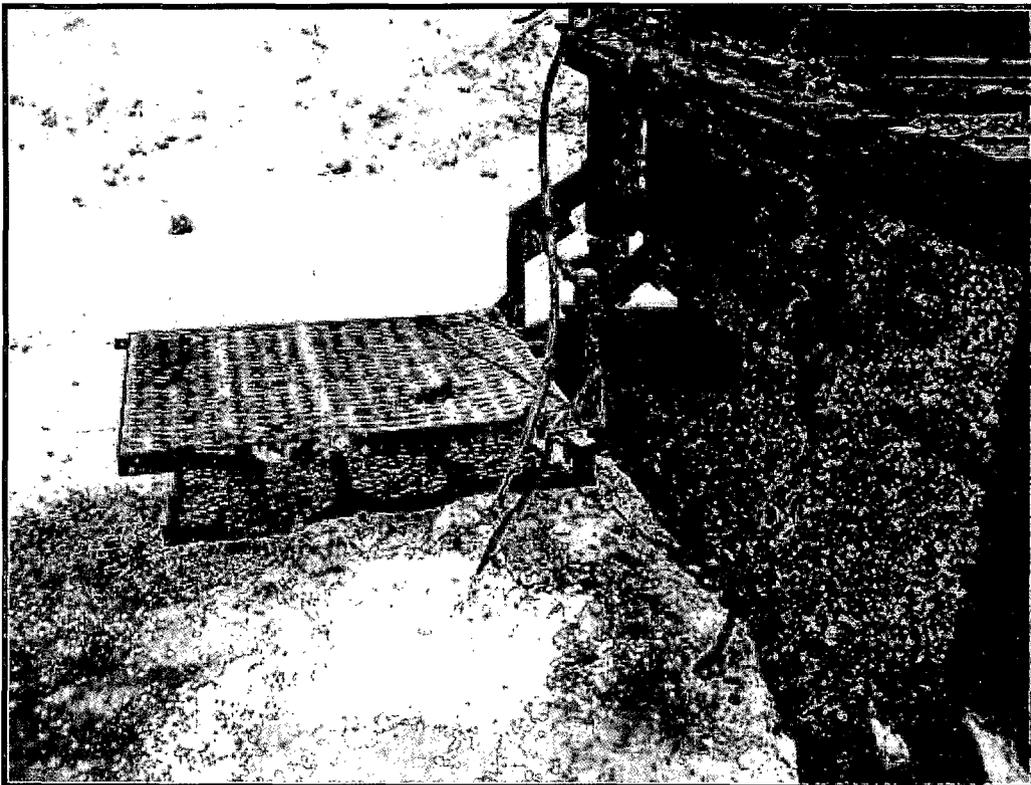
Monitor well plugged with bentonite
