Release Notification and Corrective Action

**XTO Energy
State Section 27 SWD #2
Township 18 South, Range 35 East, Section 27
Lea County, New Mexico**

Closure Report

March 5, 2010

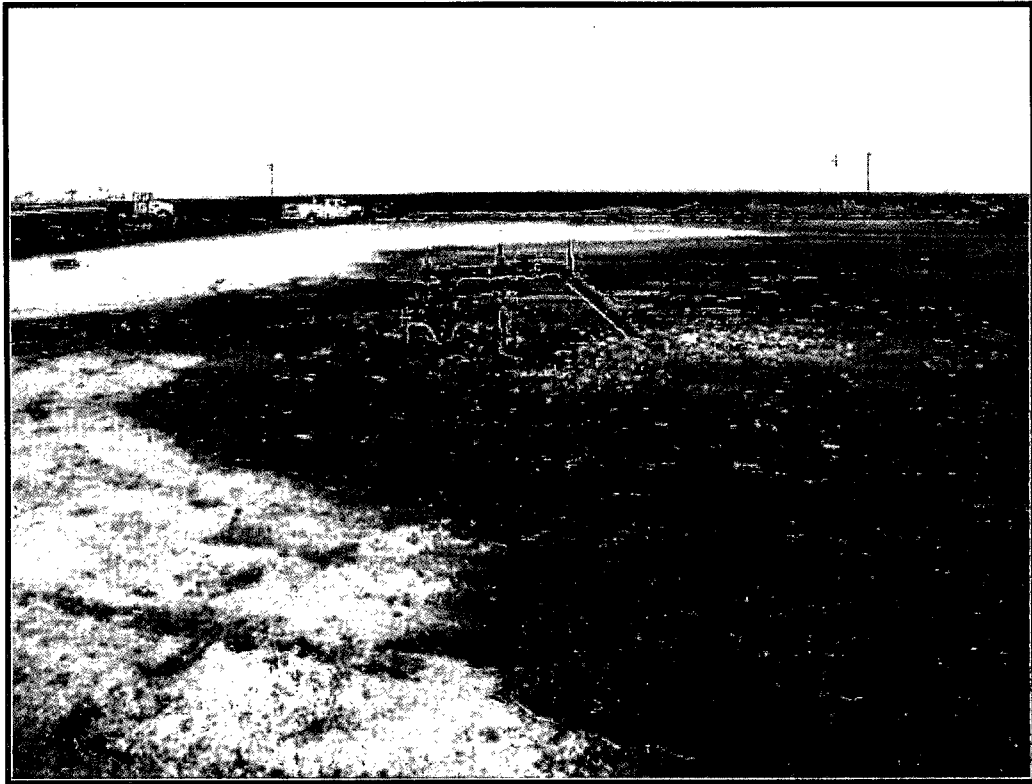
Release area facing east

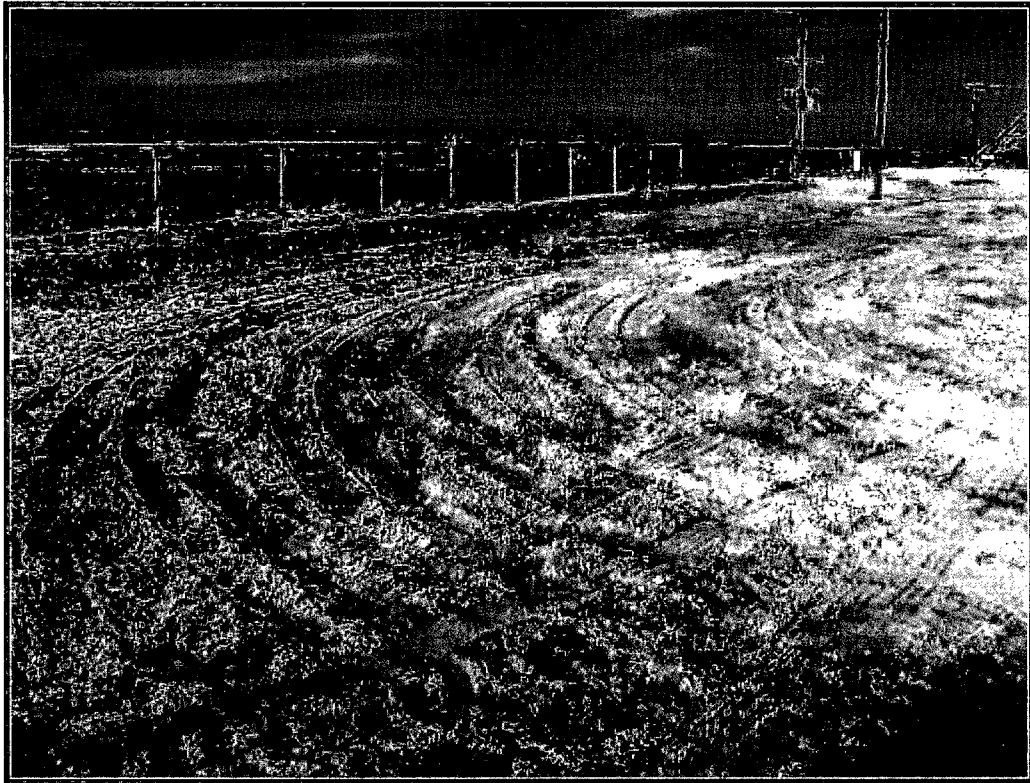
Location pad backfilled facing west

On February 22, 2010- March 4, 2010 SESI was onsite with Hungry Horse and began backfilling the excavated area with 9,060 yards of topsoil from an offsite location. The area was then contoured to its natural grade. Approximately 160 yards of caliche was used to backfill the location pad inside the fenced area as well as, a 2 ½ foot berm was installed along side the fence to prevent future releases into pasture area.
