Release Notification and Corrective Action

**Cimarex Energy Company
Missouri Unit 13 Fee #5
Unit B Section 13, Township 15S, Range 37E
Lea County, New Mexico**

Closure Report

January 28, 2011

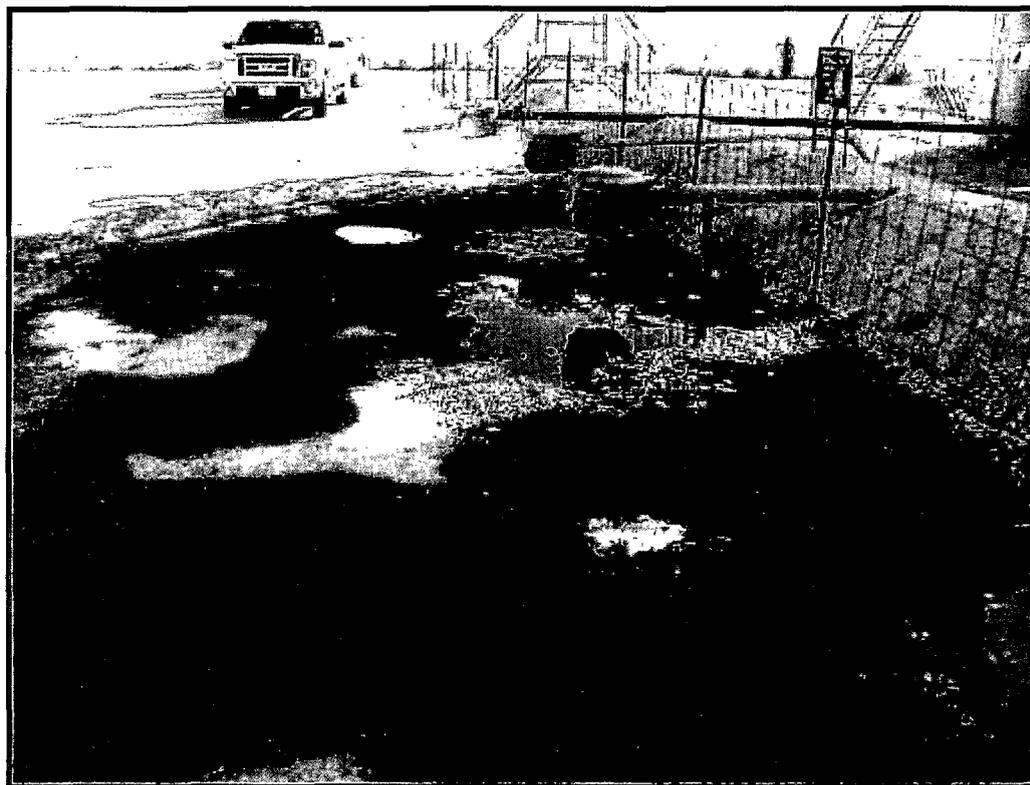
Release Point facing south

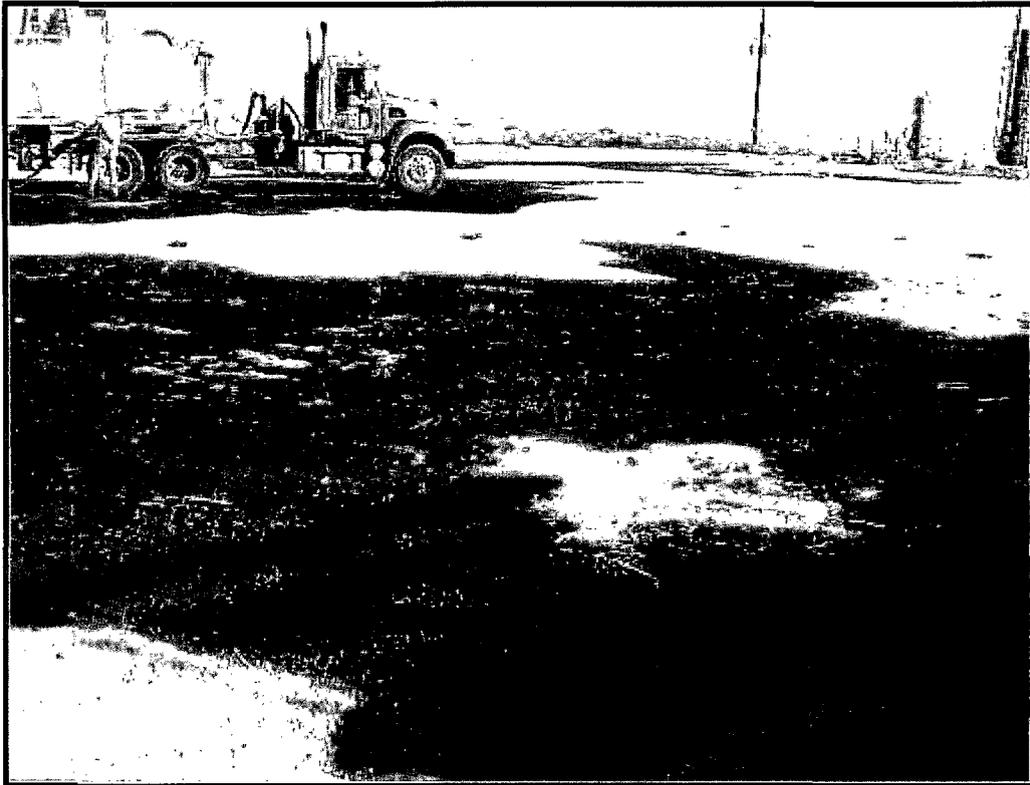
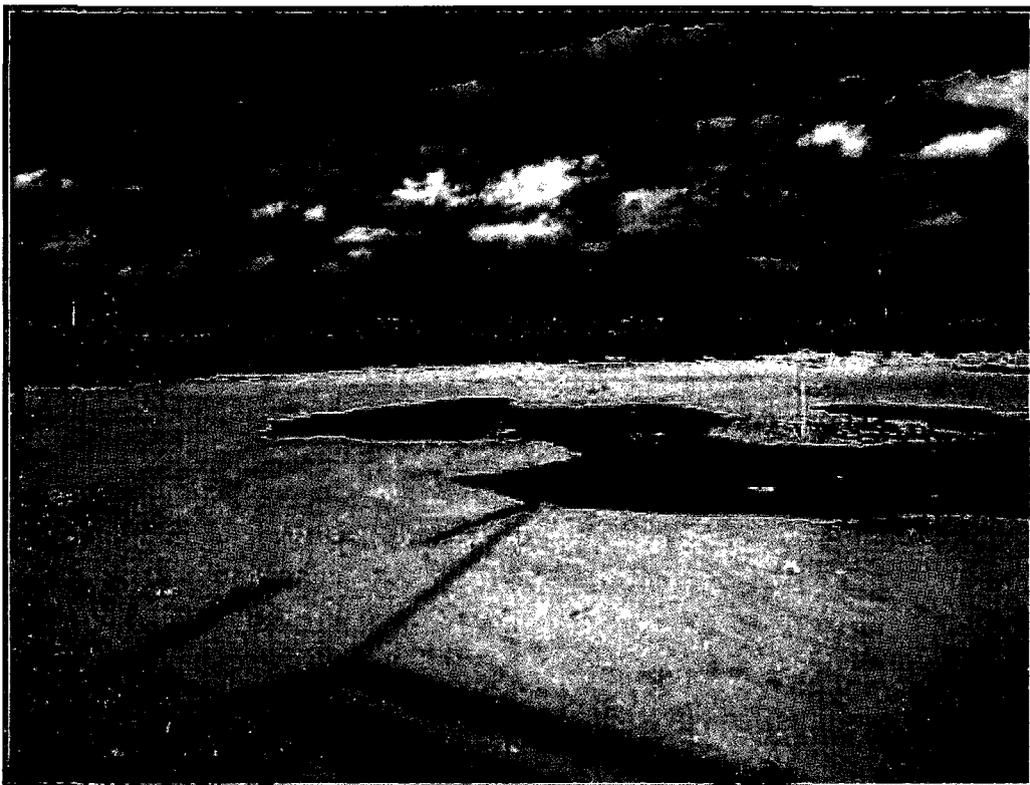
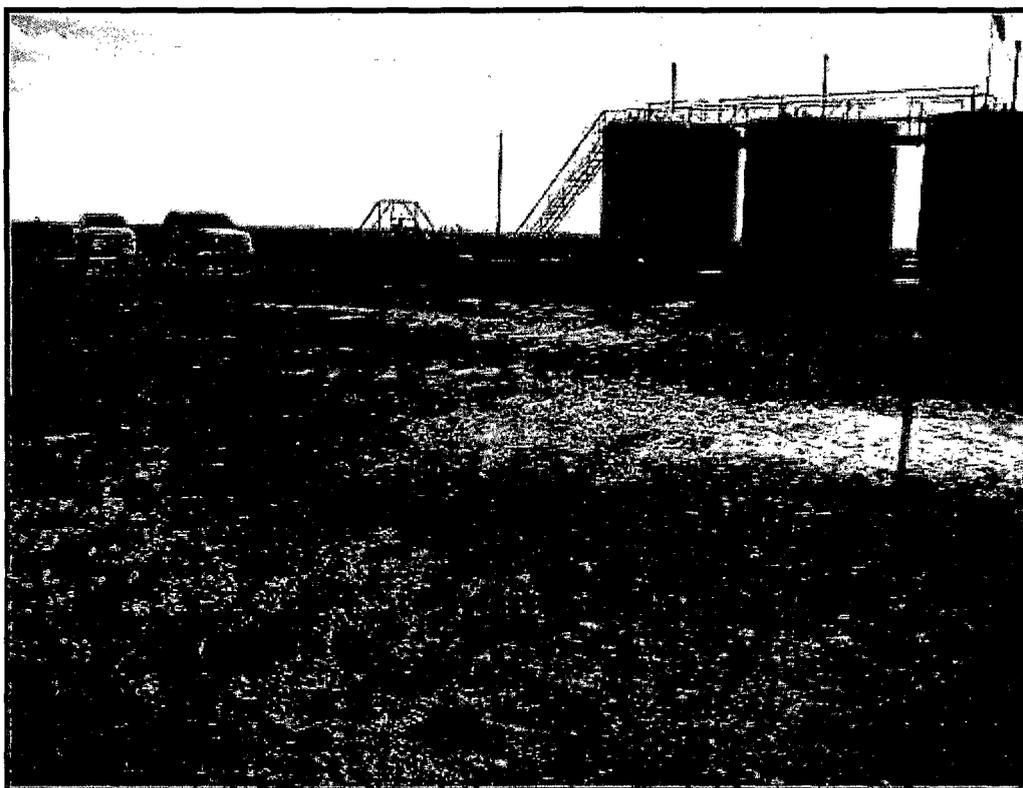
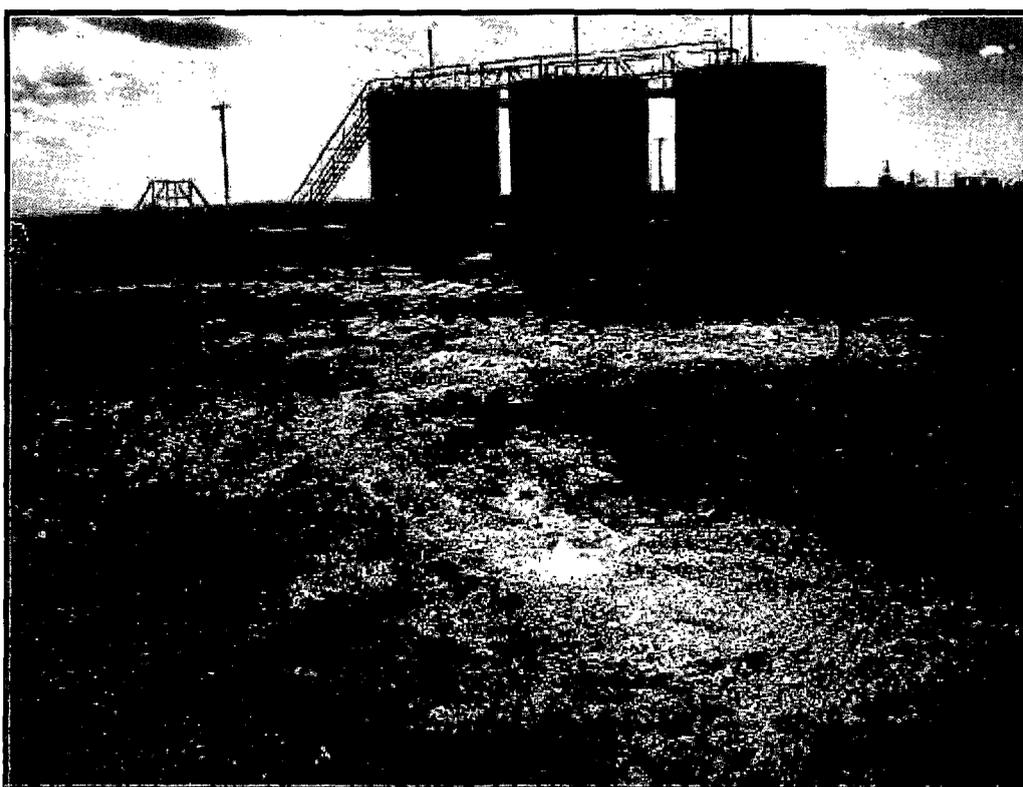
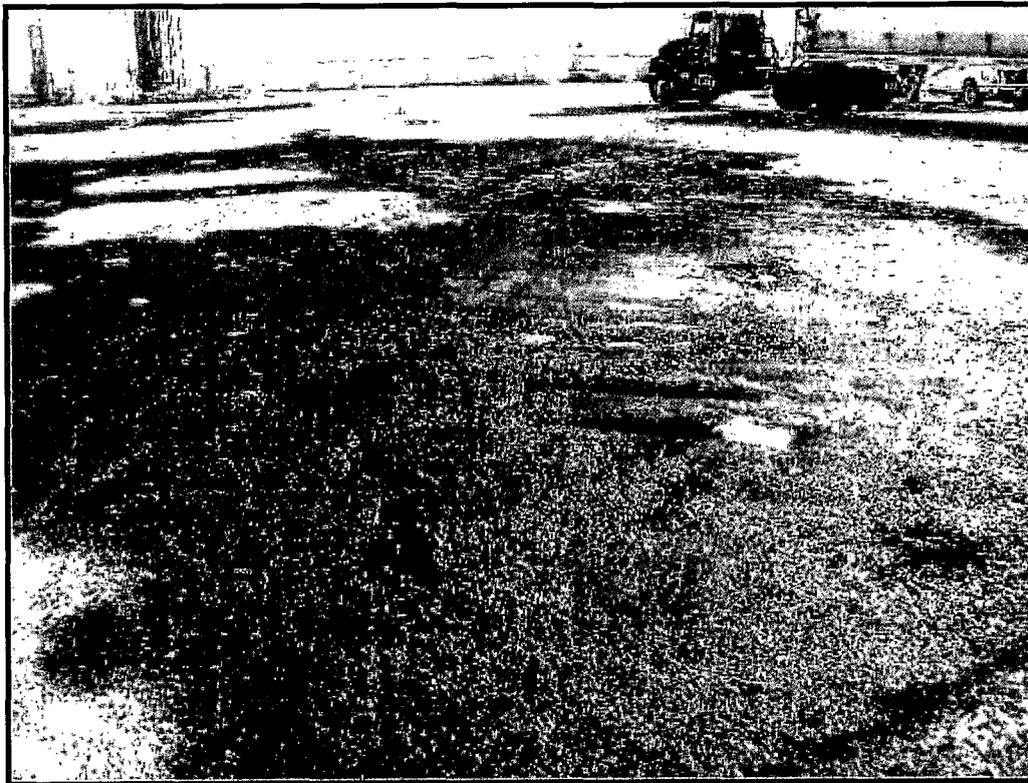
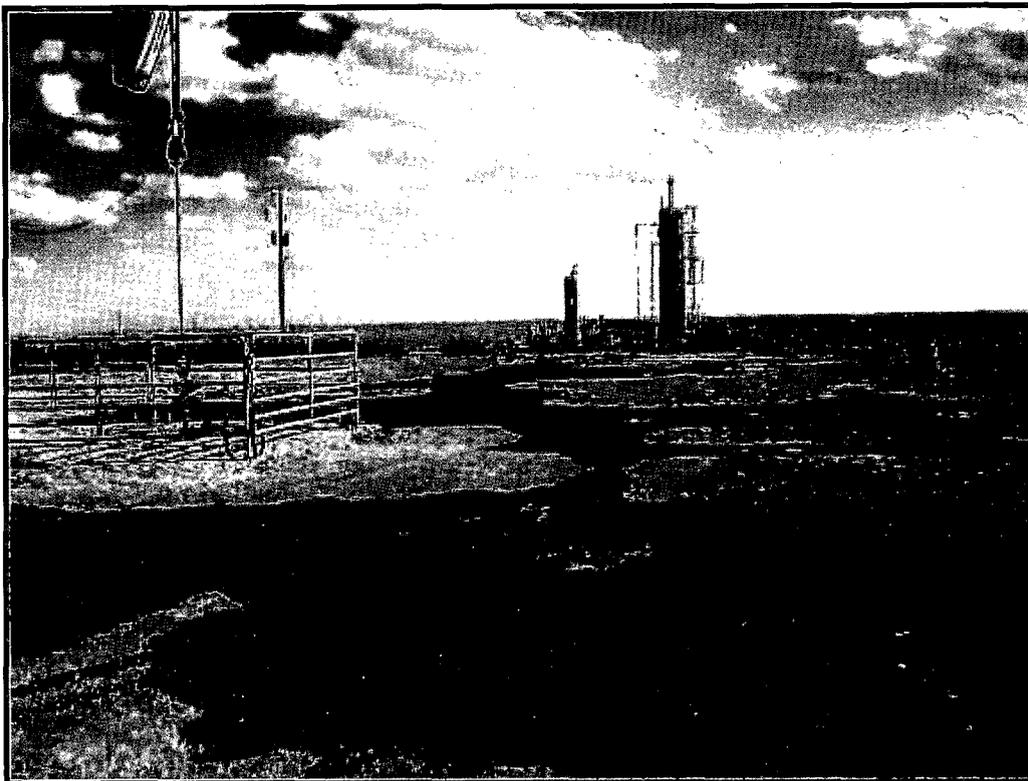
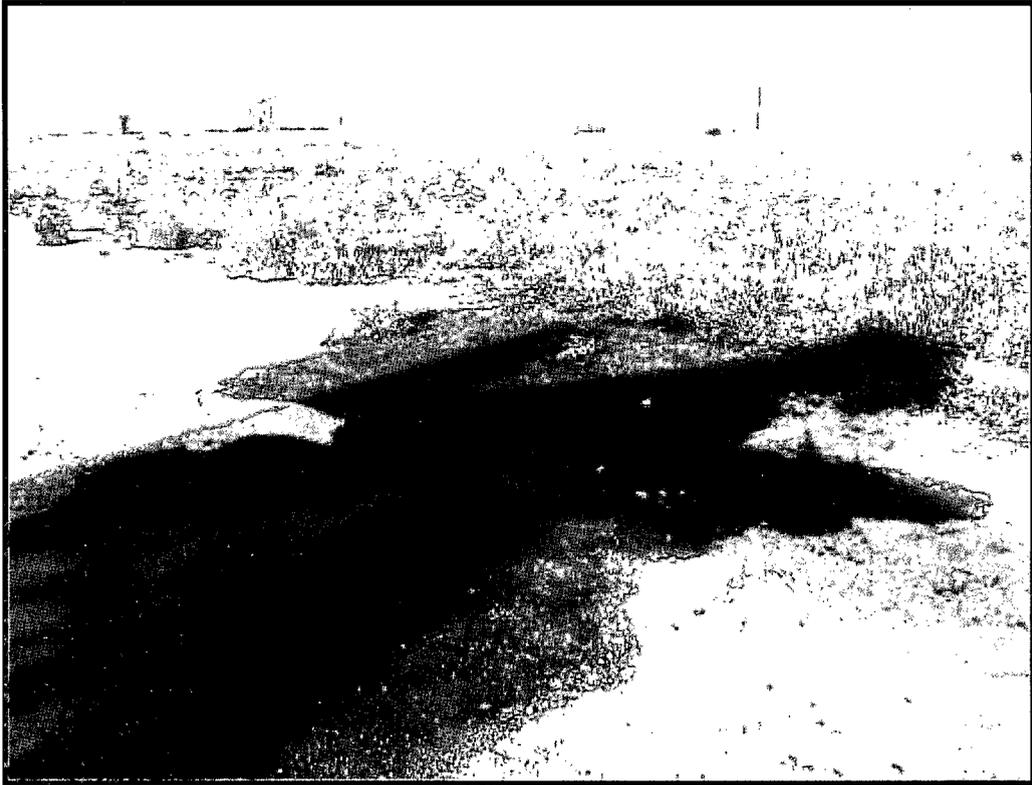
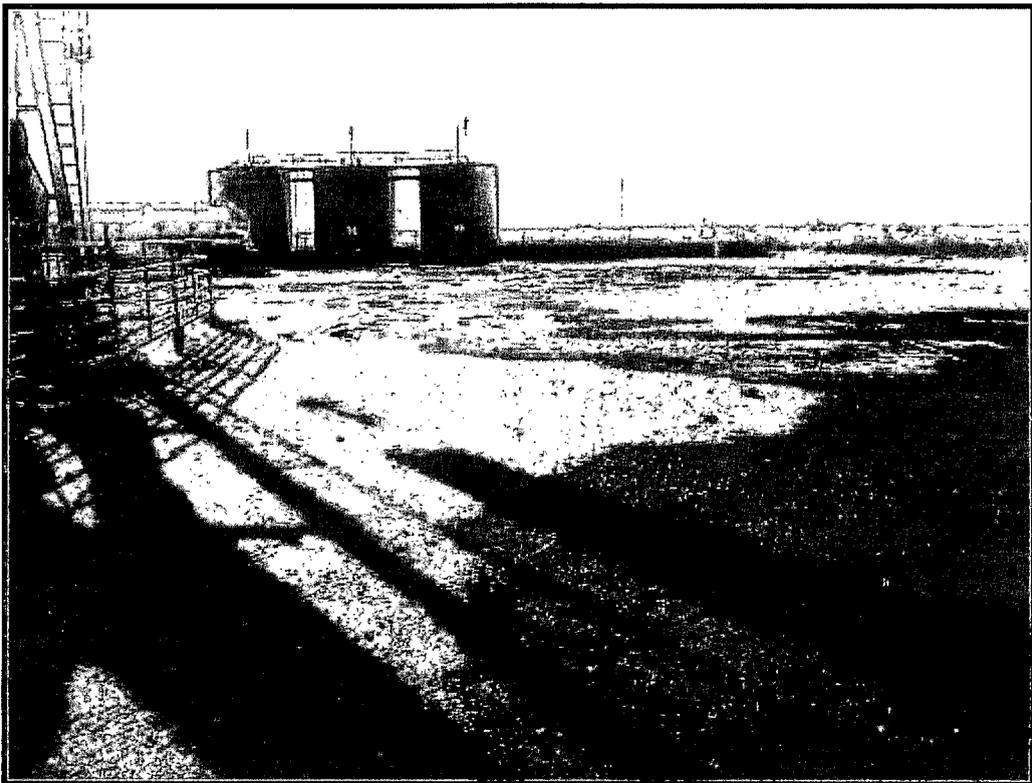
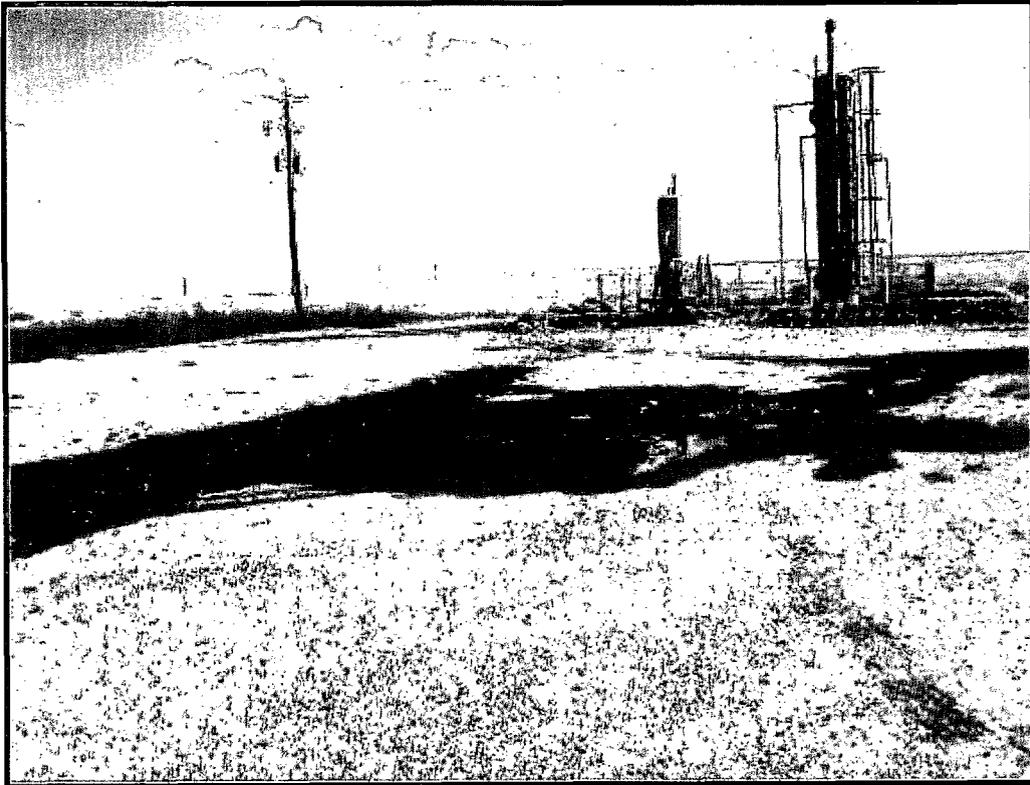
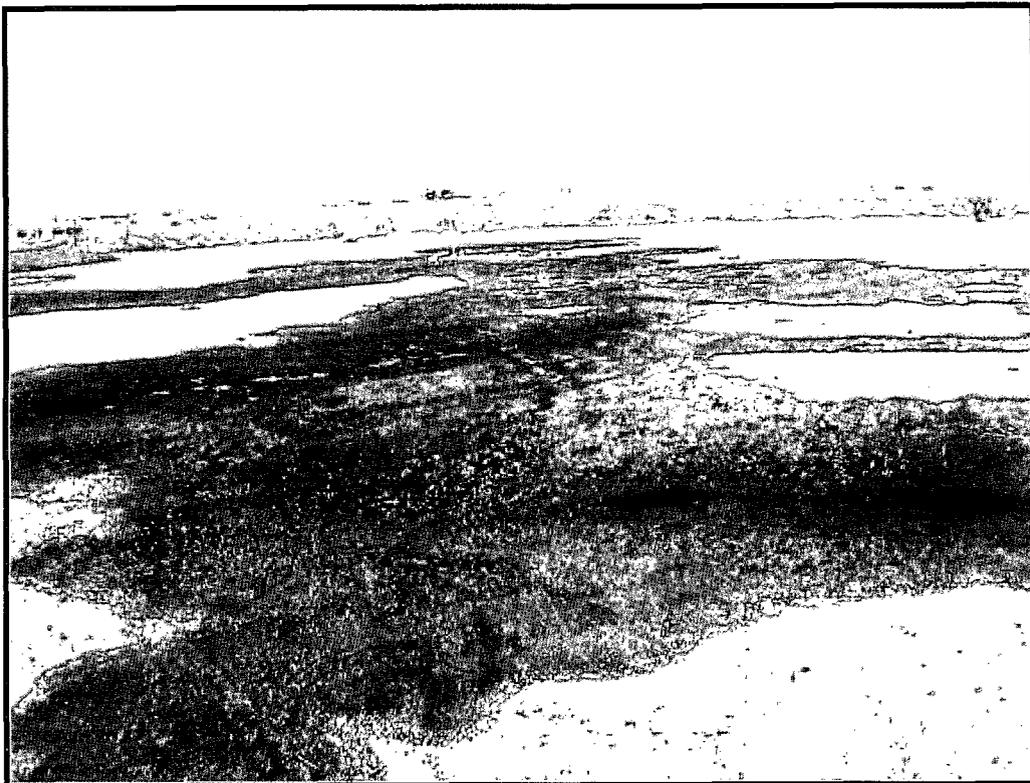
Release area facing southeast

On January 6-11, 2011, SESI was onsite with Hungry Horse to excavate the affected area to a depth of one (1) foot below grade surface (bgs). A total of 260 yards of contaminated soil was transported to Gandy Marley's land farm for disposal. The excavated area was backfilled with clean soils and the location pad repaired.

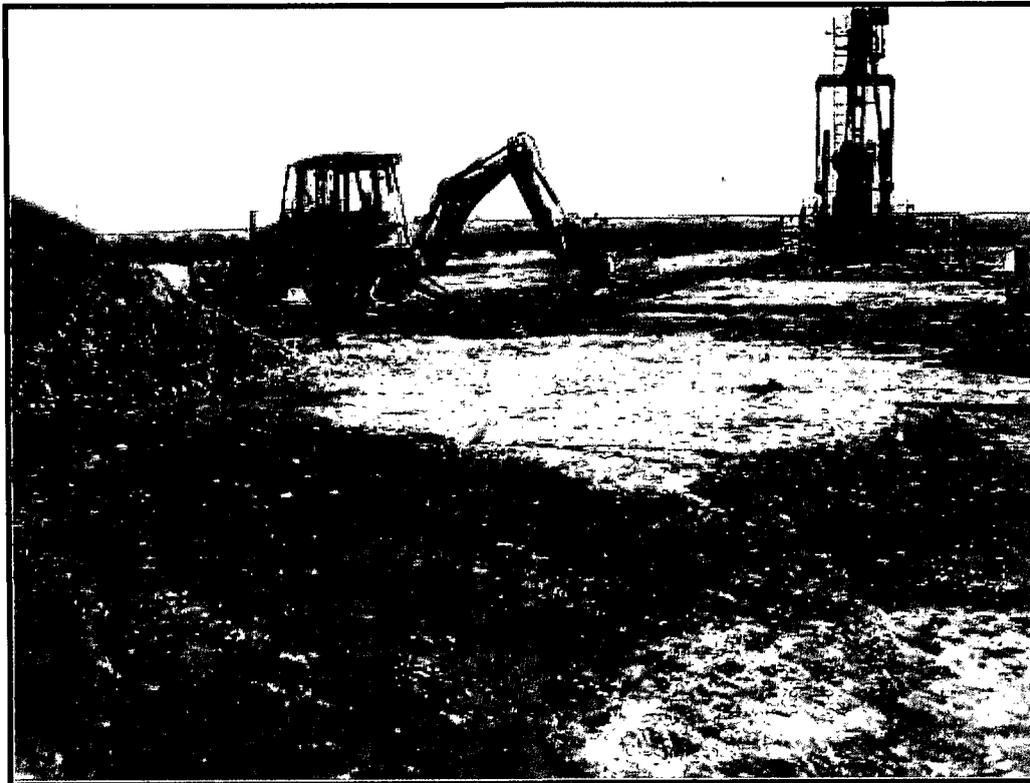
Test Trench #1 facing northeast

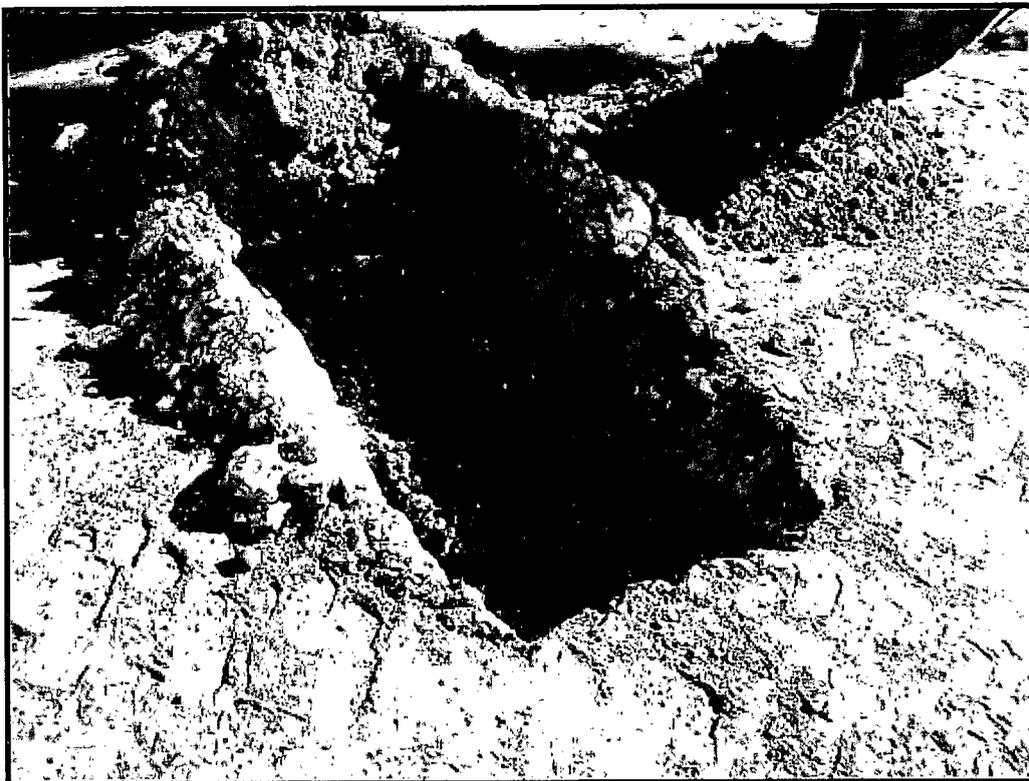
Test Trench #1 1'bgs

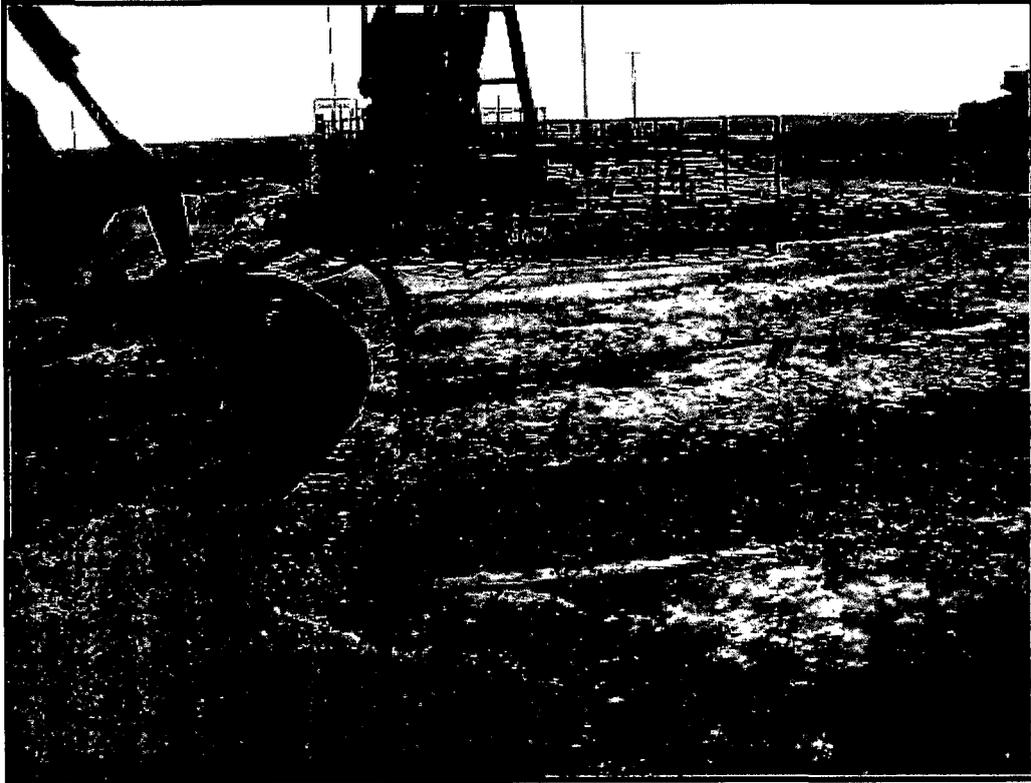
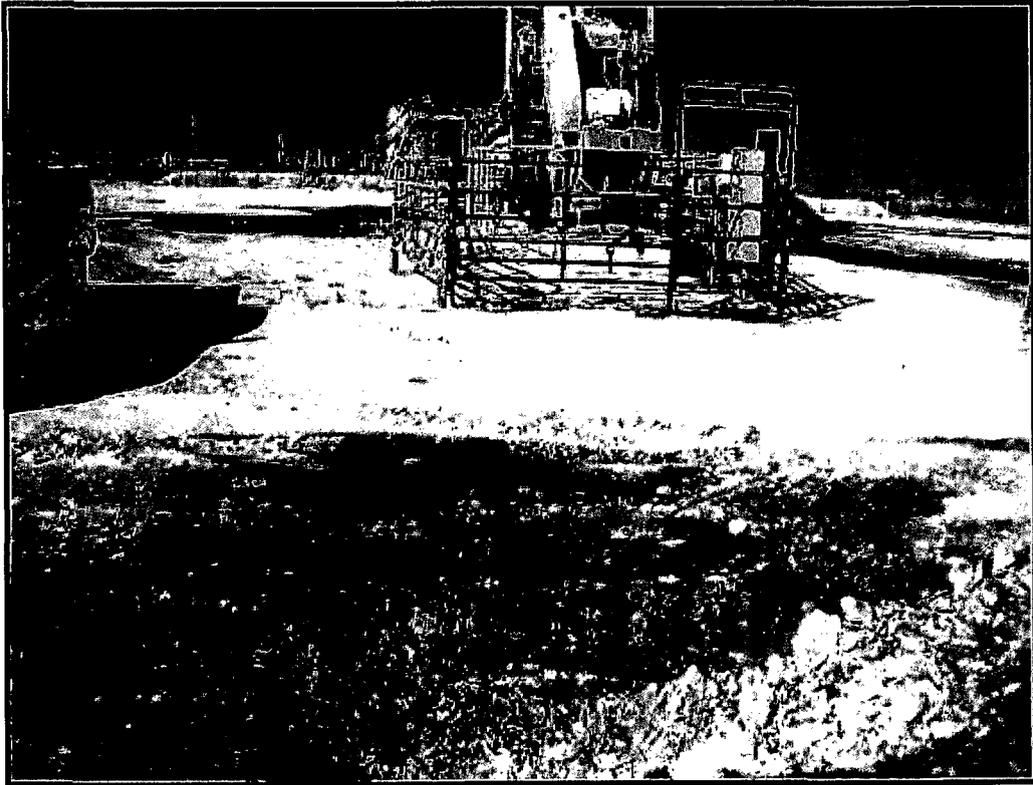
Test Trench #2 facing south

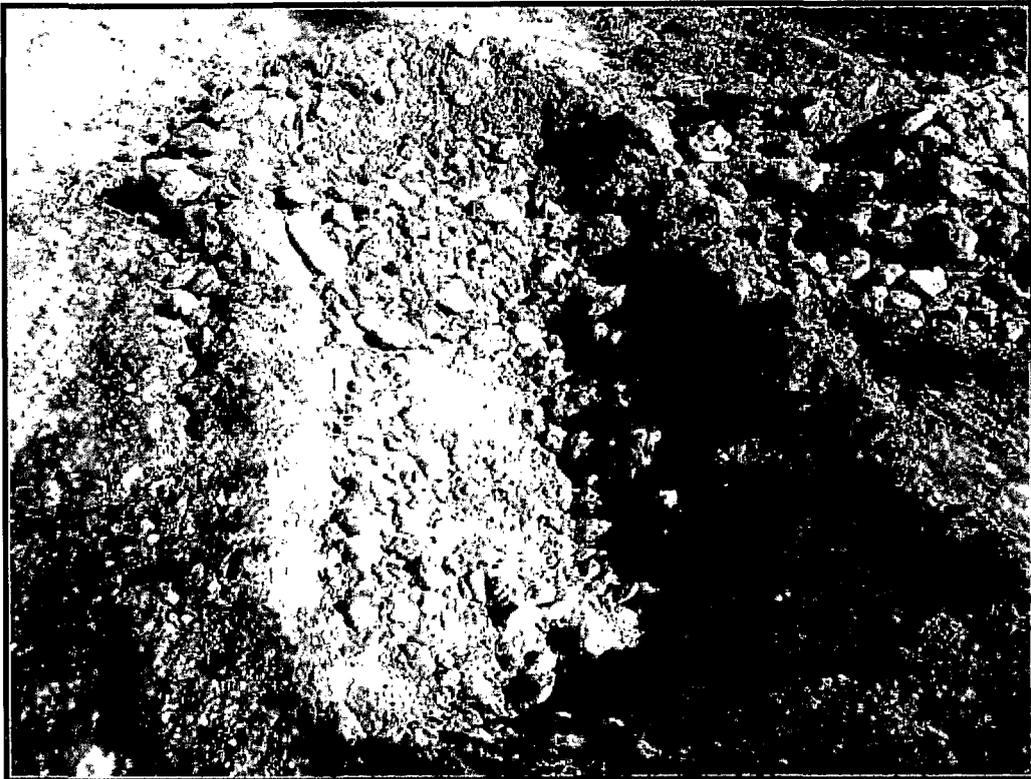
Test Trench #2 1' bgs

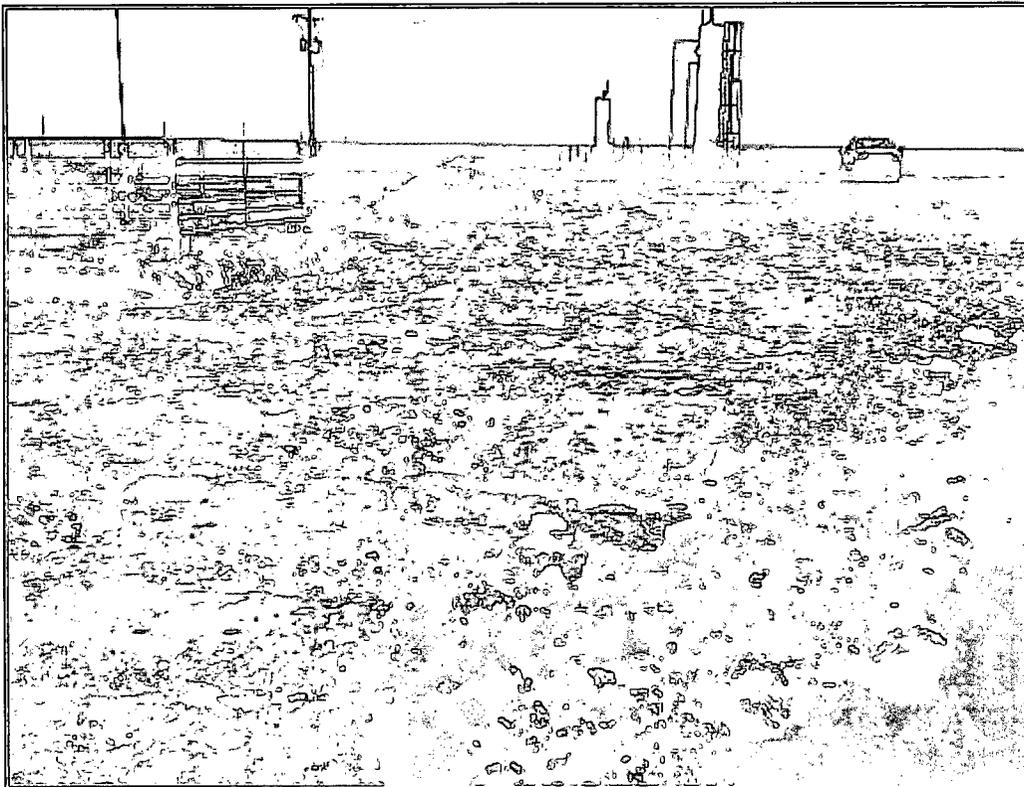
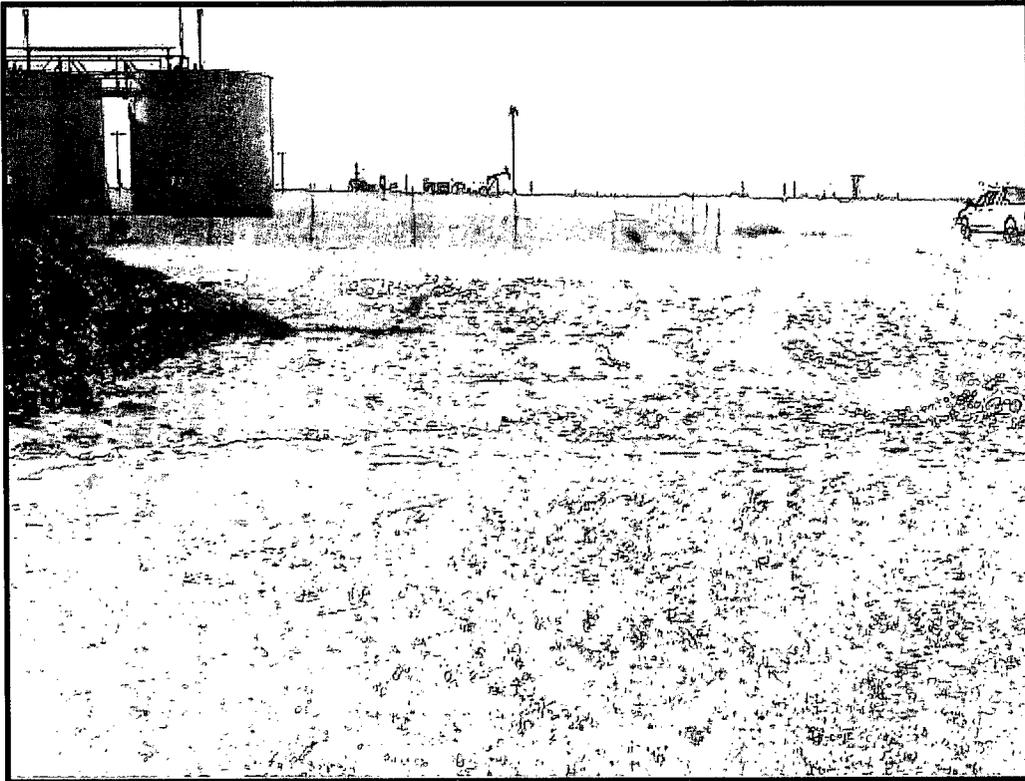
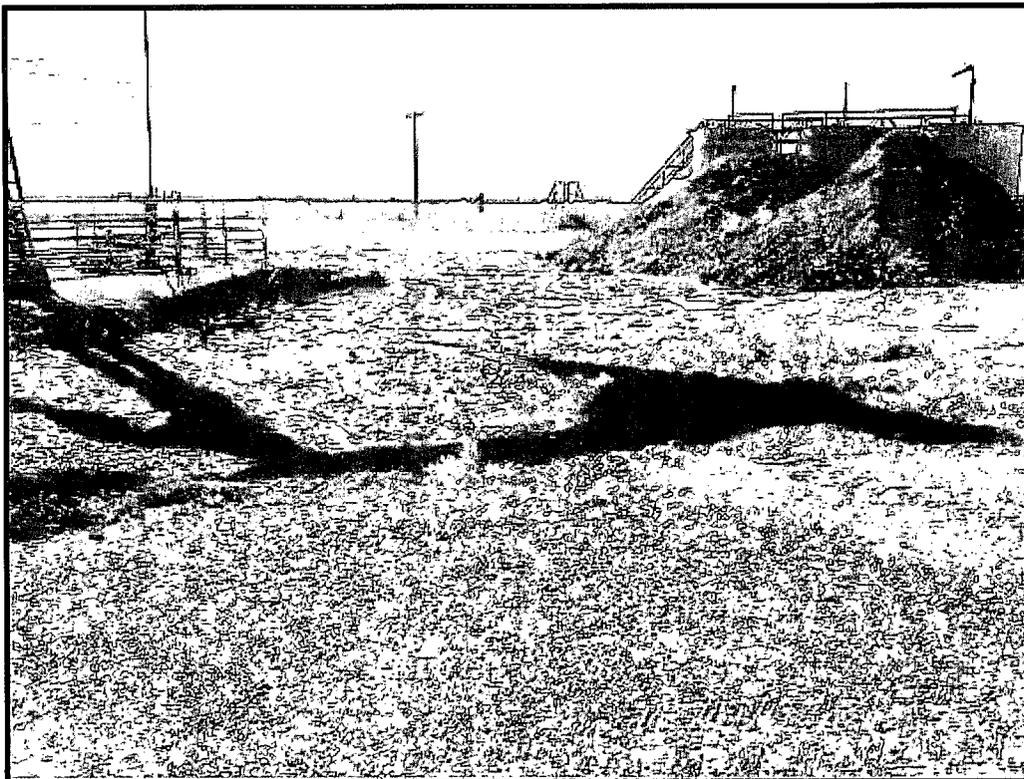
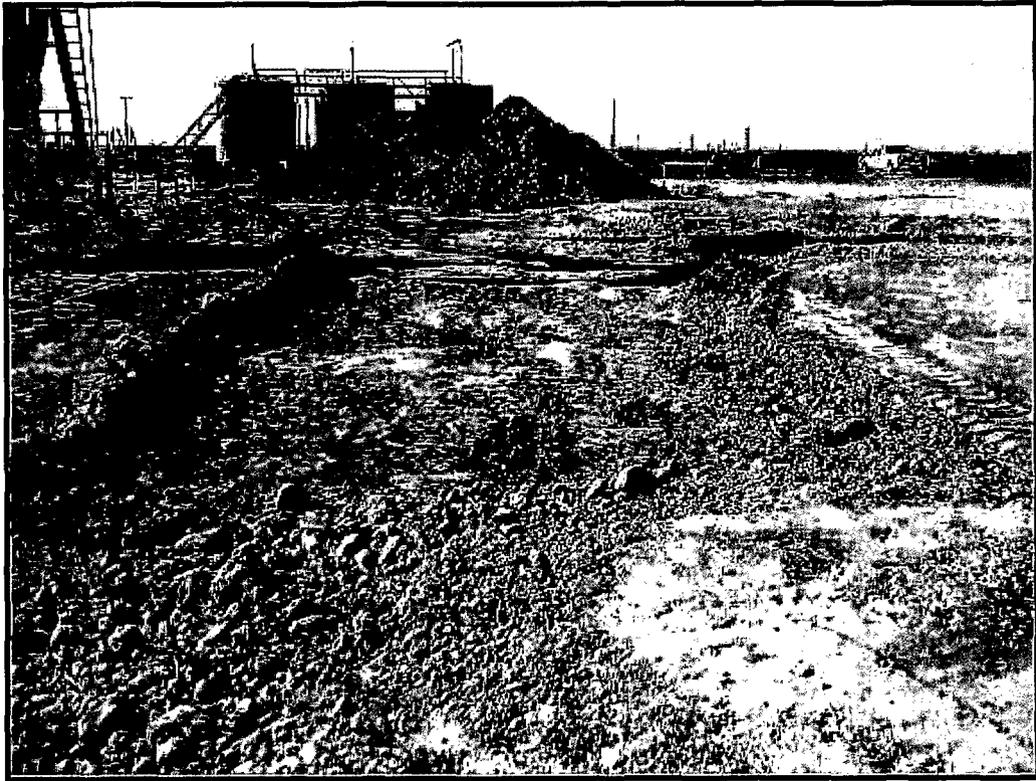
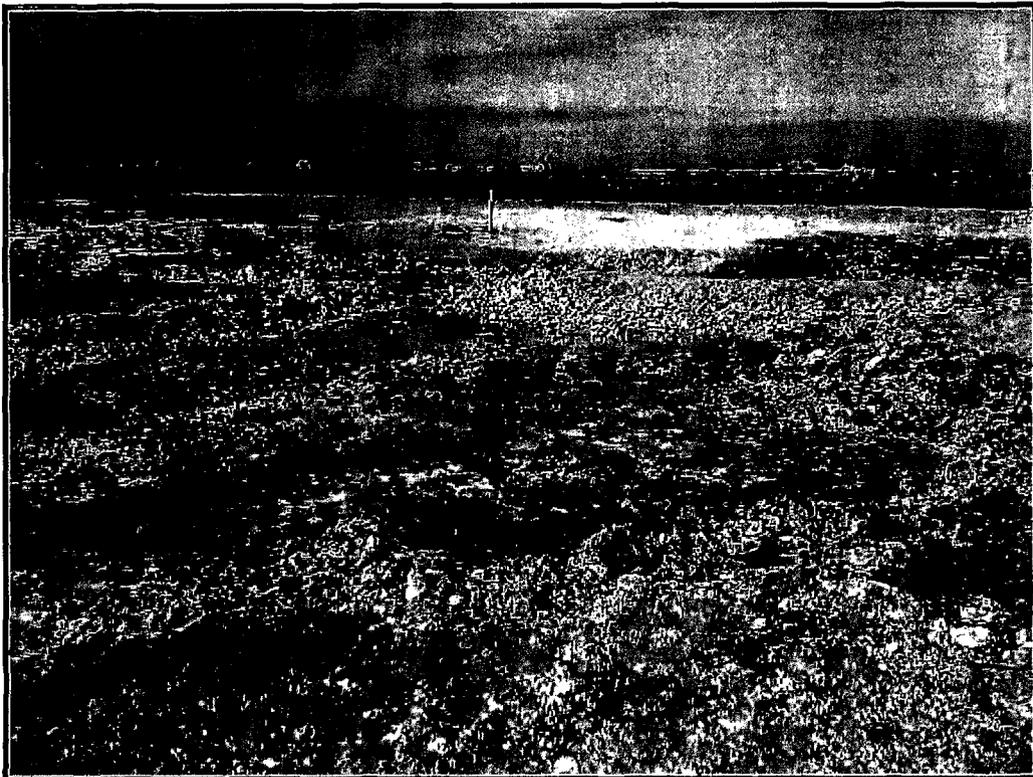
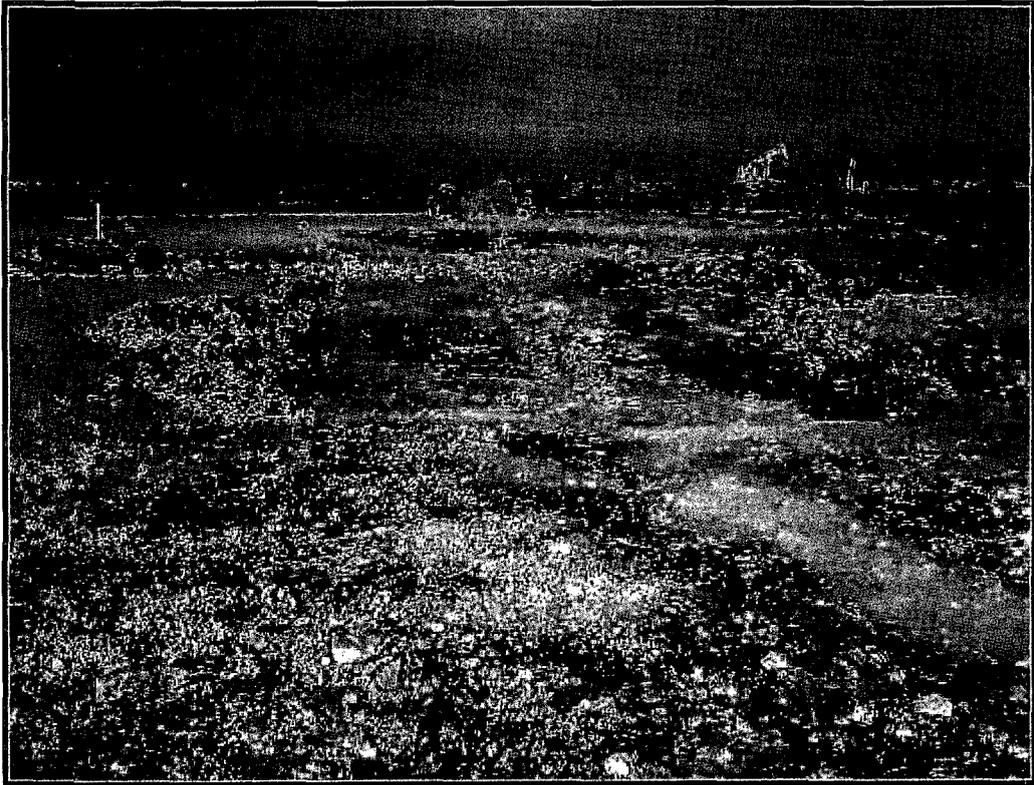
Excavated area facing east
