Release Notification and Corrective Action

**Cimarex Energy Company
Missouri Unit 13 Fee #5
Unit B Section 13, Township 15S, Range 37E
Lea County, New Mexico**

Closure Report

January 28, 2011

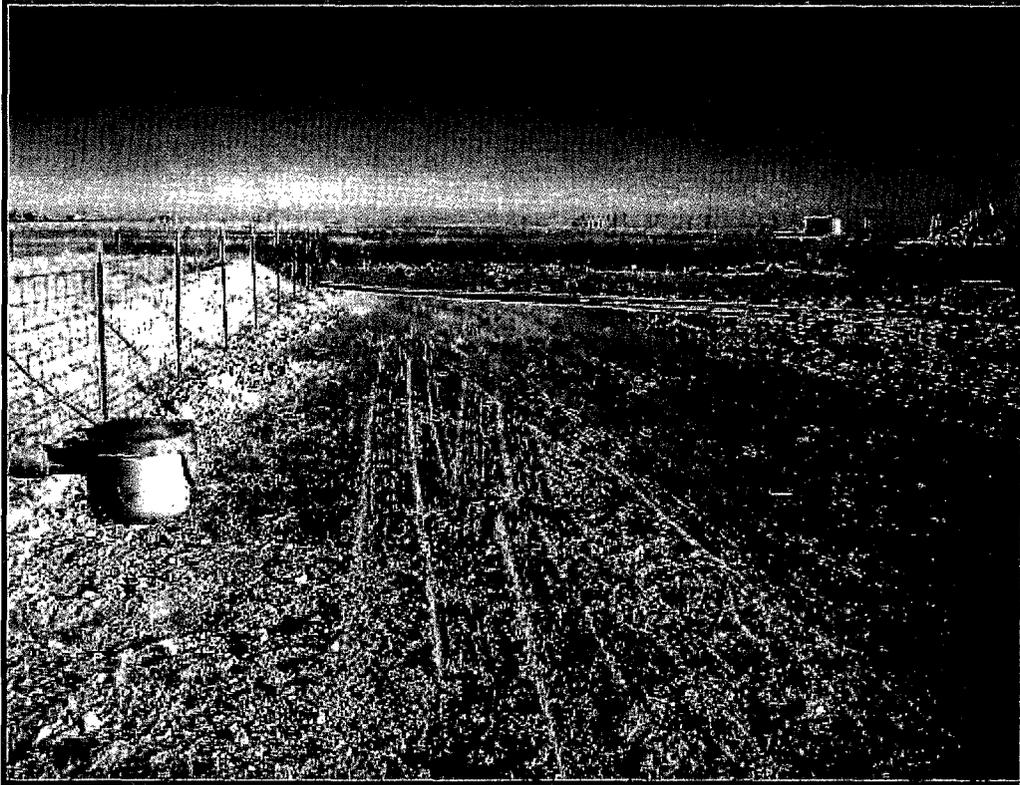
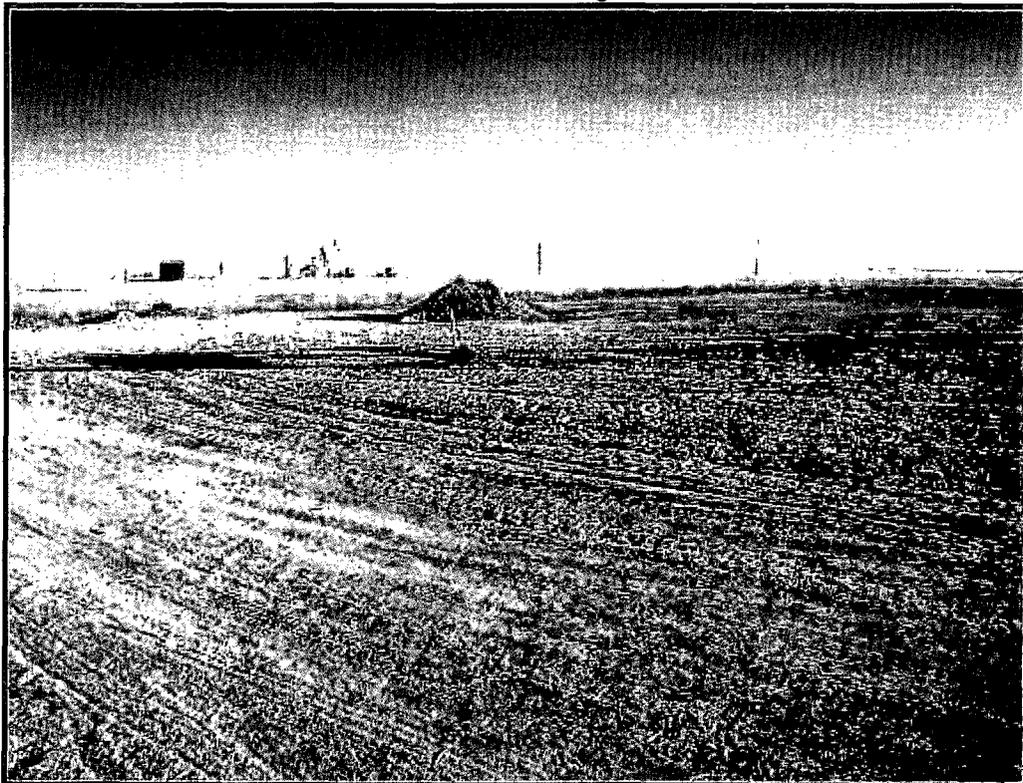
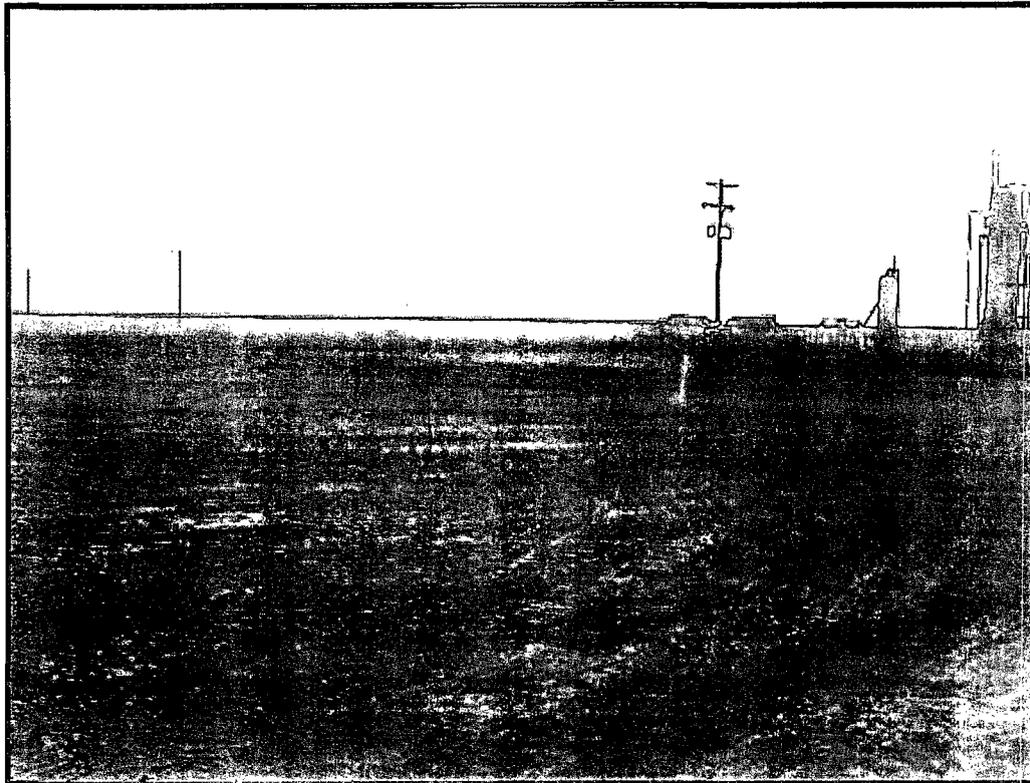
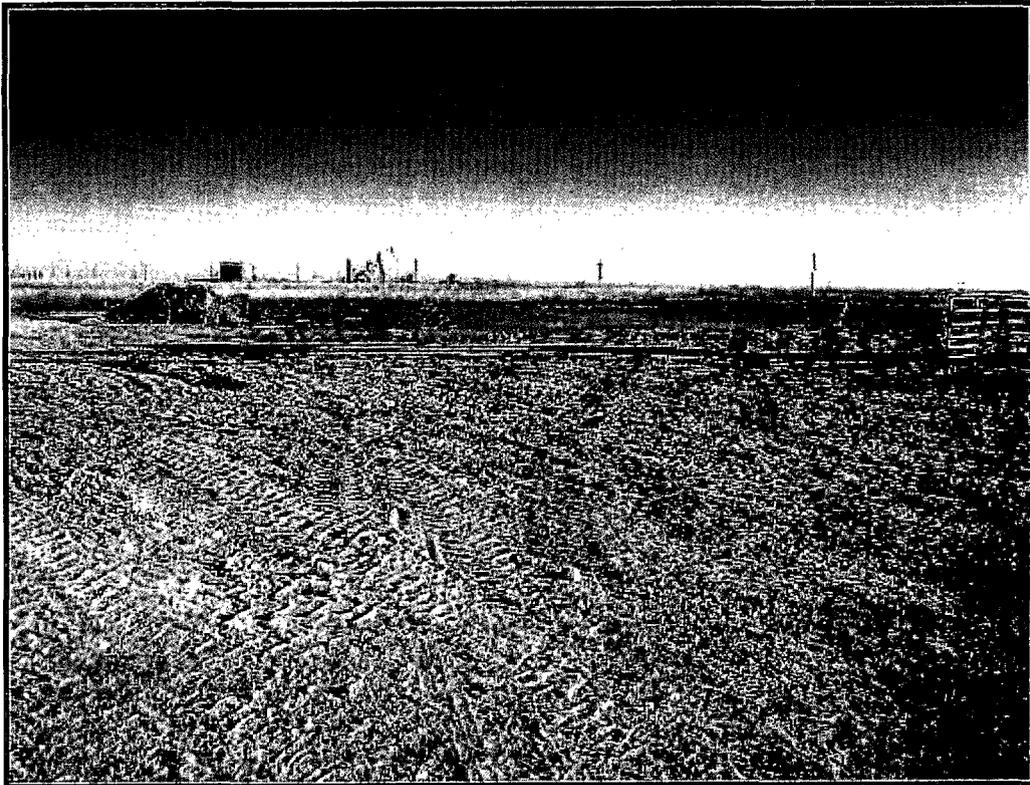
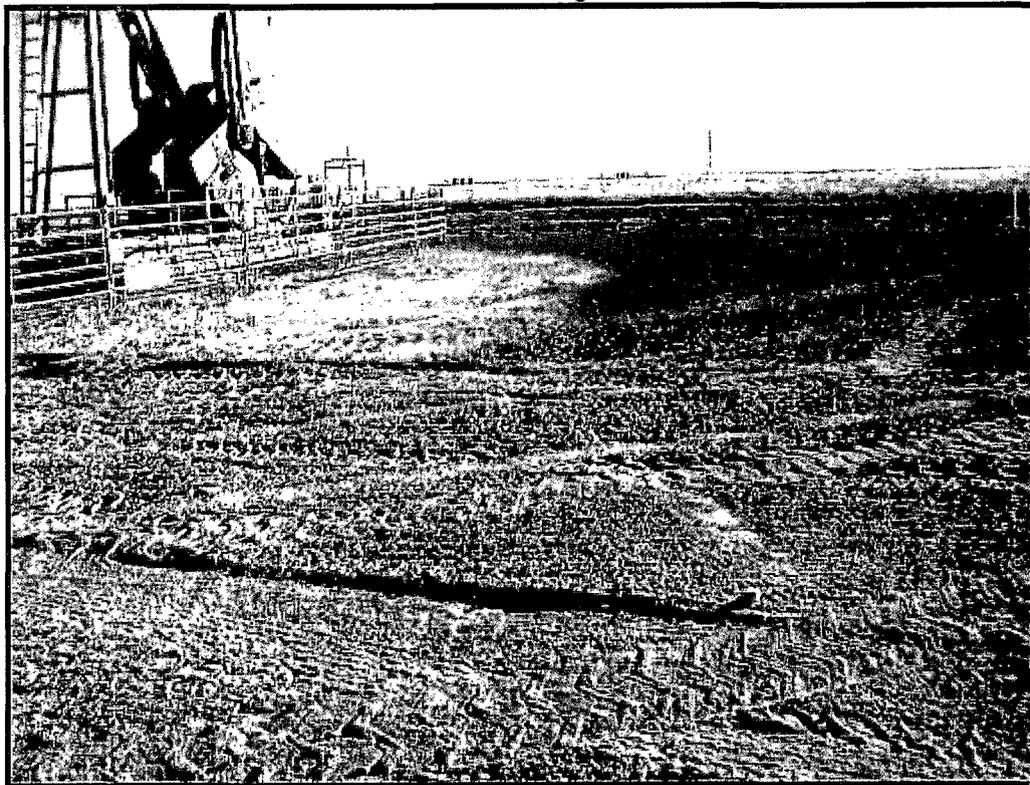
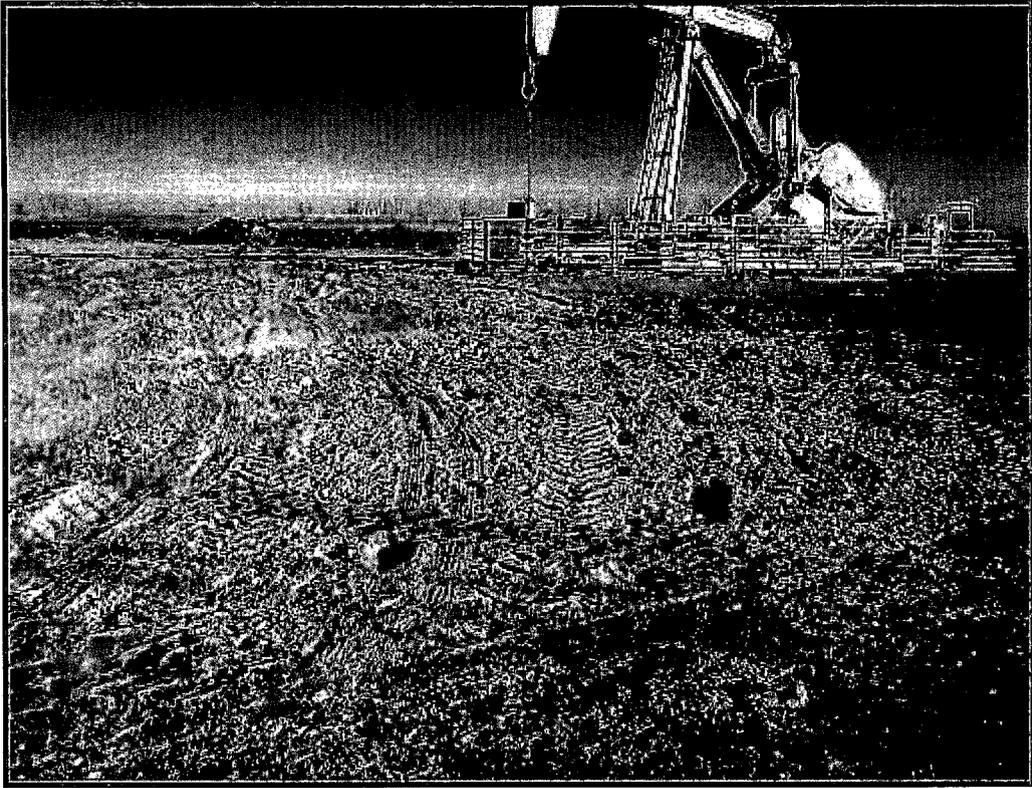
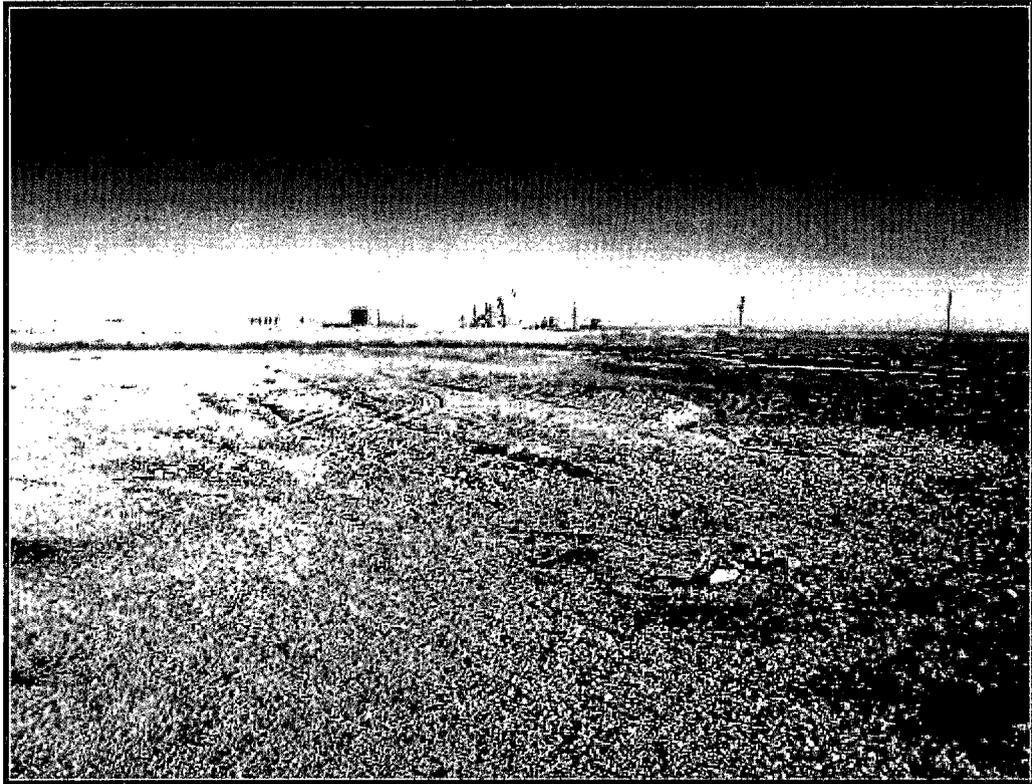
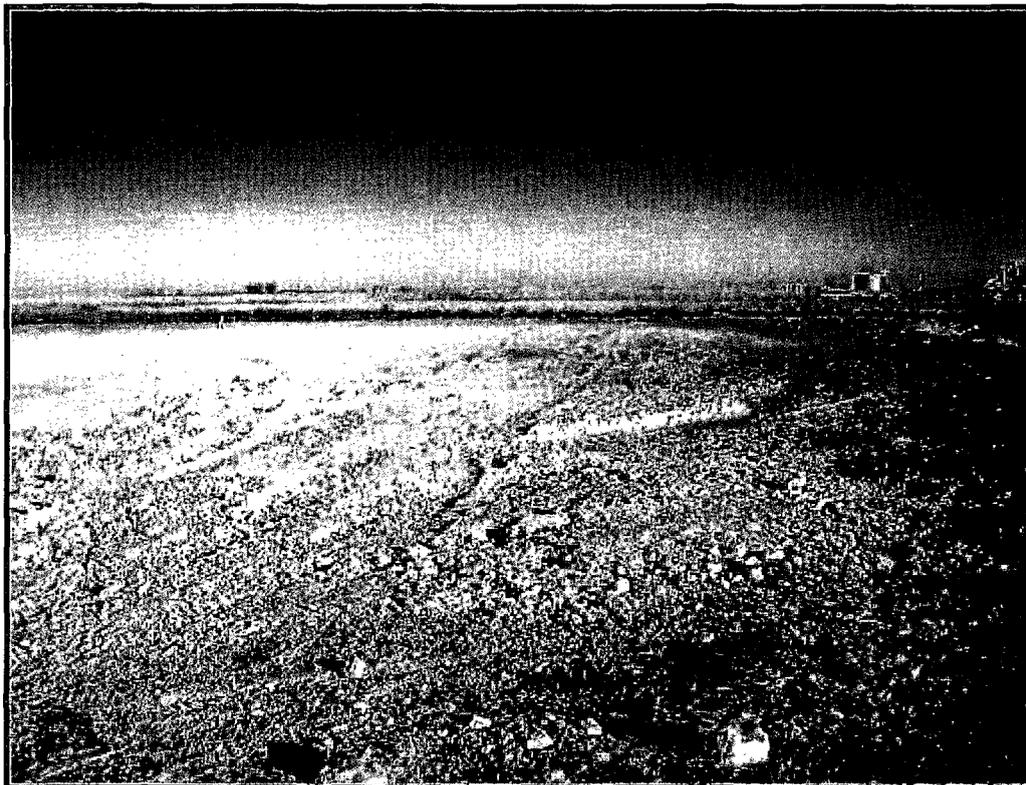
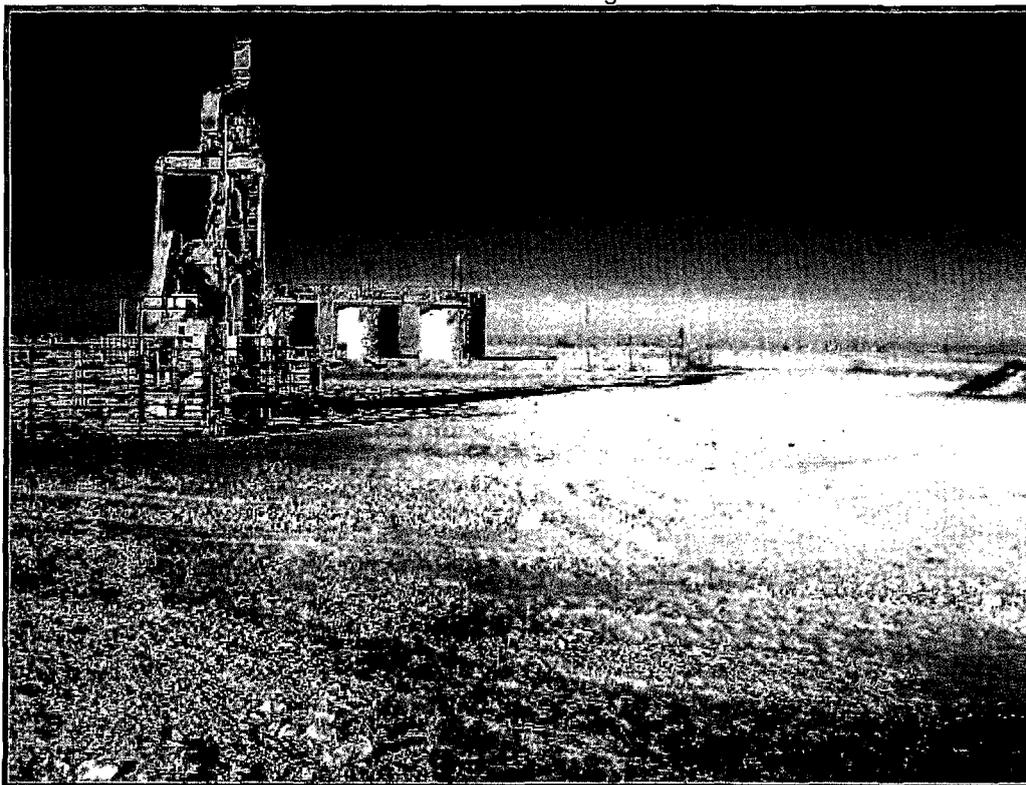
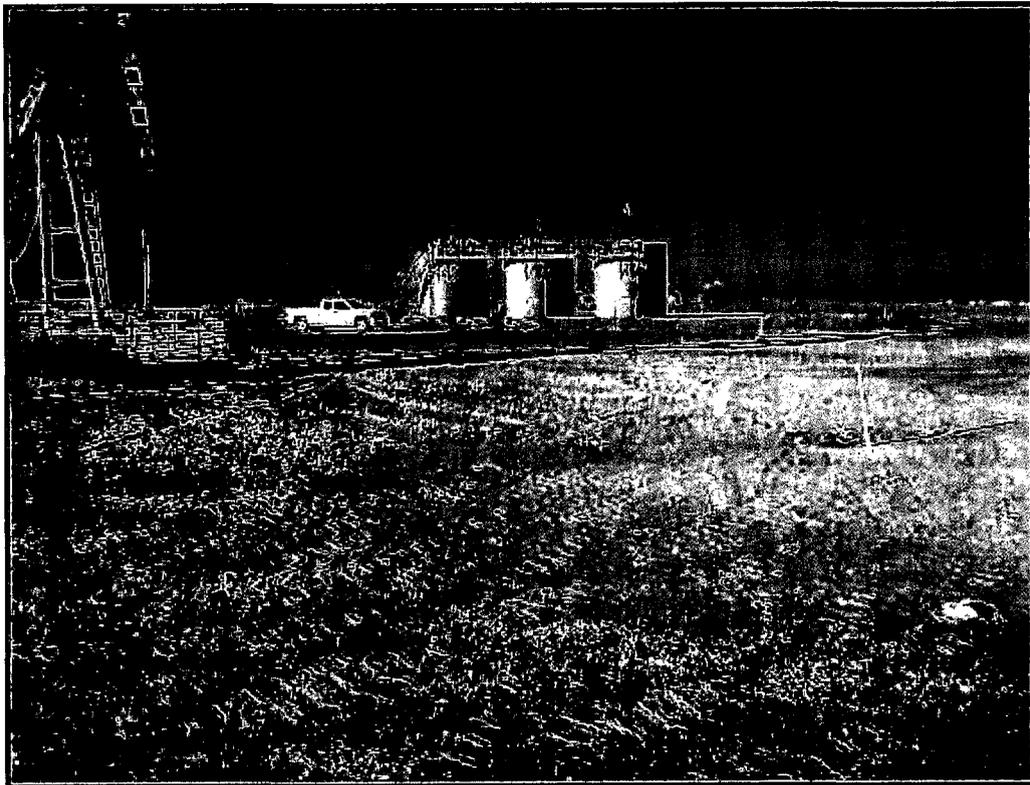
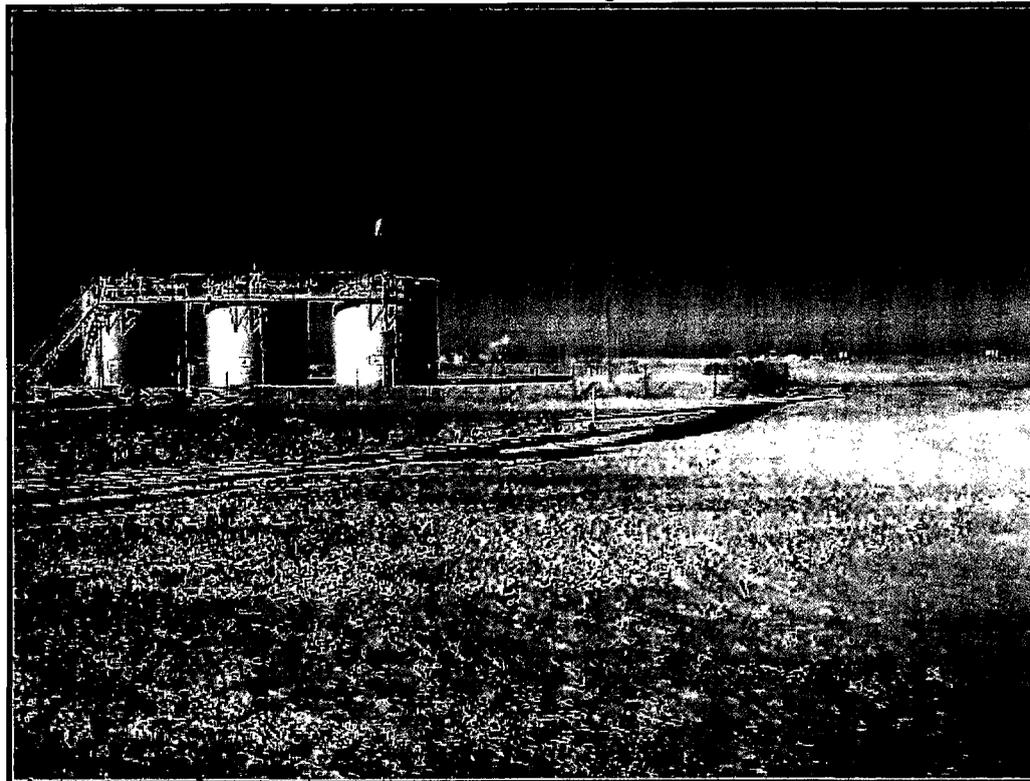
Backfilled area facing north

On January 6-11, 2011, SESI was onsite with Hungry Horse to excavate the affected area to a depth of one (1) foot below grade surface (bgs). A total of 260 yards of contaminated soil was transported to Gandy Marley's land farm for disposal. The excavated area was backfilled with clean soils and the location pad repaired.

Remedial actions at this site have all been performed with the approval of, and in accordance with all NMOCD requirements. The most highly hydrocarbon impacted soils have been disposed of and the area was backfilled with clean soil and returned to natural grade.
