The site will be named Rice BD P-19 EOL Leak site with the OCD case #1R-499.

Re: **Corrective Action Plan**  
Rice Operating Company – BD SWD System  
BD Campbell Hedrick Hardy Jct Box Leak  
UL P SEC. 19 T-21-S R-37-E

**BD Campbell Hedrick Hardy Jct Box**

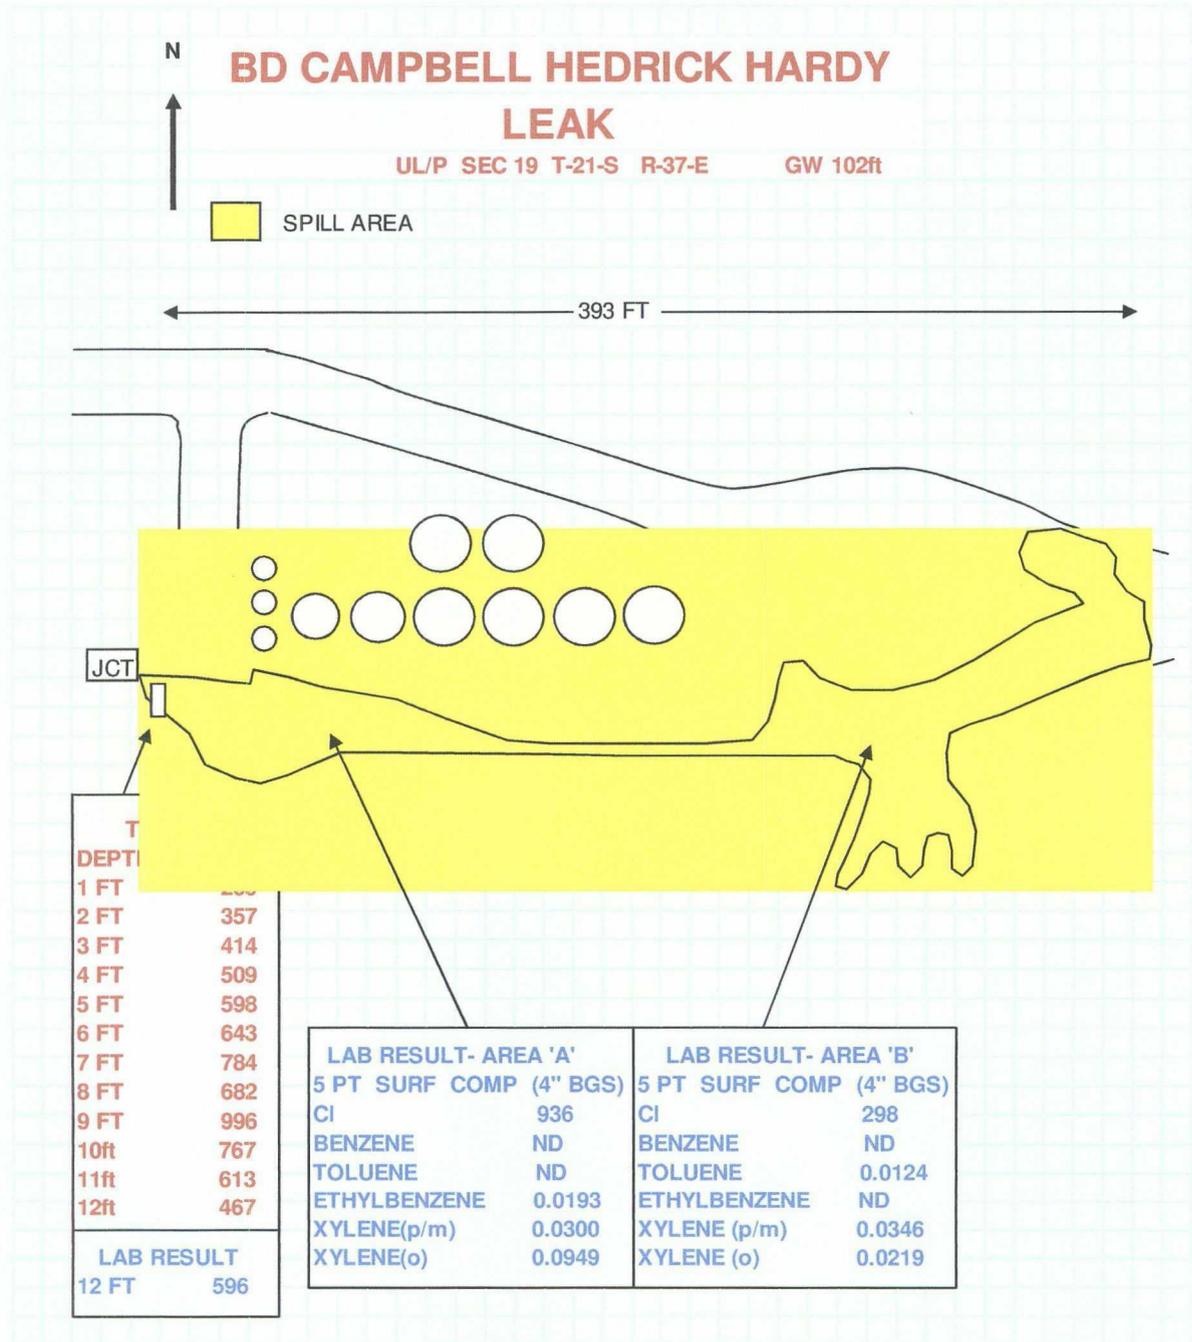
The BD CHH site is located approximately 3 miles west-northwest of the City of Eunice (Figure 1). Approximately 675 bbls of produced water were estimated to have been released, pooling in down-gradient low lying areas before being removed by a vac-truck (Figure 2). The results of a field evaluation of residual soil chlorides are summarized in Figure 3, and are indicative of moderate to low near-surface impacts. As the depth to groundwater is greater than 100 ft the potential for groundwater impact from this relatively small spill is exceedingly small. We therefore propose the following work elements as a Corrective Action Plan to restore the surface and to obtain regulatory termination:

**Figure 3 – BD Campbell Hedrick Hardy Junction Box location showing spill areas and the results of field evaluation of residual soil chlorides.**

1. The upper six to twelve inches of soil from the affected areas outside of the caliche lease road (Figures 4a & 4b) will be removed and disposed of in an approved landfill.
2. Clean soil material will be hauled in and the site graded to natural contours.
3. The site (outside of the caliche lease road) will be seeded to a native vegetation mix.
4. Photographs will be taken of the work as it is being done and upon completion, a brief report will be submitted requesting regulatory termination.

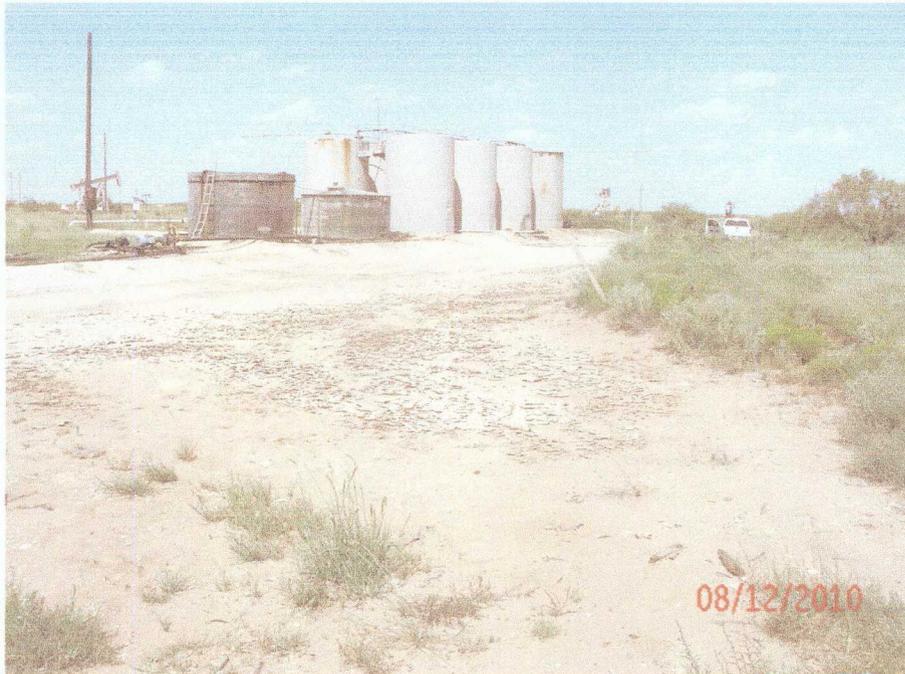
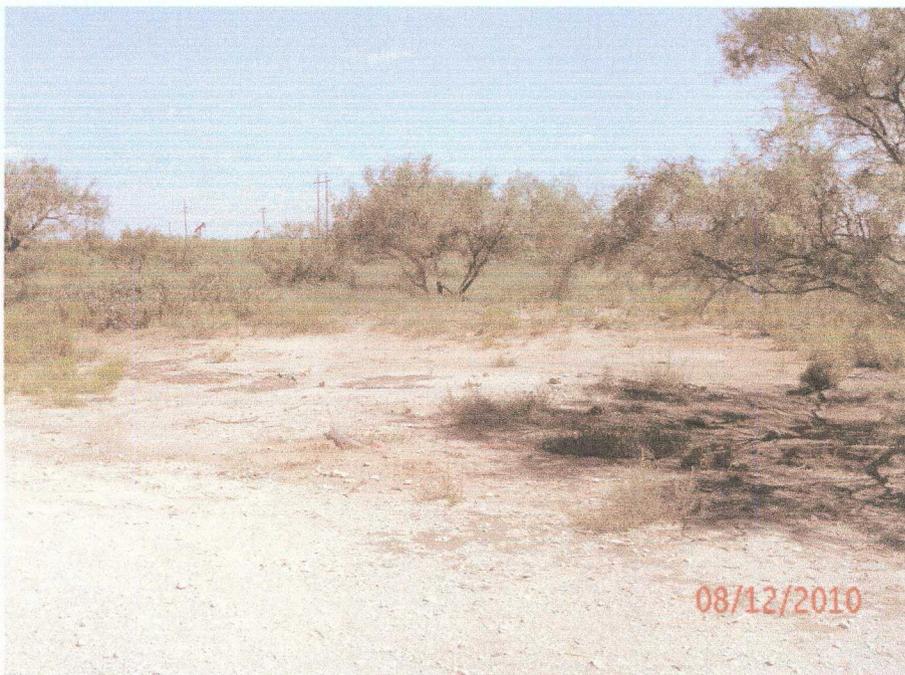
**Figure 4a & 4b** – BD Campbell Hedrick Hardy Junction Box location view looking northeast (Figure 4a, above) and east-southeast (Figure 4b, below) show areas impacted from produced water release. It is these open, un-vegetated areas that we propose to restore in the Corrective Action Plan.
