**Cimarex Energy Company
Cottonwood Draw "22" Federal Com #5
Unit Letter A, Section 22, Township 25S, Range 26E
Eddy County, New Mexico**

Delineation Report/Work Plan

September 1, 2010

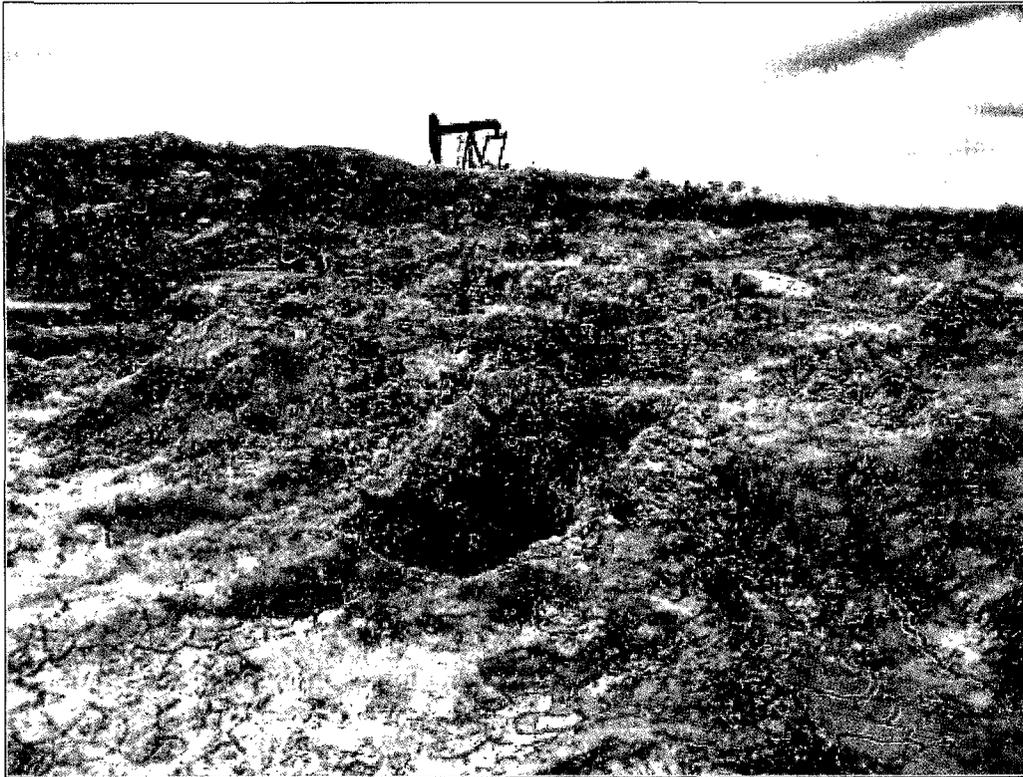
Test Trench A

Lab ID	Sample ID	Cl ⁻ (mg/kg)
Analysis Date:	-	08/26/10
H020713-01	TT. A SURFACE	1200
H020713-02	TT. A-1' BGL	192
H020713-03	TT. B-SURFACE	256
H020713-04	TT. C-SURFACE	304
H020713-05	TT. C-1' BGL	160
H020713-06	TT. D-SURFACE	656
H020713-07	TT. D-1' BGL	128
H020713-08	TT. E-SURFACE	1920
H020713-09	TT. E-1' BGL	512
