Executive Summary Melrose Energy Conoco 7 State No. 3 Spill Remediation Report

**Remediation Protocol
Melrose Energy Co.
Conoco 7 State No. 3 Battery**

Photographic Narrative of Significant Events

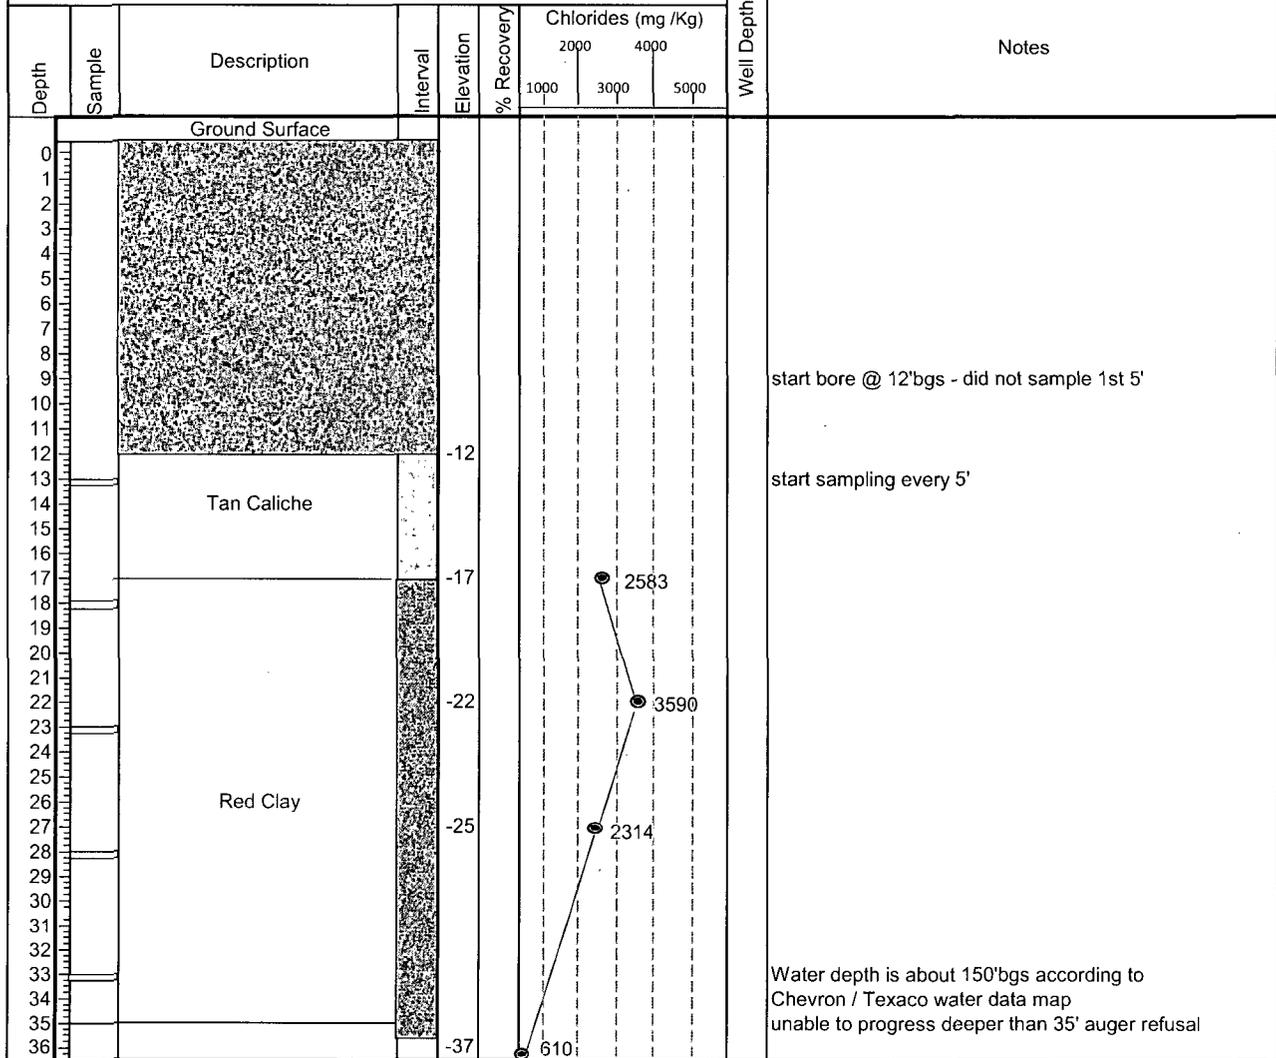
Chloride Delineation Boring Log of Melrose Conoco 7 St. No. 3

Client	Isramco/Jay Mgmt	Drill Method	Solid Stem Auger
Project	Conoco 7 St. No. 3	Borehole Dia.	5 1/4"
Location	Lea County, N.M.	Total Depth	35' bgs
Latitude	32.67685N	Driller	Whole Earth
Longitude	104.11491W	Bore Purpose	Delineation
Date Drilled	12/11/2009	Status	Grouted
Date Completed	12/11/2009	Technician	R. Rascon

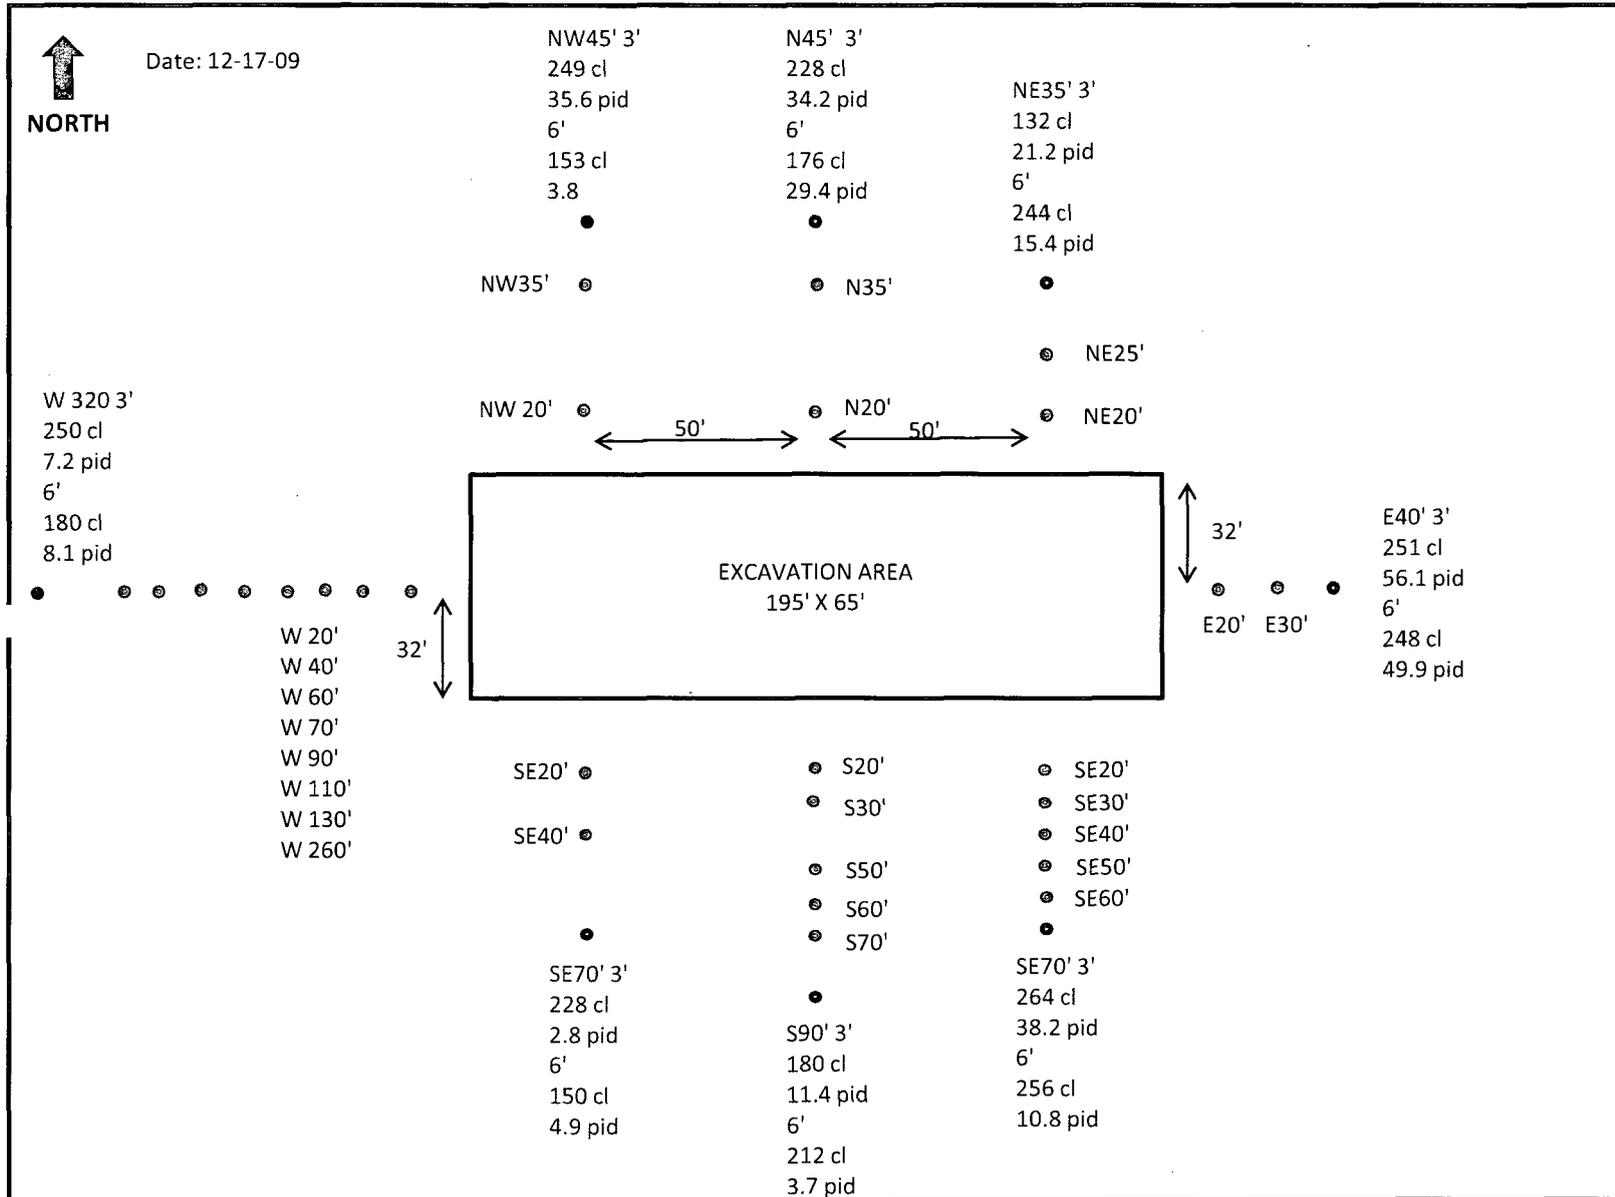
**Chloride Field Titration Results and Sample Points
Melrose Conoco 7 State 3 Tank Battery**

LOCATION: MELROSE OPERATING CONOCO 7 ST. #3 TANK BATTERY								
DEPTH TO GW: 140' TO 150' according to Chevron/Texaco Eddy Co. depth to gw map								
Sample pt.	DEPTH	SOIL	WATER	CF	AGNO3	CL-	PID	Soil Lithology
Bore #1 W. end of excavation	17'bgs	14.8	30.2	2.04	0.38	2584	2.4	2.5YR-6/4 light reddish brown, silty clayey soil damp
	22'bgs	8.3	31.4	3.78	0.95	3593	3.6	2.5YR-5/4 reddish brown, sandy silty clayey soil damp
	27'bgs	13.2	29.5	2.23	0.31	2309	6.9	10R-3/3 dusky red, red bed clay damp
	32'bgs	13.2	29.1	2.20	0.37	2039	25.9	10R-3/3 dusky red, red bed clay damp
	37'bgs	10.5	33	3.14	0.1	628	36.8	10R-3/3 dusky red, red bed clay damp
Bore #2 Middle of excavation	9'bgs	5.9	35.3	5.98	1.12	6699	2.1	2.5YR-7/2 pale red sandy caliche damp
	14'bgs	7.1	34.3	4.83	0.82	3960	2.4	2.5YR-7/3 light reddish brown caliche damp
	19'bgs	8.4	31.6	3.76	1.11	4174	2.6	10R-3/4 dusky red, red bed clay damp
	24'bgs	8	37.4	4.68	0.95	4440	2.6	10R-3/4 dusky red, red bed clay damp

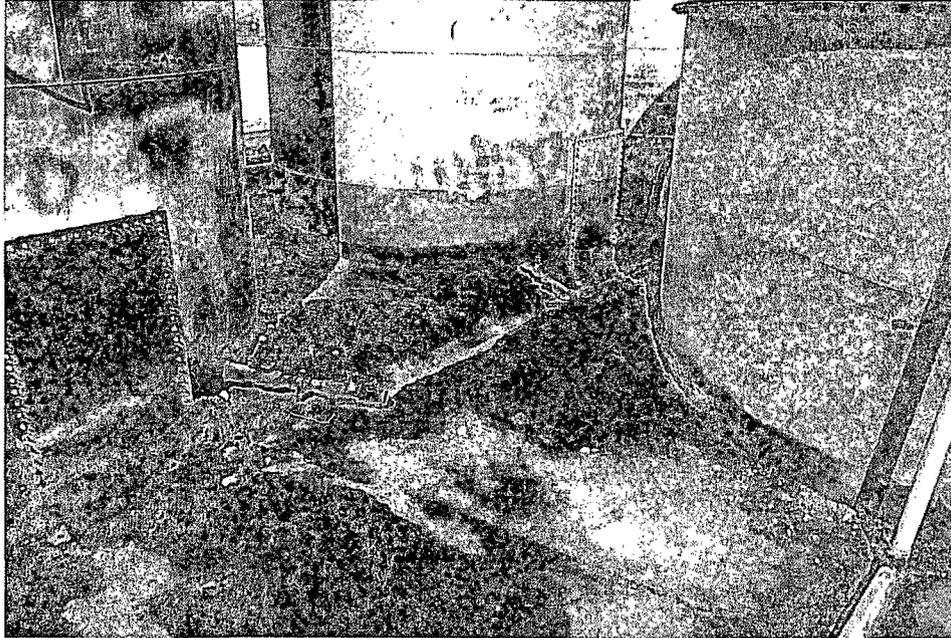
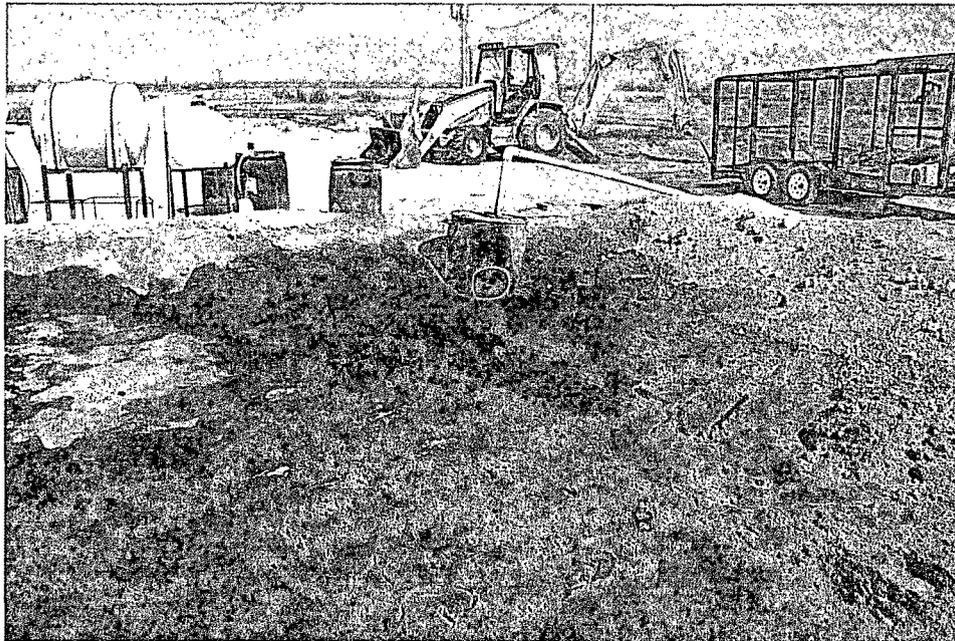
On September 9, 2009 Melrose discovered a leak caused by the failure of line to the heater-treater resulting in hydrocarbons being spilled within the containment berms.

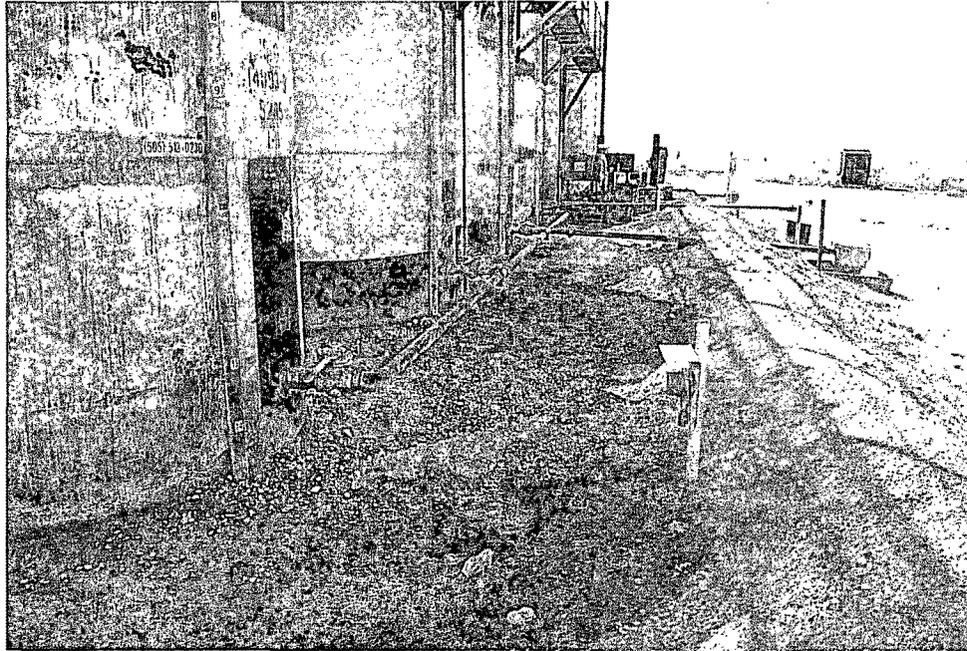
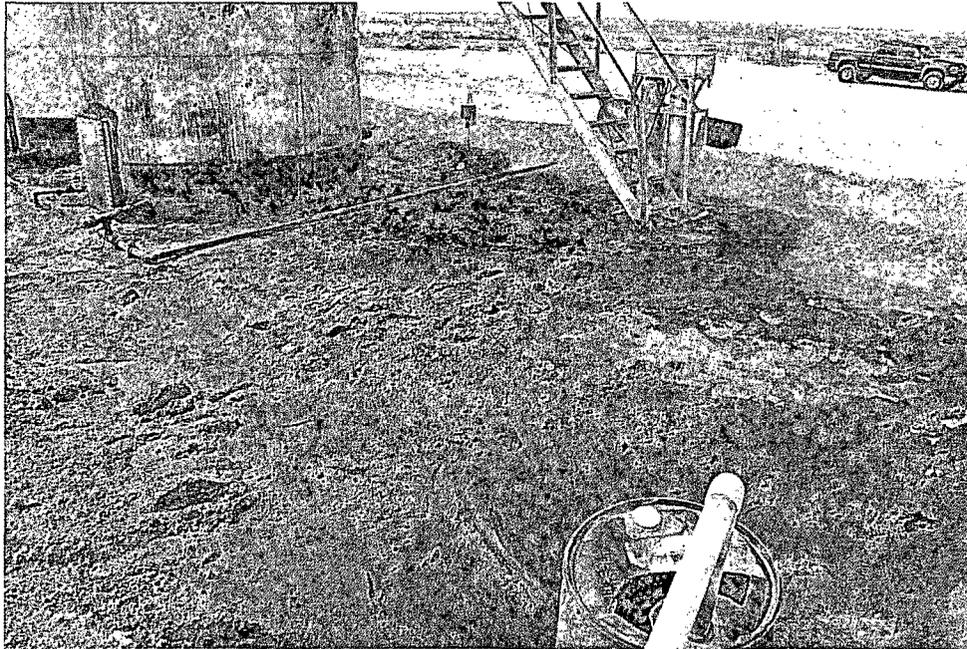
By December 9, 2009 the affected area was excavated and contaminated soils were sent to commercial disposal.

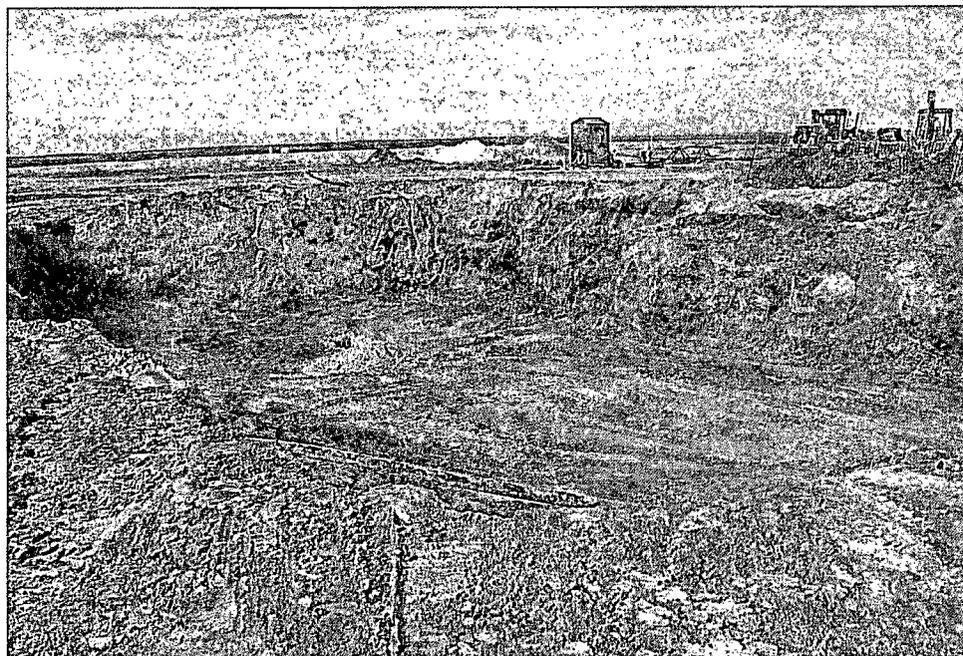
By December 13 the site was vertically and laterally delineated using deep coring and surface (3' & 6') excavations.

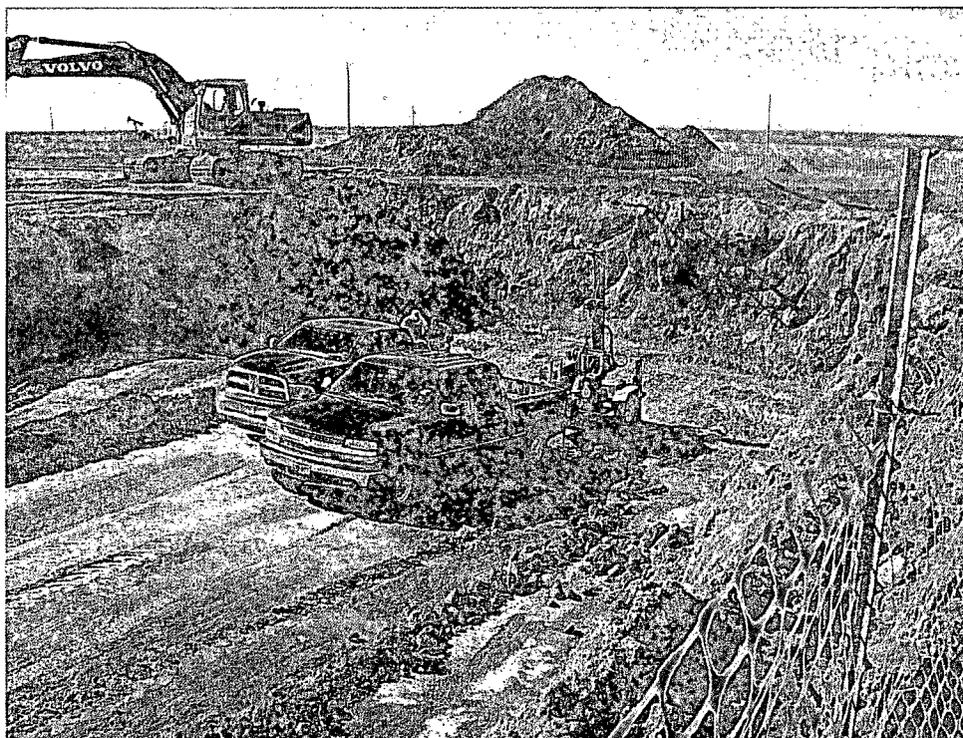
On December 15th the excavated area was prepared for lower liner installation.

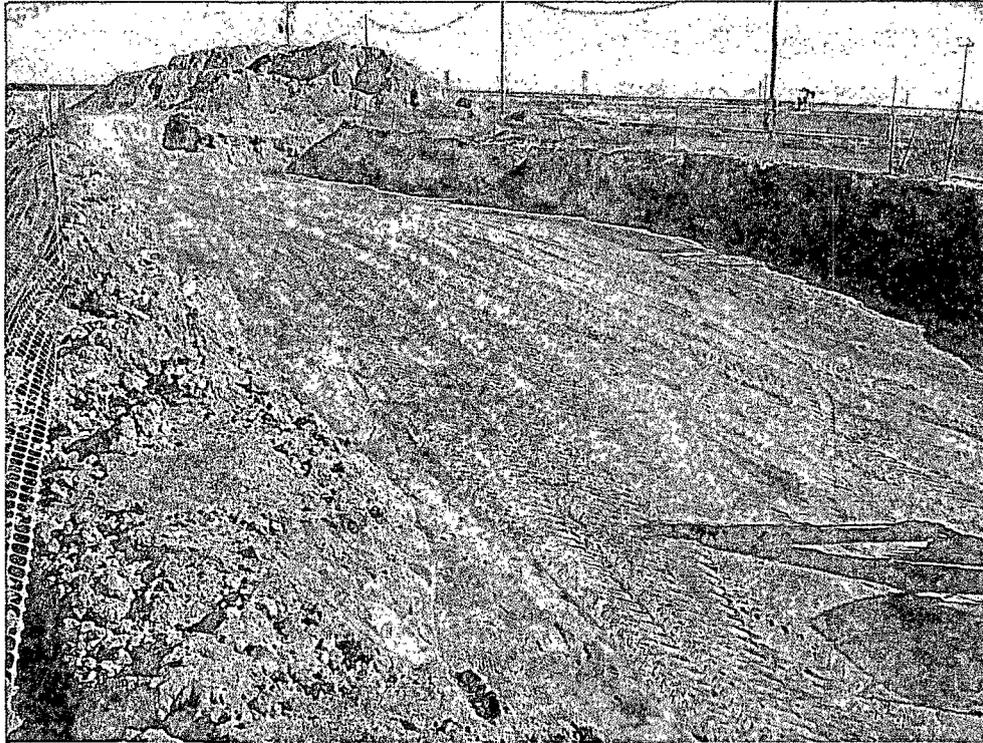
The lower liner was set at an average depth of five feet below ground surface.

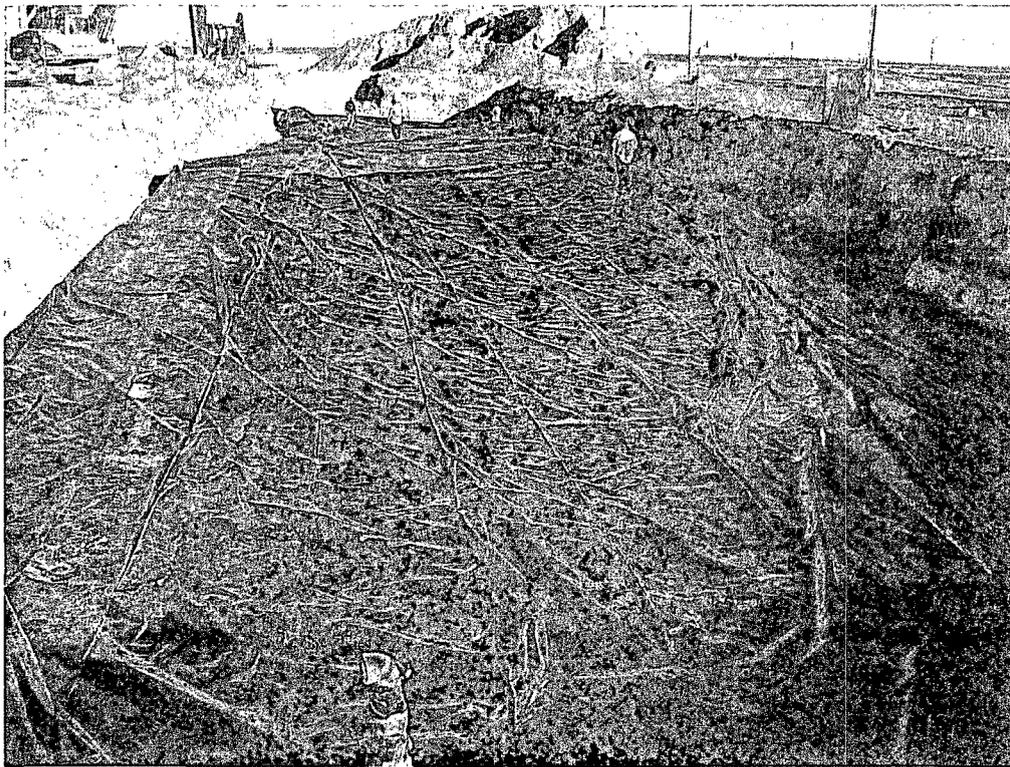
The upper liner was set & tied into the containment berms.

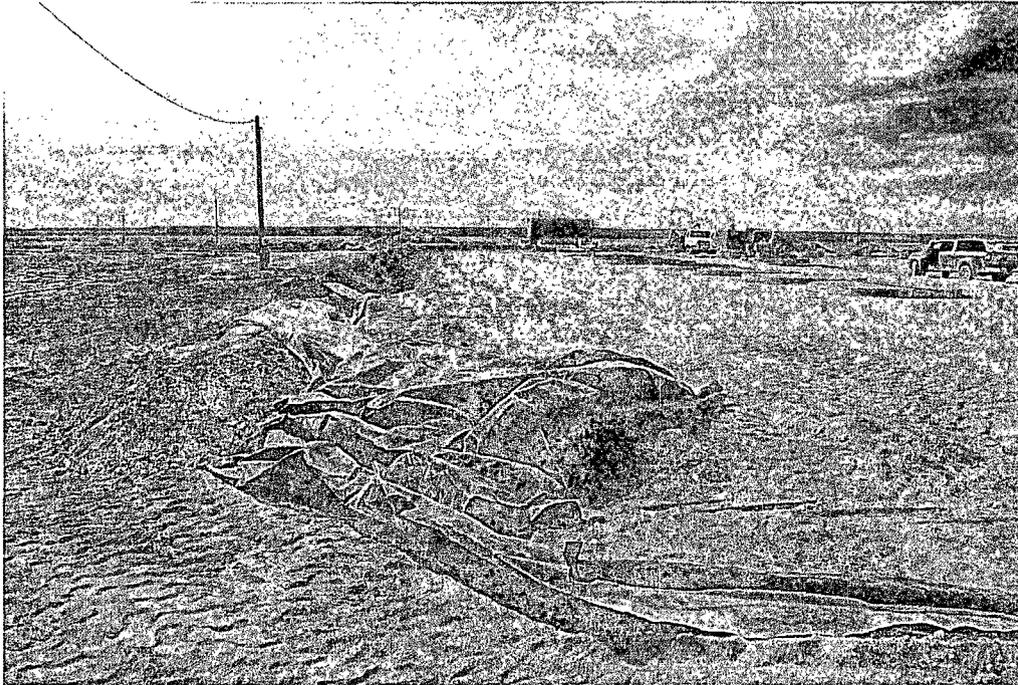
Final containment rings and gravel were placed below the newly installed tanks.
