**EME B-13 EOL**

**RICE OPERATING COMPANY  
JUNCTION BOX FINAL REPORT**

Unit B, Section 13, T20S, R36E

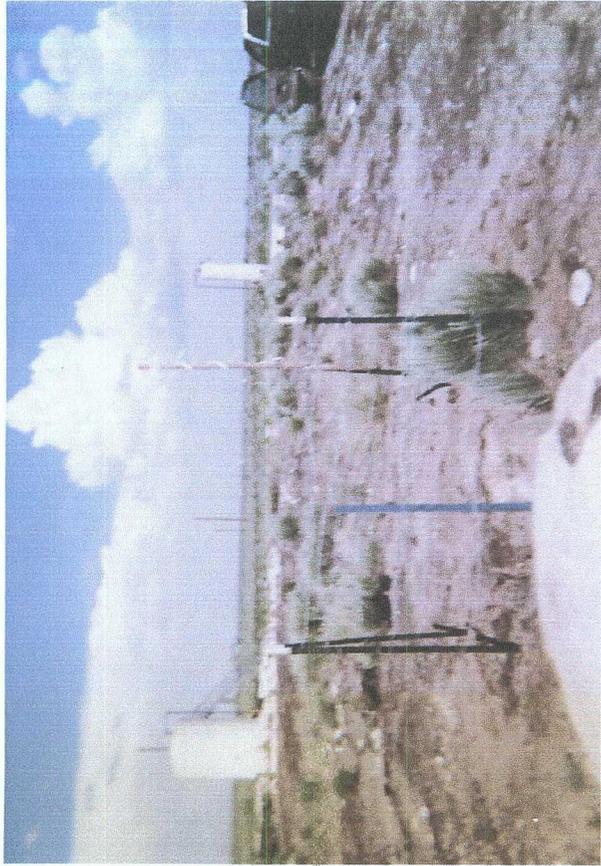
Site prior to delineation

6/14/2010

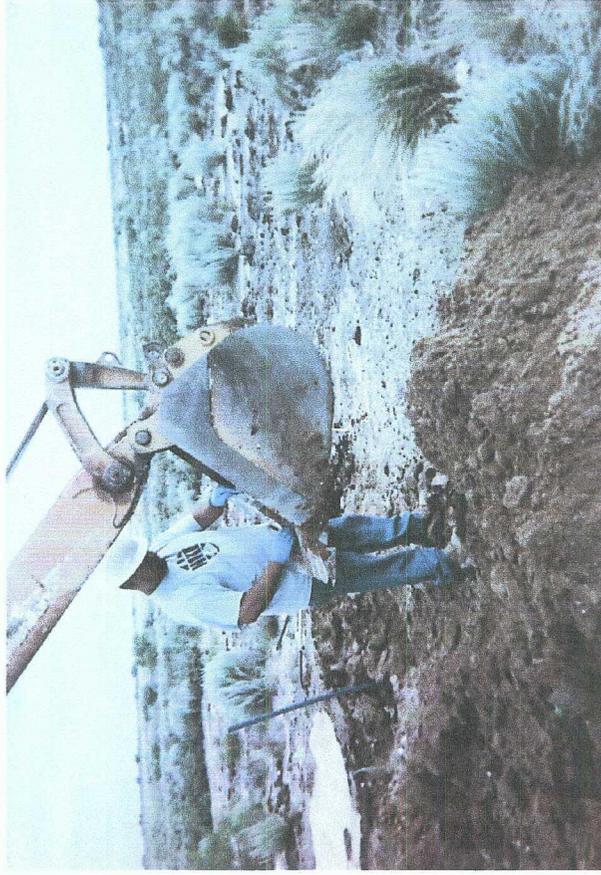
Collecting samples

6/15/2010

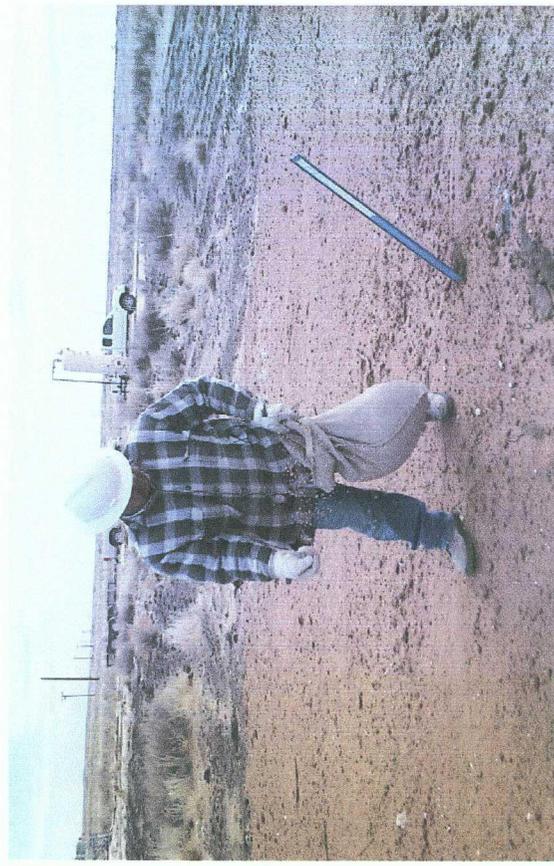
Seeding site

3/8/2011

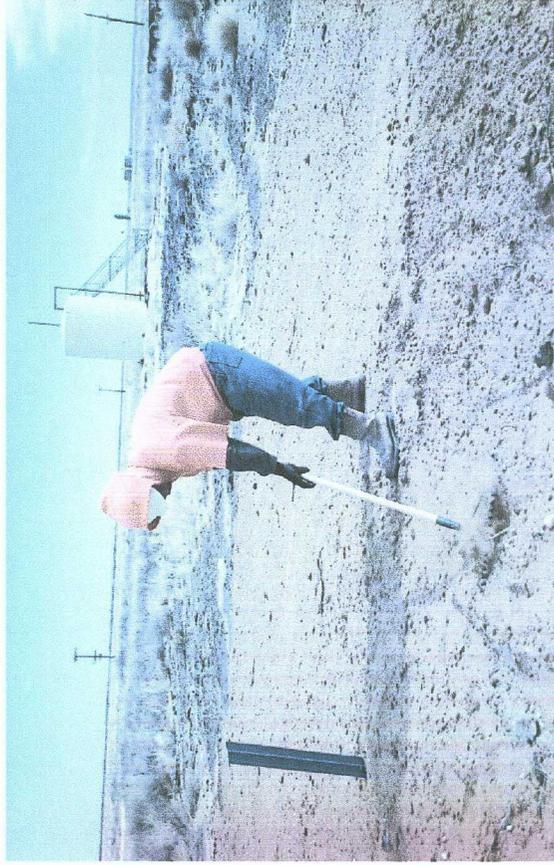
Covering seed

3/8/2011

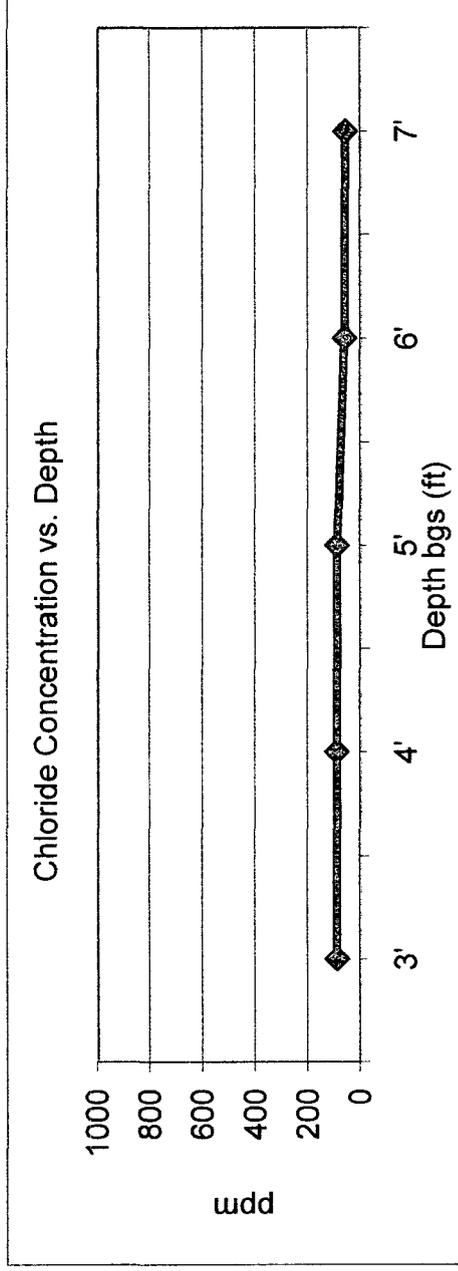
CHLORIDE CONCENTRATION CURVE

Backhoe samples at the junction (source)

Depth bgs (ft)	[Cl <sup>-</sup> ] ppm
3'	87
4'	88
5'	87
6'	59
7'	56

Groundwater = 32 ft.
