CLOSURE

**RICE OPERATING COMPANY
JUNCTION BOX FINAL REPORT**

EME I-25 EOL

Unit I, Section 25, T19S, R36E

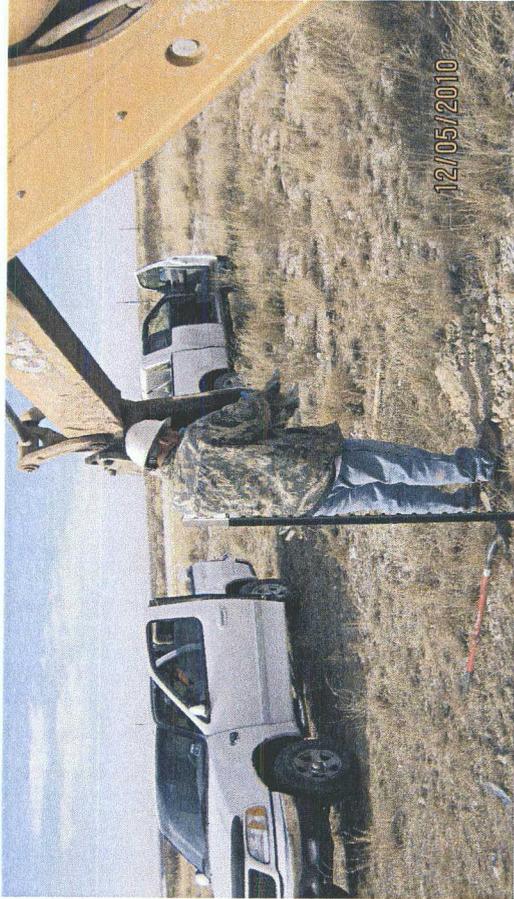
Sampling initial vertical delineation trench

General Description of Remedial Action: This junction and line were eliminated during the pipeline/upgrade program. After the former junction box was removed, an investigation was conducted using a backhoe to collect samples at regular intervals producing a 5X2X7-ft. deep excavation. Chloride field test were performed on each sample, which yielded low concentrations of chloride, similar to that of the background sample. Organic vapors were measured using a PID, which yielded low concentrations. The deepest sample, 7 ft. BGS, was sent to a commercial laboratory for analysis of chloride and TPH, which confirmed low concentrations of each. The excavated soil was returned to the excavation to ground surface and contoured to the surrounding area. On 12/06/2010, the site was seeded with a blend of native vegetation and is expected to return to a productive capacity at a normal rate.

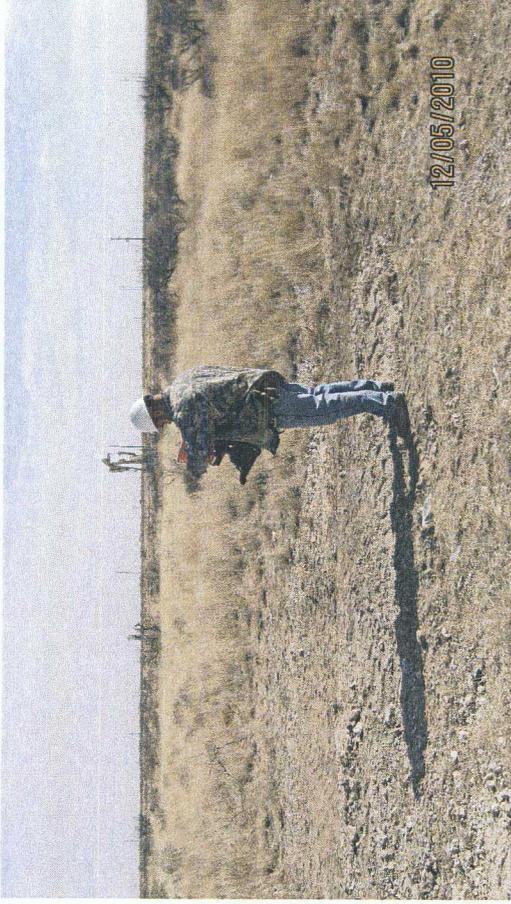
Seeding site

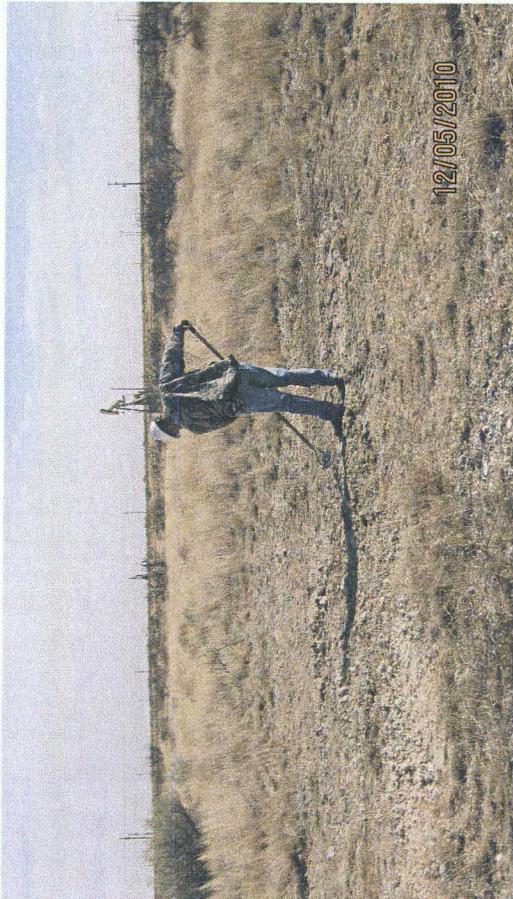
Raking in seed

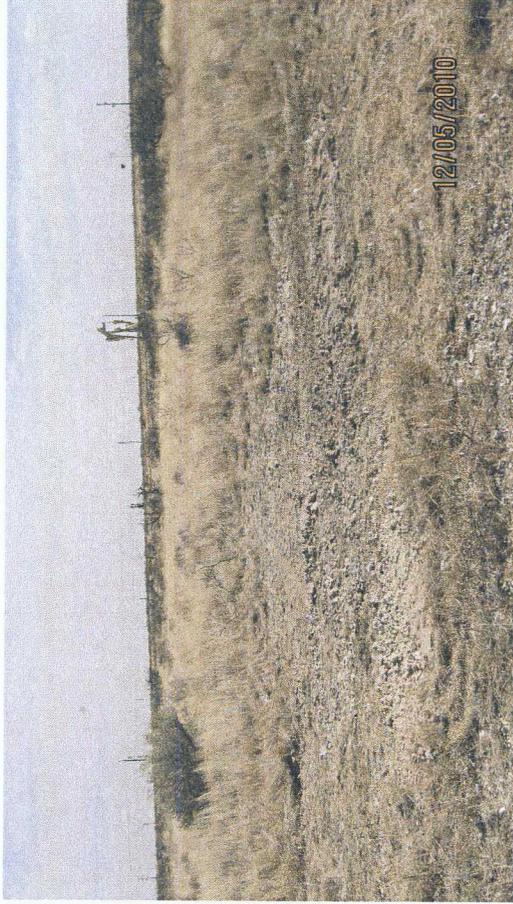
Site final photo

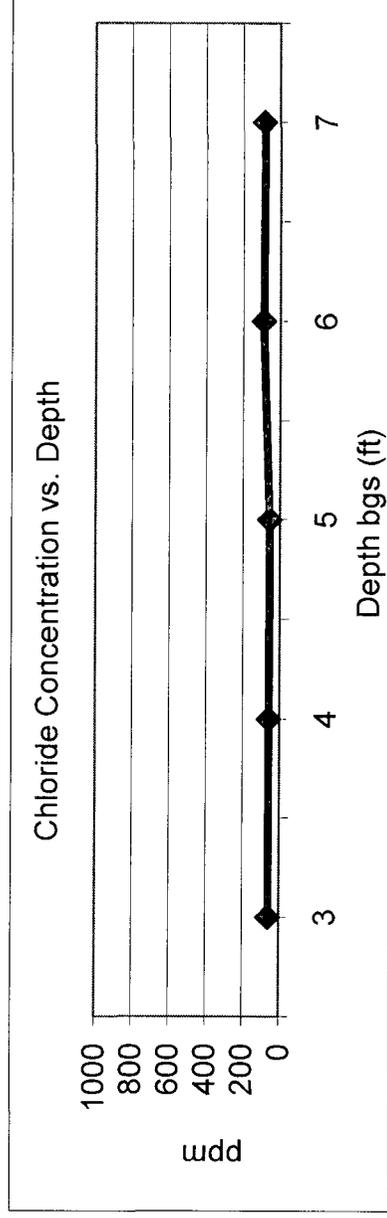
CHLORIDE CONCENTRATION CURVE

Backhoe samples at the junction (source)

Depth bgs (ft)	[Cl ⁻] ppm
3	61
4	58
5	55
6	90
7	84

Groundwater = 43 ft.

CHLORIDE FIELD TESTS		
LOCATION	DEPTH	mg/kg
Background	6"	58
vertical delineation trench at the junction (source)	3'	61
	4'	58
	5'	55
	6'	90
	7'	84
