RICE OPERATING COMPANY

JUNCTION BOX FINAL REPORT

EME L-15 EOL

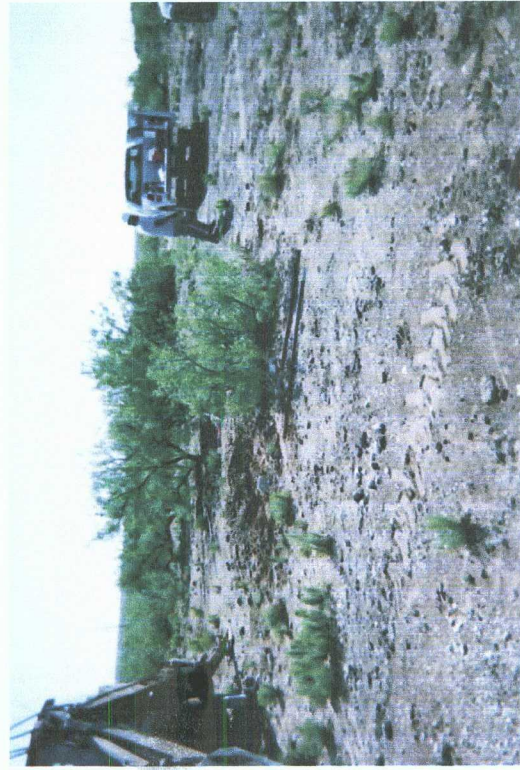
6/25/10

SITE PRIOR TO EXCAVATION

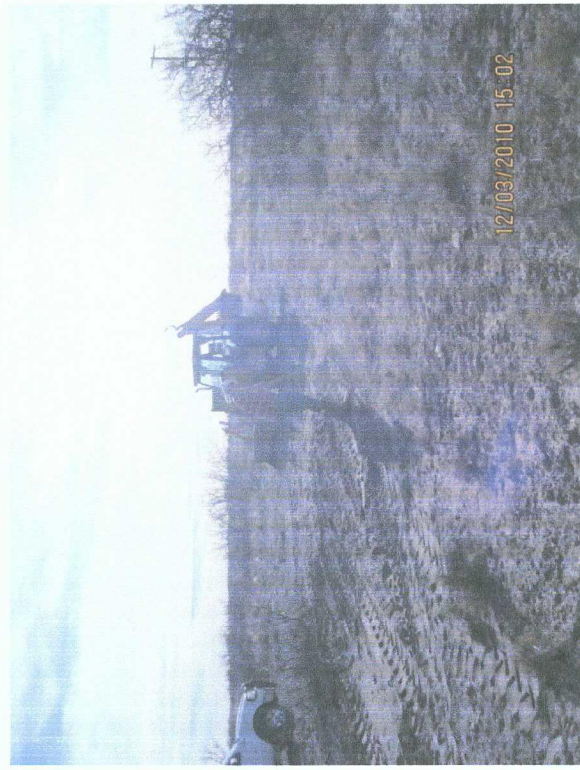
12/3/10

SEEDING SITE

returned to the excavation, to ground surface and contoured to the surrounding area. On 12/03/2010, site was seeded with a blend of native vegetation and is expected to return to a productive capacity at a normal rate.

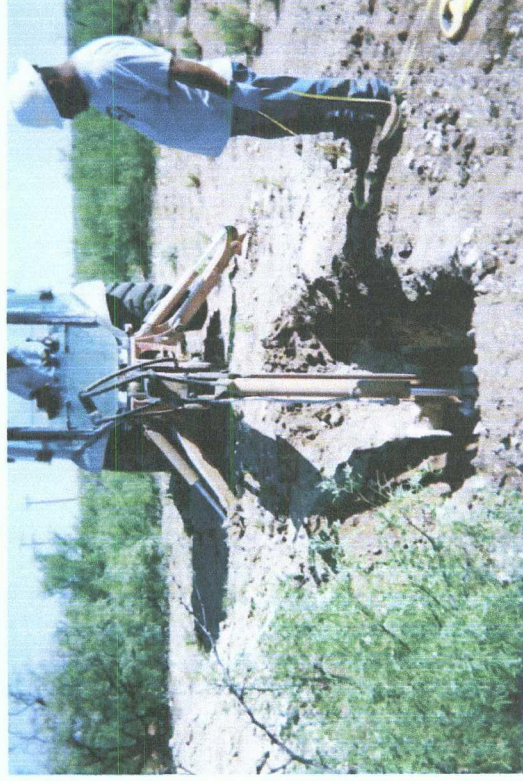
6/25/10

DELINEATION TRENCH BEING EXCAVATED

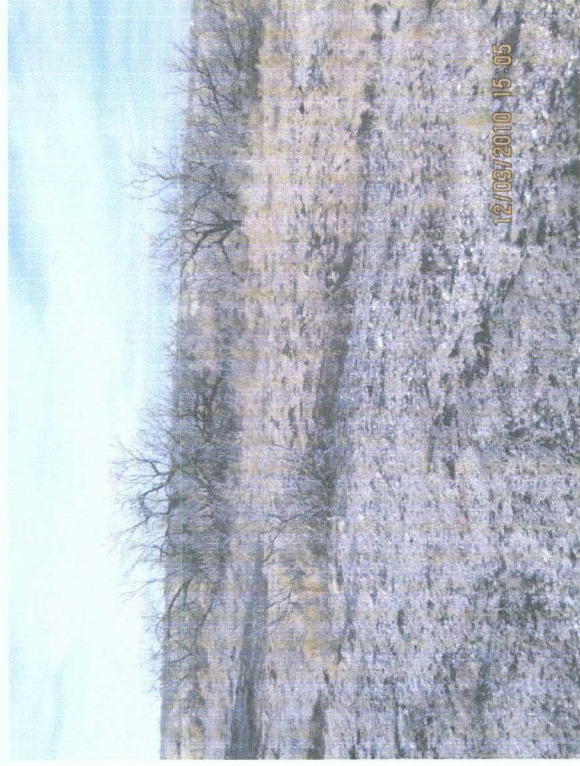
12/3/10

SITE COMPLETE

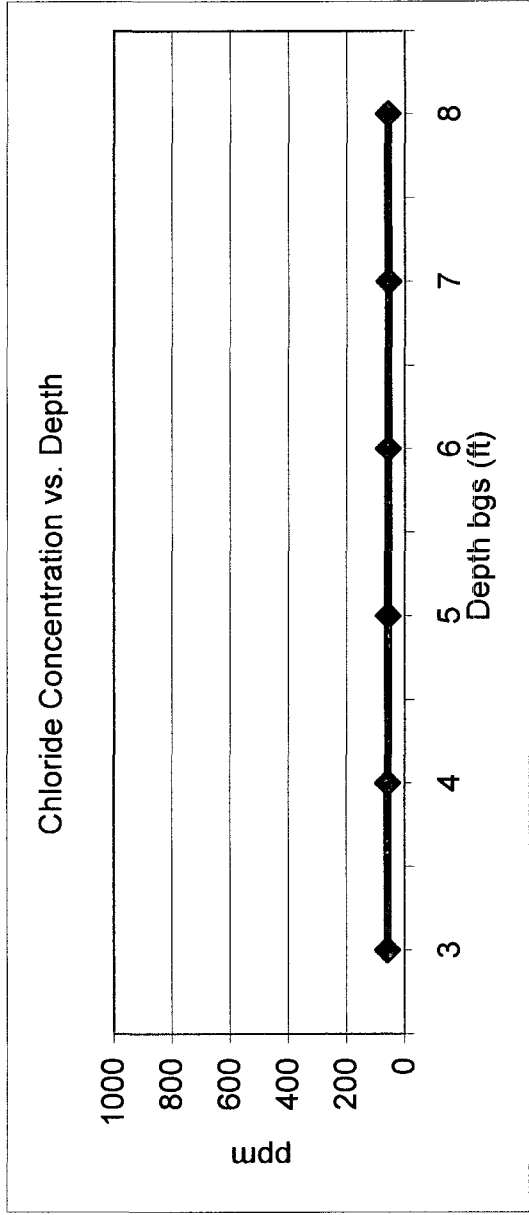
Delineation of Source

Depth bgs (ft)	[Cl ⁻] ppm
3	59
4	57
5	56
6	56
7	55
8	58

Groundwater = 195 ft
