EME Jct. F-10

CLOSURE

**RICE OPERATING COMPANY
JUNCTION BOX FINAL REPORT**

Unit F, Section 10, T21S, R36E

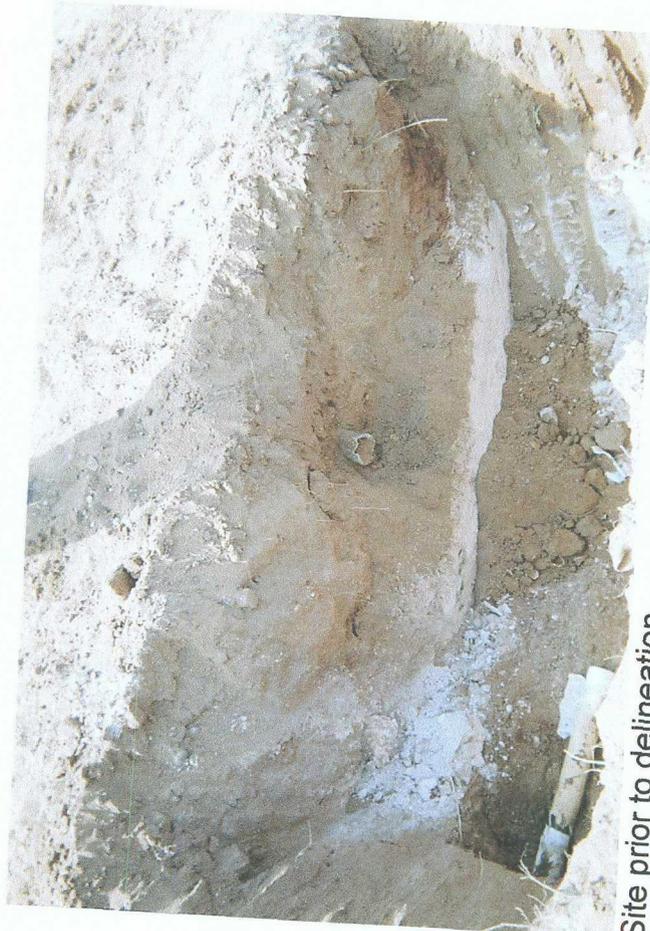
10/15/2010

Site prior to delineation

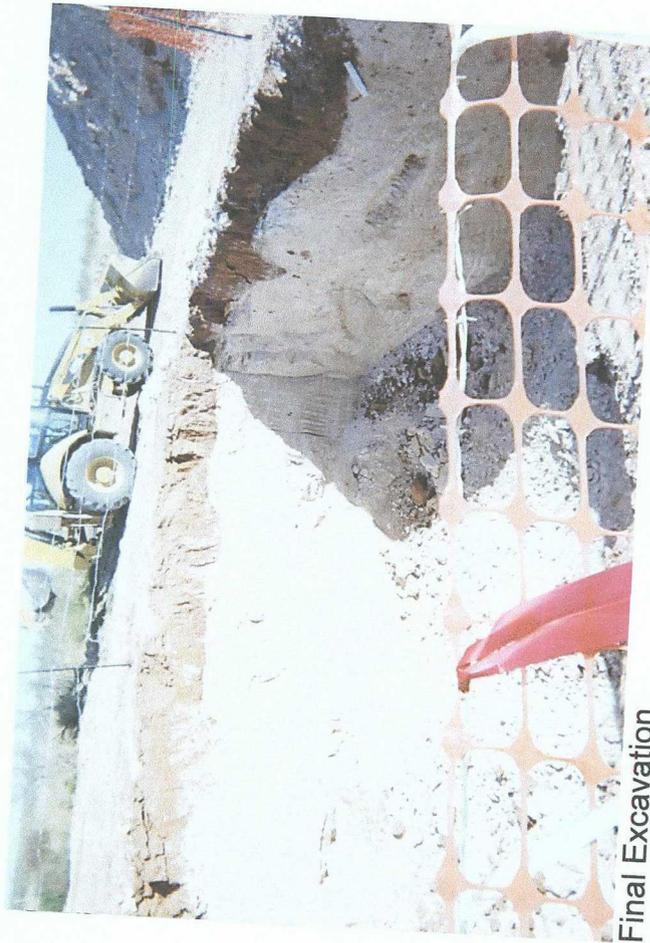
10/26/2010

Final Excavation

during the pipeline replacement/upgrade program. After the former junction box was removed, an investigation was conducted using a backhoe to collect soil samples at regular intervals creating a 30X30X12-ft. deep excavation. Chloride field test performed on each sample yielded chloride concentrations that did not relent with depth. Organic vapors were measured using a PID, which yielded some elevated concentrations. 286 yards of excavated soil was hauled to a NMOCD approved facility. The remaining excavated soil was blended on site and representative samples were collected from the blended backfill, the bottom of the excavation, and excavation walls. The representative samples were sent to a commercial laboratory for analysis of chloride, TPH, and BTEX.

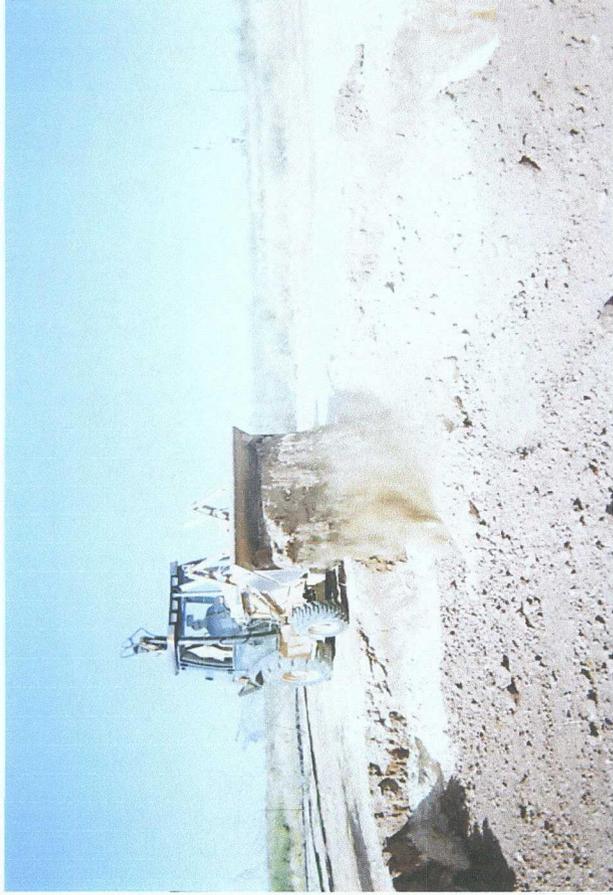
11/8/2010

Backfilling excavation above clay liner

At 5-4 ft., a 1-ft. thick clay barrier was installed with compaction test performed on 11/08/2010. The remaining excavation was backfilled using the blended backfill to 2 ft. BGS and the remaining excavation was backfilled with clean imported soil to ground surface and contoured to the surrounding area. On 11/11/2010, the site was seeded with a blend of native vegetation and is expected to return to a productive capacity at a normal rate. An identification plate was placed on the surface of the former junction box site to mark the presence of clay below. To further investigate the depth of chloride presence, a soil bore was initiated on 11/18/2010 at 15 ft. east of the former junction box. The boring was advanced to a depth of 35 ft. BGS with soil samples collected every 5 ft. between 15-35 ft. Chloride field test performed on each sample yielded chloride concentrations that did not relent with depth. Organic vapors were measured using a PID, which yielded low concentrations. The 20 ft. and 35 ft. sample were sent to a commercial laboratory for analysis of chloride and TPH. The entire bore was plugged with bentonite to ground surface.

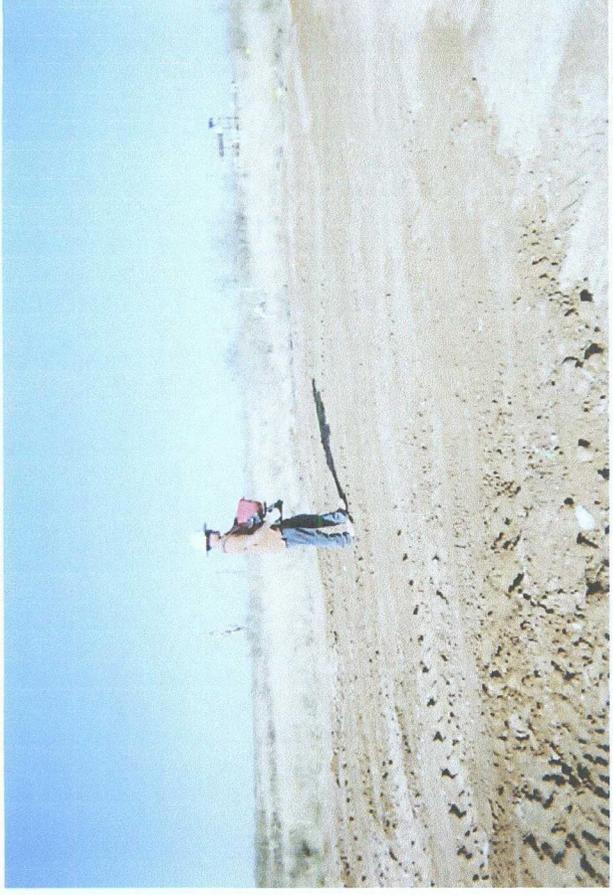
11/11/2010

Seeding site

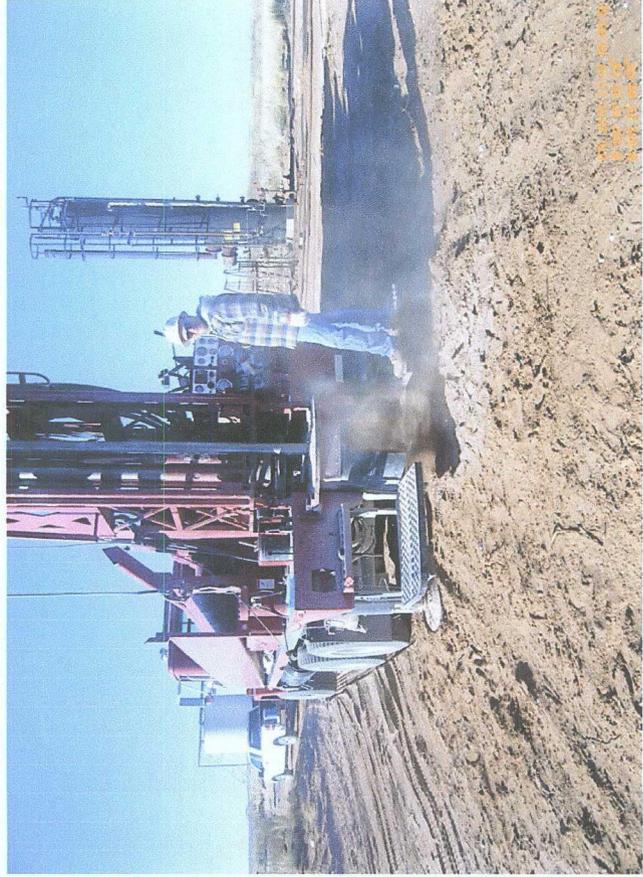
11/18/2010

Installing Soil Bore

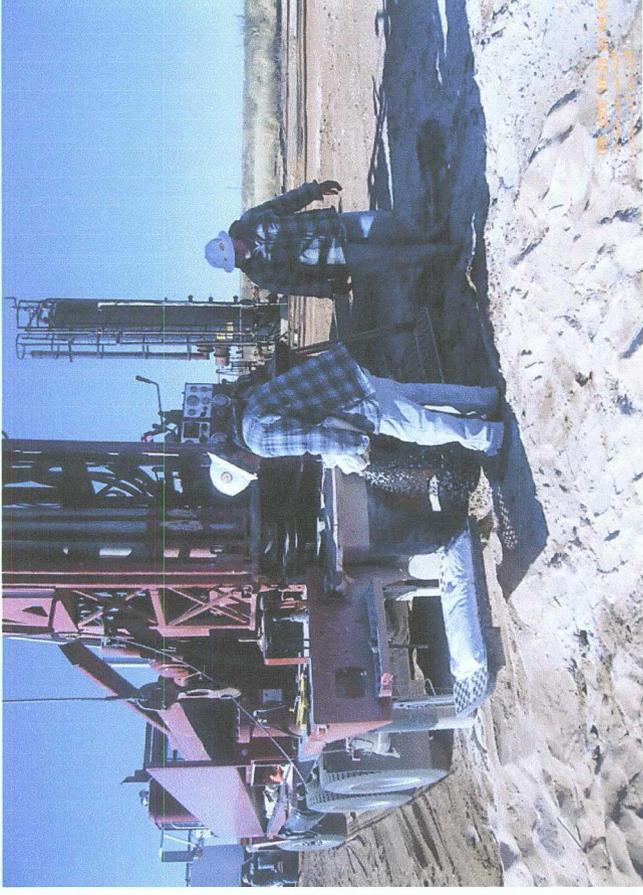
11/18/2010

Plugging the soil bore with bentonite

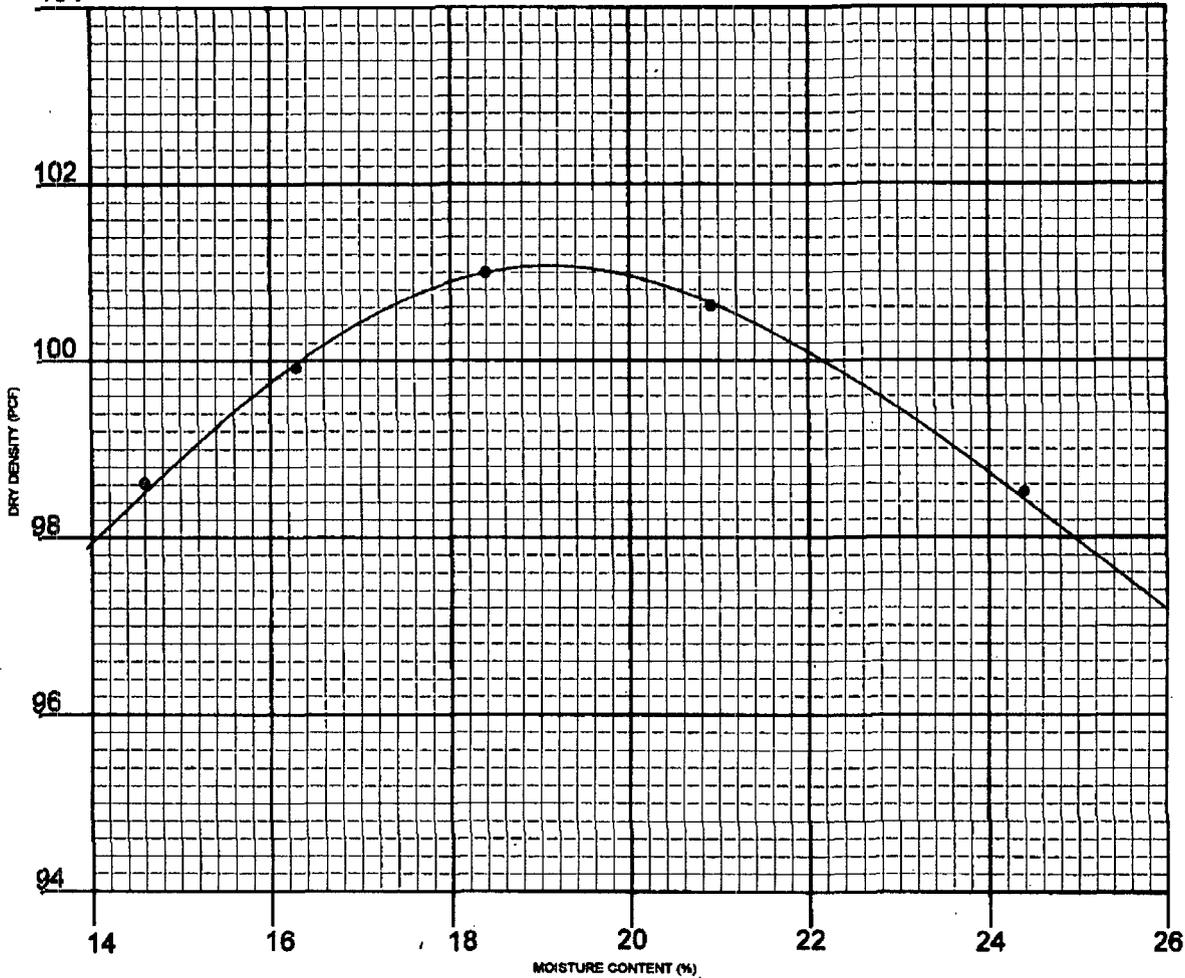
DRY WEIGHT LB/CU. FT. 101.1 MOISTURE CONTENT % 19.0

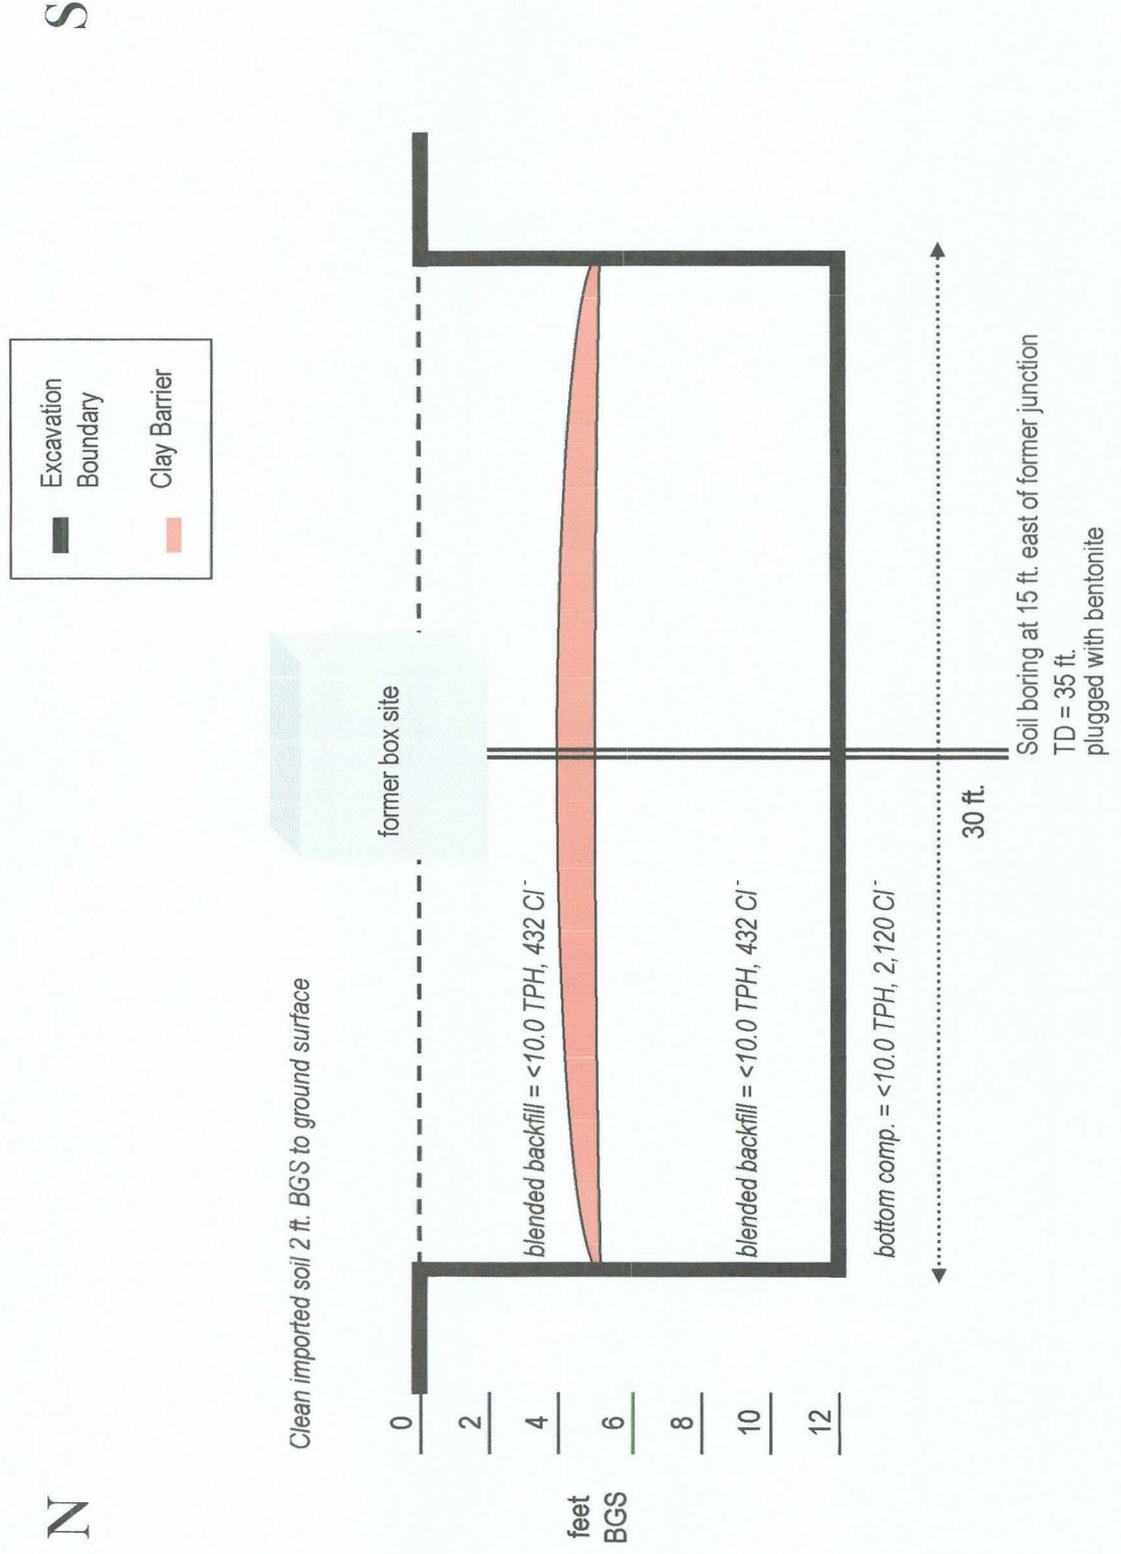
Excavation Cross-Section

The excavation was backfilled with the blended backfill to 5 ft. below ground surface (BGS).

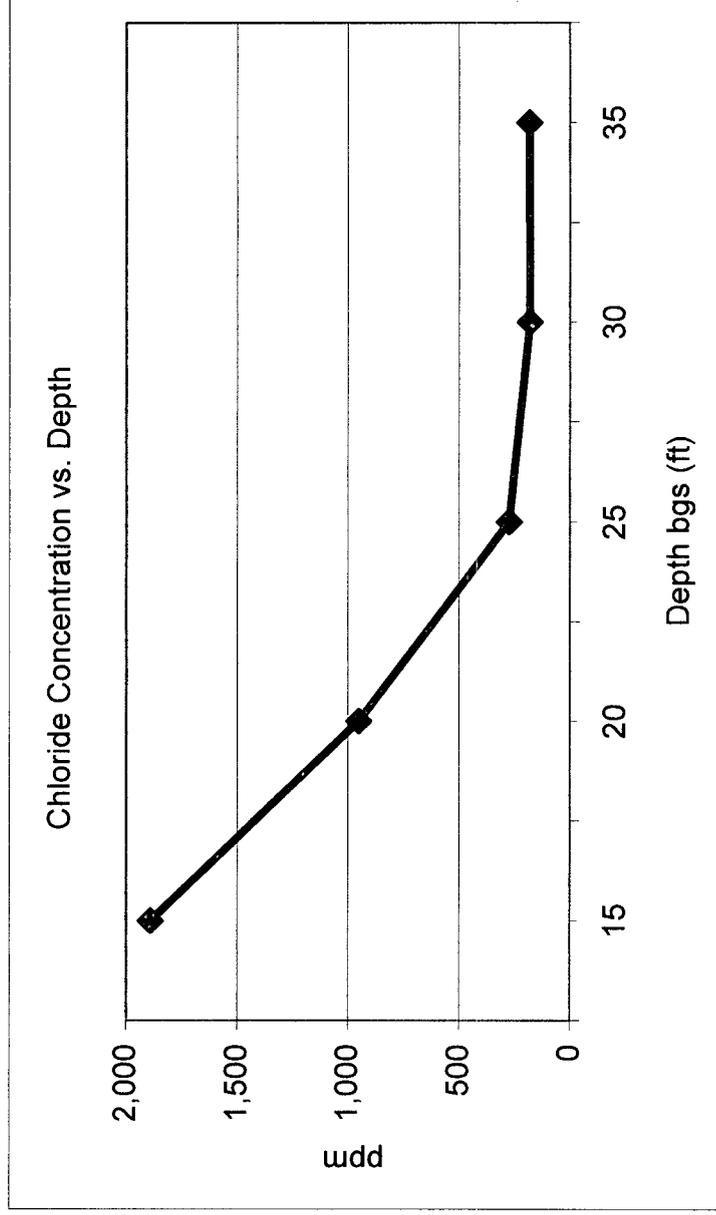
CHLORIDE CONCENTRATION CURVE

Soil bore at 15 ft. east of the junction (source)

Depth bgs (ft)	[Cl ⁻] ppm
15	1,889
20	950
25	273
30	178
35	181

Groundwater = 200 ft
