EME Jct. I-27

CLOSURE

**RICE OPERATING COMPANY  
JUNCTION BOX FINAL REPORT**

Unit I, Section 27, T19S, R36E

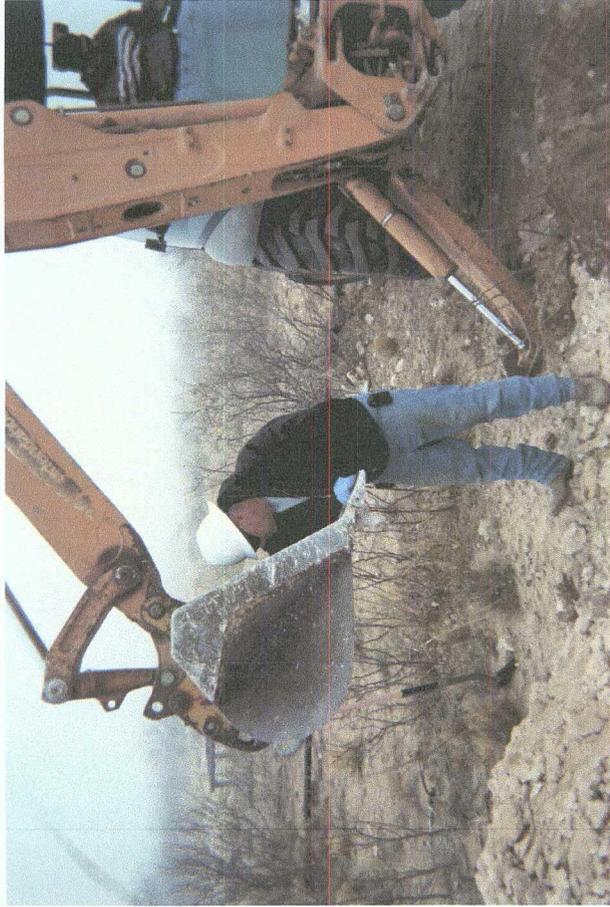
Sampling vertical

1/27/2010

**General Description of Remedial Action:** This junction was eliminated during the pipeline replacement/upgrade program. After the former junction box was removed, an investigation was conducted using a backhoe to collect soil samples at regular intervals producing a 20x10x12-ft-deep excavation. Chloride field tests were performed on each sample which yielded generally low concentrations. Organic vapors, measured using a PID, yielded low concentrations of organic vapors. Representative composite samples were collected from the excavation walls, bottom, and blended backfill. Laboratory analysis confirmed low concentrations of chloride with regards to depth and organics were non detected. The entire backfill was hauled to an NMOCD approved facility. The excavation was backfilled with clean imported soil to ground surface and contoured to the surrounding area. On 2/16/2010, site was seeded with a blend of native vegetation and is expected to return to a productive capacity at a normal rate.

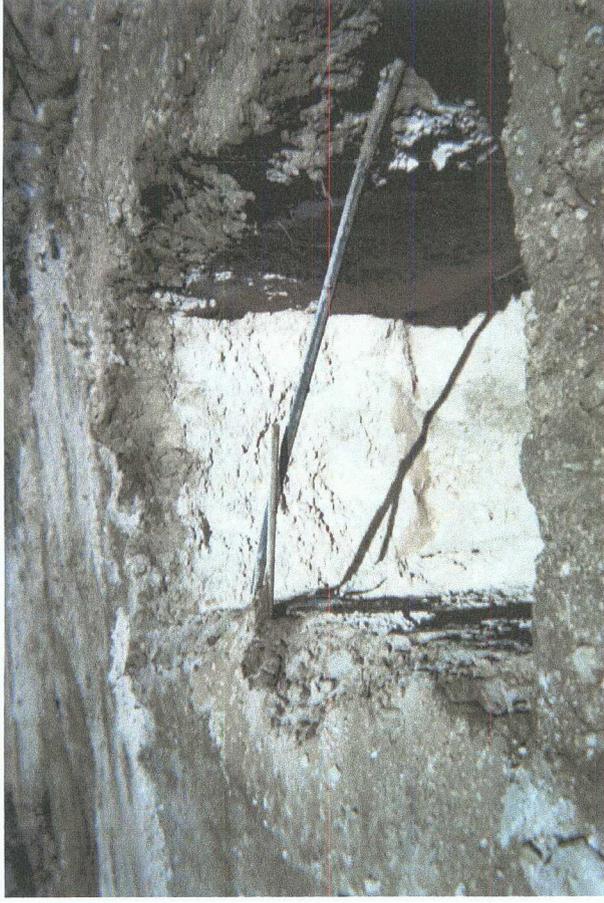
Final excavation

2/12/2010

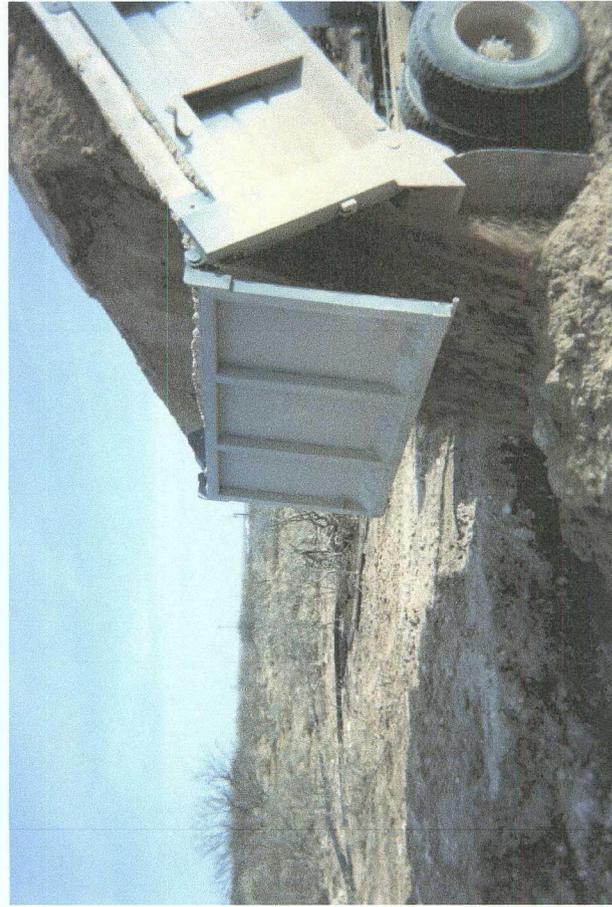
Backfilling site

2/15/2010

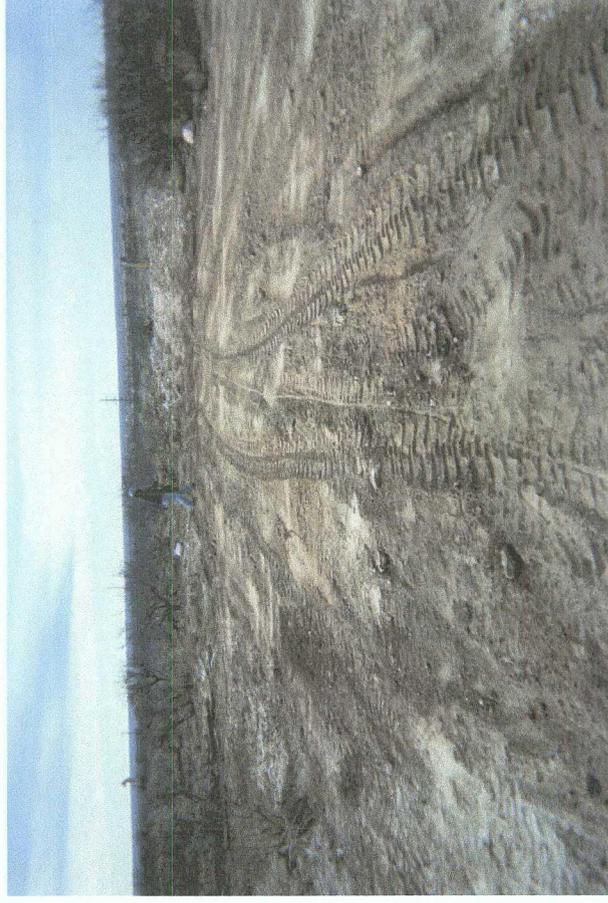
Seeding site

2/16/2010

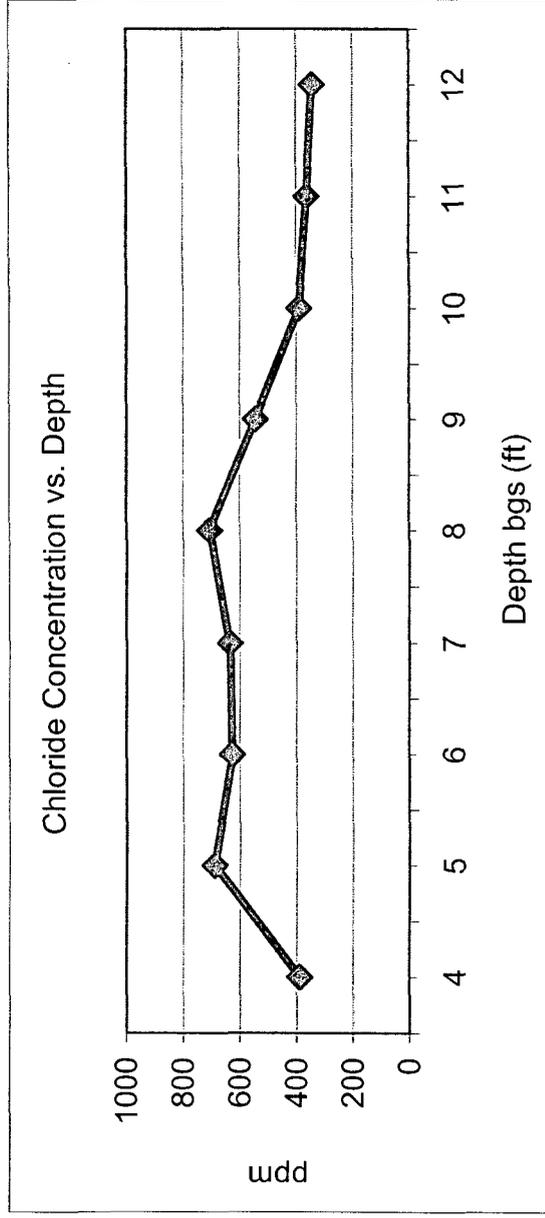
CHLORIDE CONCENTRATION CURVE

Backhoe samples at the junction (source)

Depth bgs (ft)	Cl ppm
4	388
5	690
6	627
7	636
8	707
9	545
10	390
11	362
12	344

Groundwater = 49 ft

LOCATION	DEPTH	mg/kg
4-wall comp.	n/a	723
bottom comp.	12'	284
backfill comp.	n/a	418
Delineation trench at former junction box (Source)	4'	388
	5'	690
	6'	627
	7'	636
	8'	707
	9'	545
	10'	390
	11'	362
	12'	344
