**EME P-25 EOL
2010**

**RICE OPERATING COMPANY
JUNCTION BOX FINAL REPORT**

SWD SYSTEM	JUNCTION	UNIT	SECTION	TOWNSHIP	RANGE	COUNTY	BOX DIMENSIONS - FEET		
							Length	Width	Depth
Eunice-Monument-Eumont (EME)	P-25 EOL	P	25	20S	36E	Lea	Eliminated

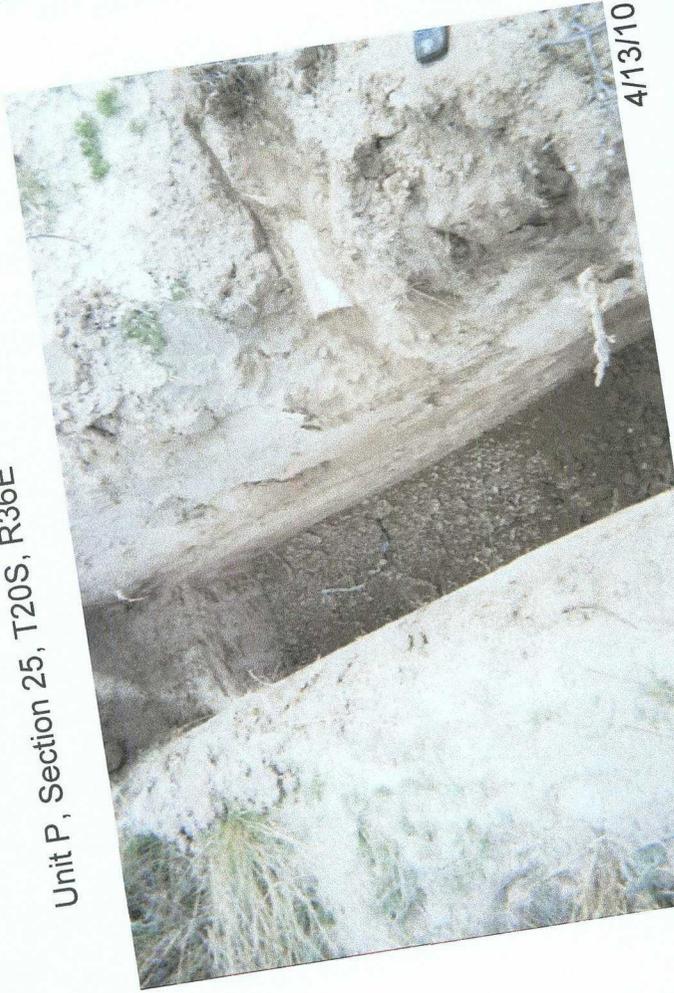
Final excavation

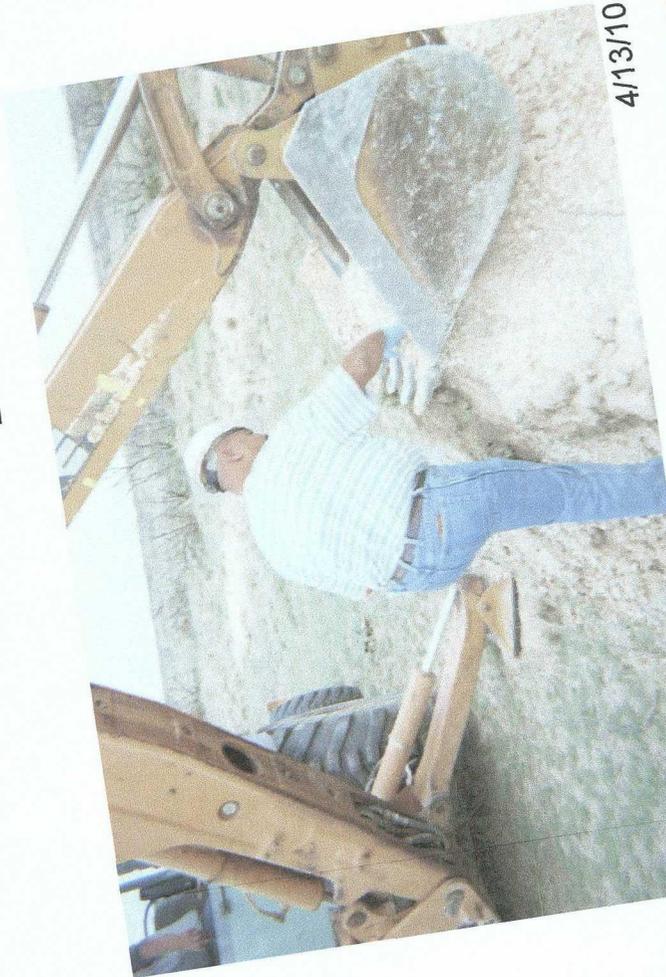
Sampling the source

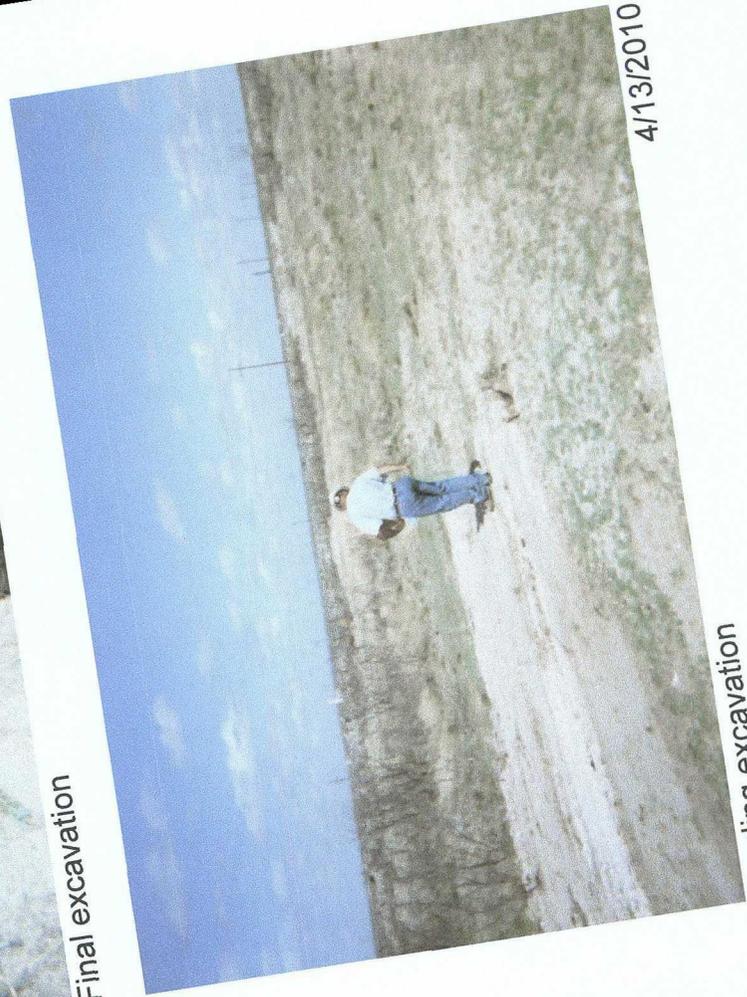
Seeding excavation

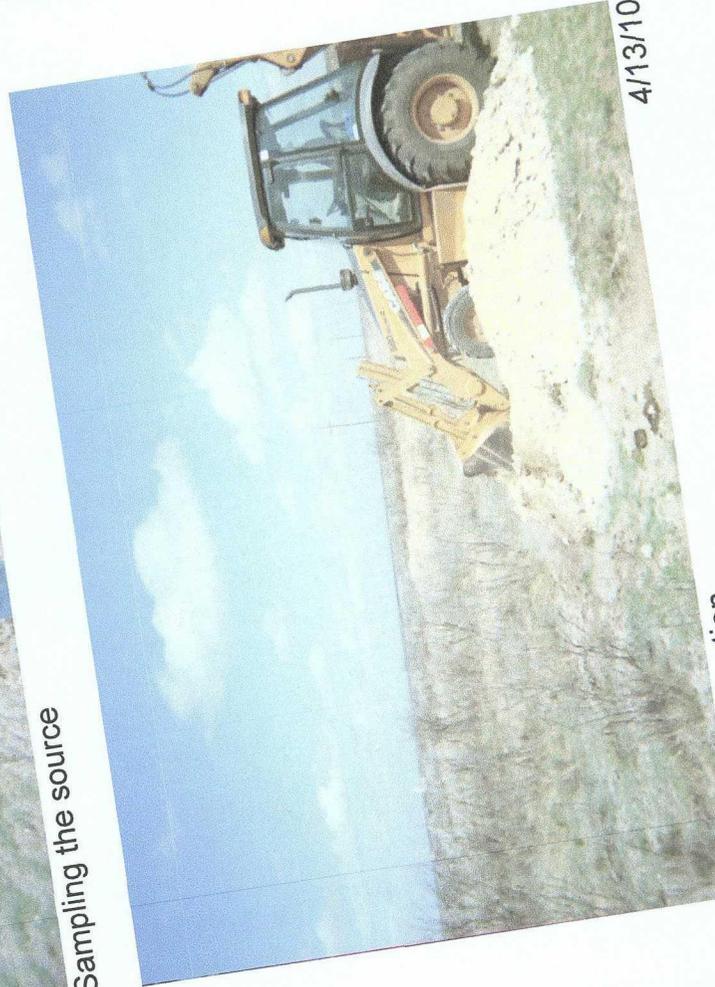
Backfilling excavation

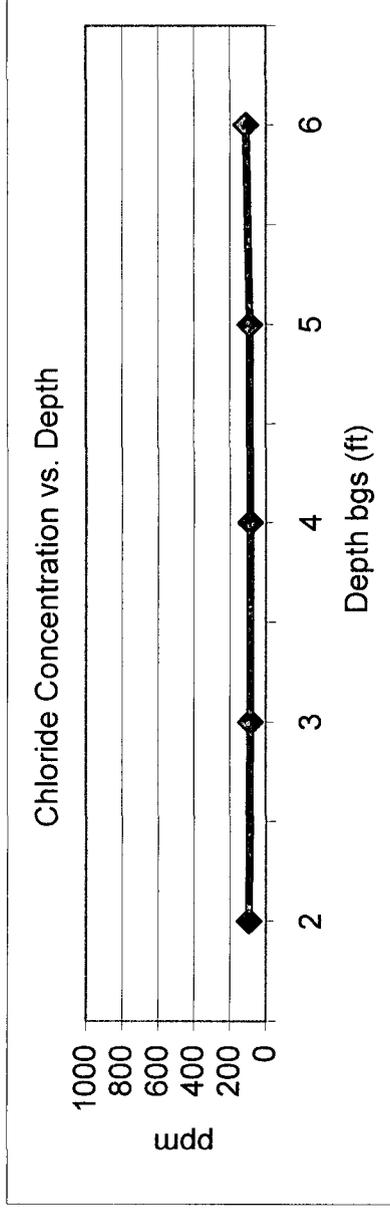
CHLORIDE CONCENTRATION CURVE

Backhoe samples at the junction (source)

Depth bgs (ft)	[Cl ⁻] ppm
2	95
3	85
4	87
5	89
6	113

Groundwater = 106 ft
