EME C-17 EOL

CLOSURE

**RICE OPERATING COMPANY
JUNCTION BOX FINAL REPORT**

Unit C, Section 17, T21S, R36E

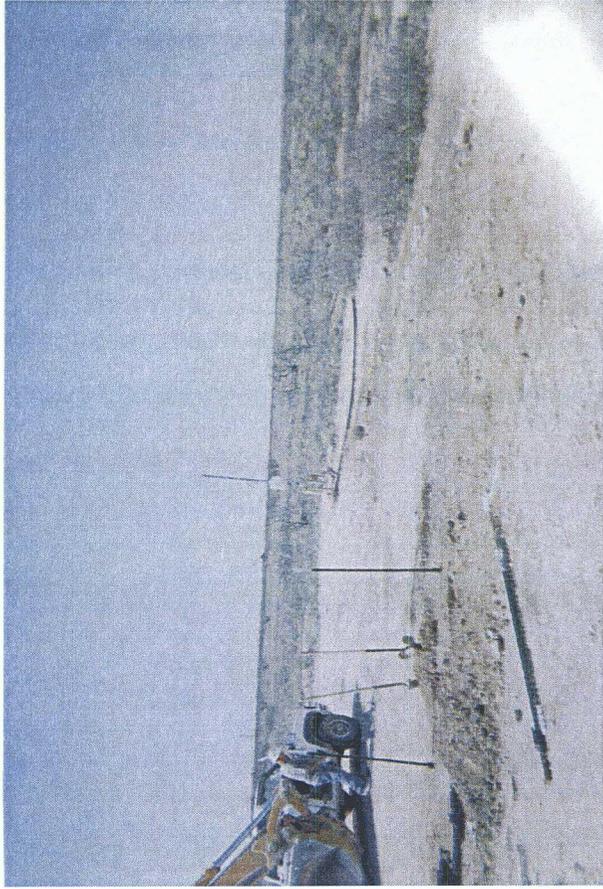
Site prior to excavation 3/29/10

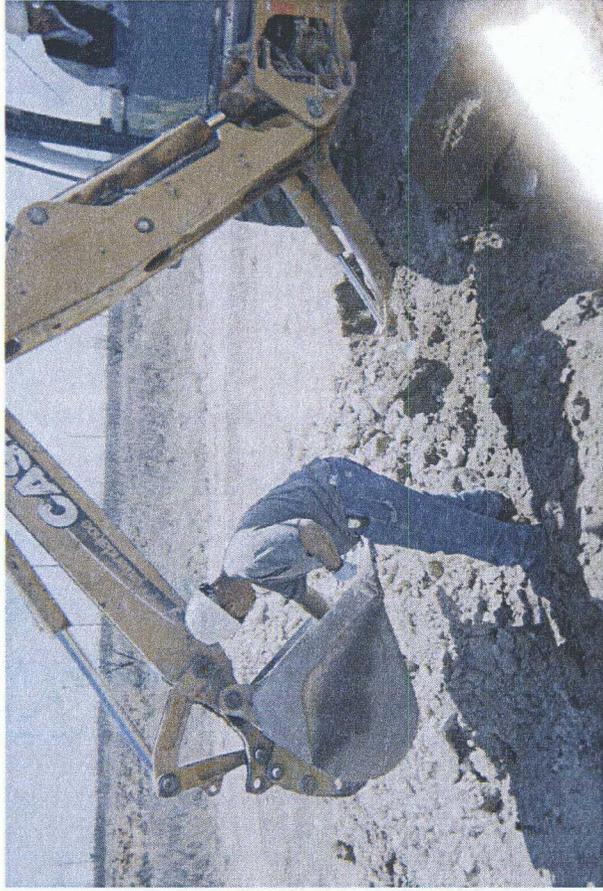
Collecting a soil sample 3/29/10

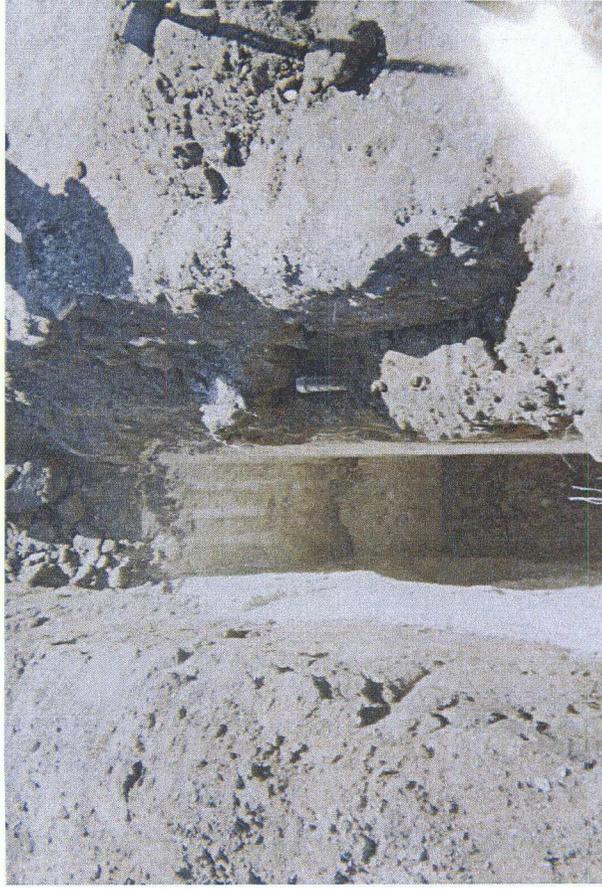
Final excavation 3/29/10

General Description of Remedial Action: This junction and line were eliminated during the pipeline replacement/upgrade program. After the former junction box was removed, an investigation was conducted using a backhoe to collect soil samples at regular intervals producing a 3X5X10-ft-deep-excavation. Chloride field test performed on each sample yielded low concentrations similar to that of the background. Organic vapors were measured using a PID, which also yielded relative low concentrations.

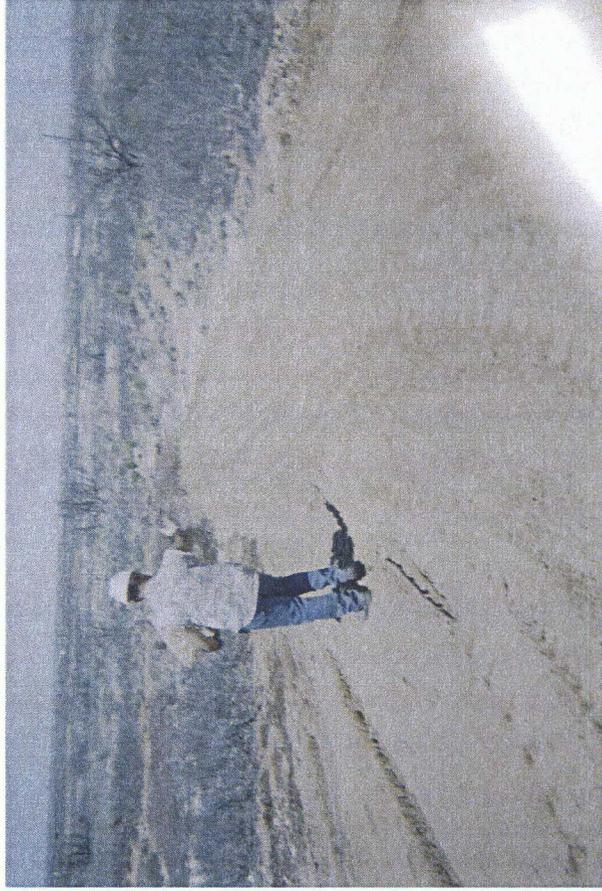
Seeding site 3/30/10

The deepest sample, 10 ft. BGS was sent to a commercial laboratory for analysis of chloride and TPH, which confirmed low concentrations of each. The excavated soil was returned to the excavation to ground surface and contoured to the surrounding area. On 3/30/2010, site was seeded with a blend of native vegetation and is expected to return to a productive capacity at a normal rate.

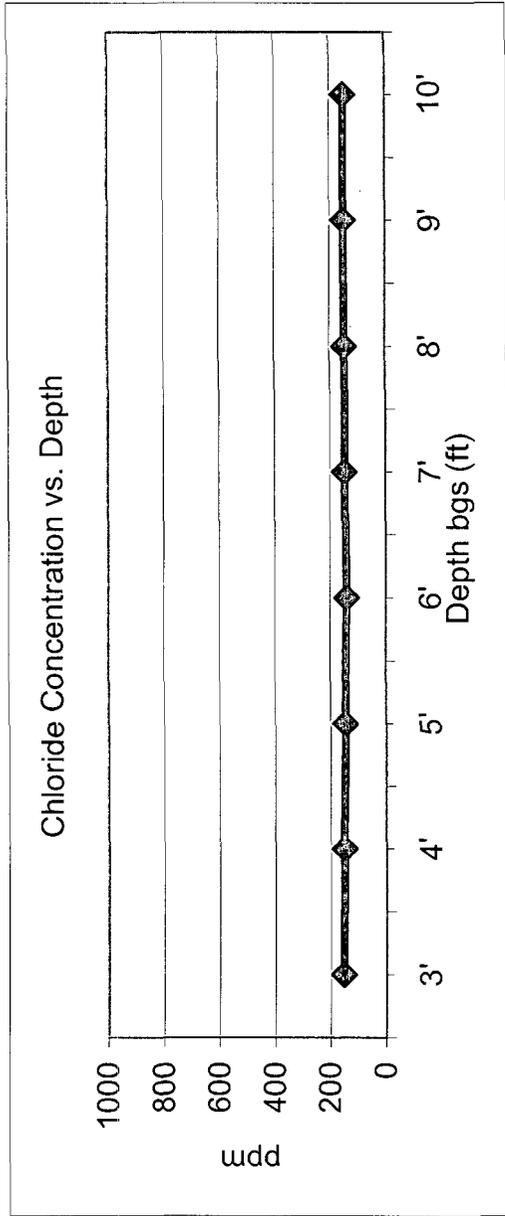
Backhoe samples at the junction (source)

Depth bgs (ft)	[C] ppm
3'	153
4'	151
5'	146
6'	141
7'	147
8'	146
9'	151
10'	151

Groundwater = 178 ft
