BD Jct. G-12

**RICE OPERATING COMPANY
JUNCTION BOX Disclosure* REPORT**

SWD SYSTEM	JUNCTION	UNIT	SECTION	TOWNSHIP	RANGE	COUNTY	BOX DIMENSIONS - FEET		
							Length 5 ft	Width 5 ft	Depth 3 ft
Blineby-Drinkard (BD)	Jct. G-12	G	12	22S	37E	Lea	New water tight box built 196 ft. west

Unit G, Section 12, T22S, R37E

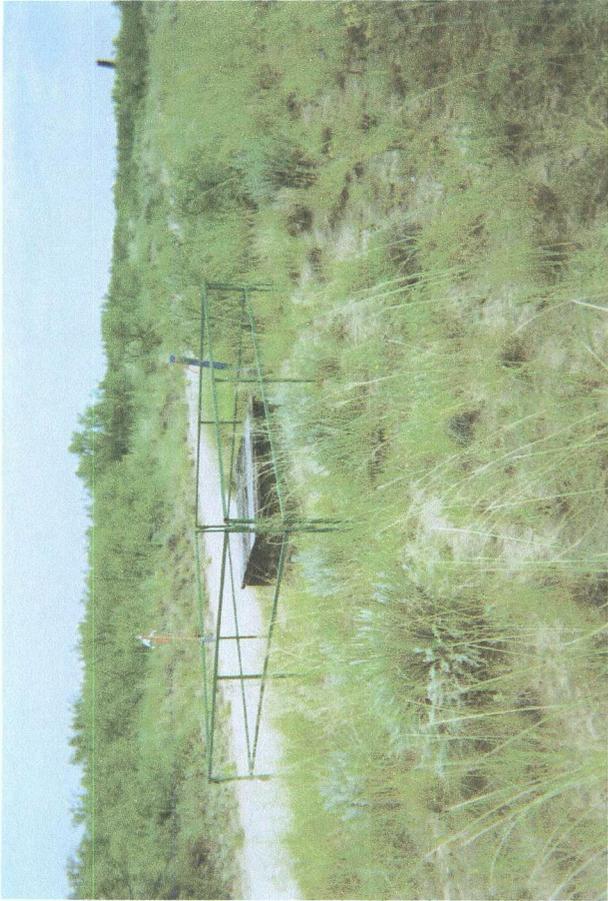
Site prior to delineation

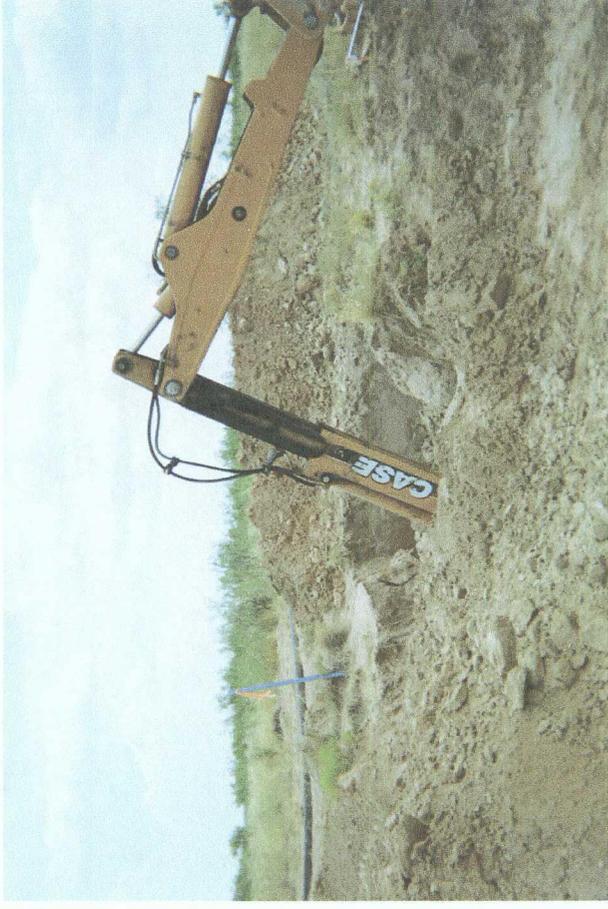
8/30/2010

Delineation trench being excavated

the pipeline replacement/upgrade program. After the former junction box was removed,
an investigation was conducted using a backhoe to collect soil samples at regular
intervals creating a 25X20X12-ft. deep excavation. Chloride field test performed on
each sample yielded concentrations that did not relent with depth. Organic vapors
were measured using a PID, which yielded some elevated concentrations. The

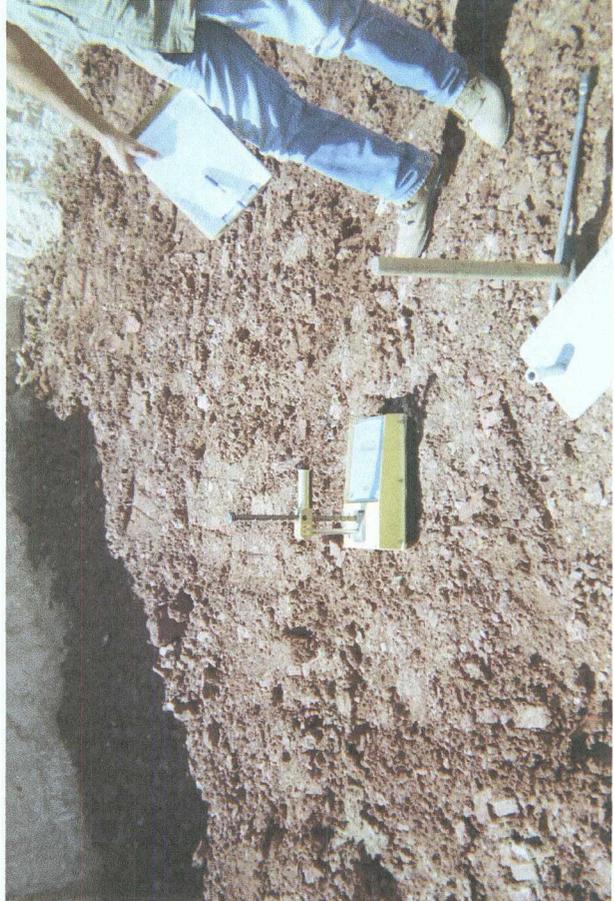
9/16/2010

Compaction test

Test No.	Location	Dry Density		Depth
		% Max	% Moisture	
SG 1	10' N. & 5' E. of SW Corner	83.4	16.8	5' Below Natural Ground
RT SG 1	10' N. & 5' E. of SW Corner	90.5	17.5	5' Below Natural Ground

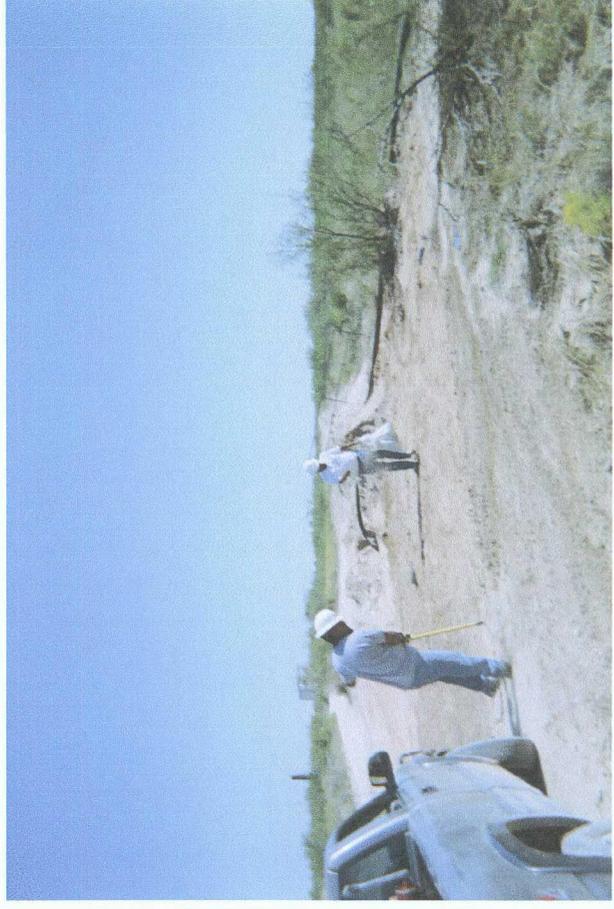
9/30/2010

Seeding excavation

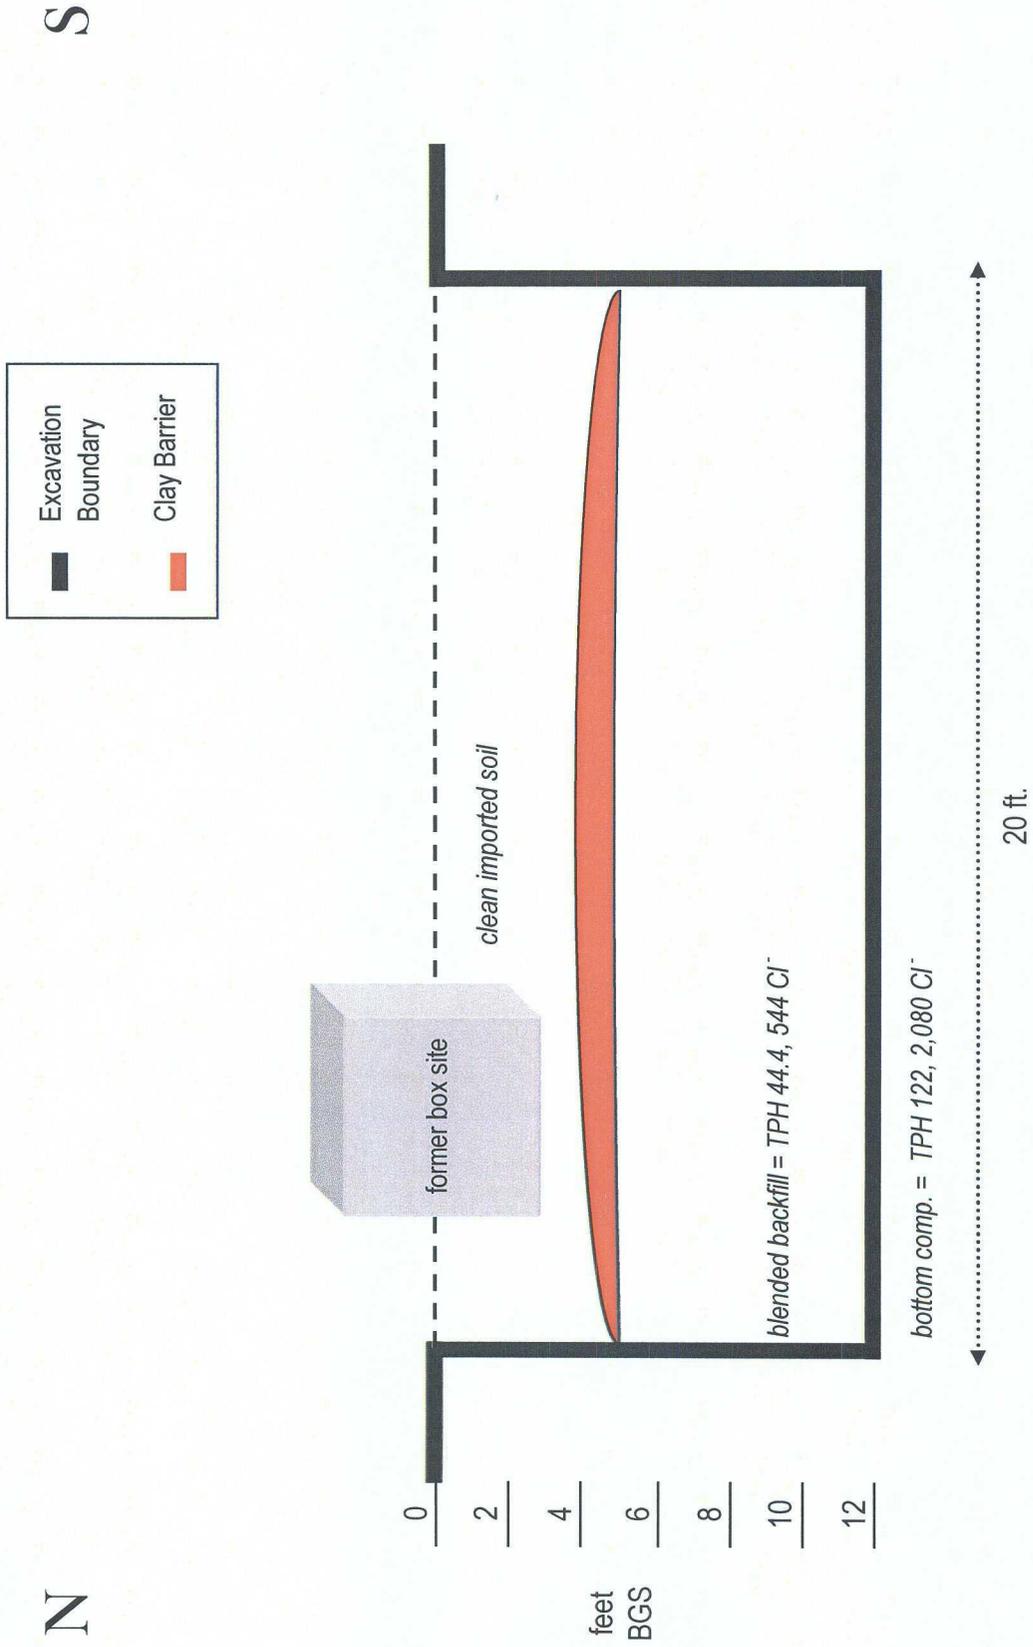
Excavation Cross-Section

BD JCT G-12
Unit 'G', Sec. 12, T22S, R37E

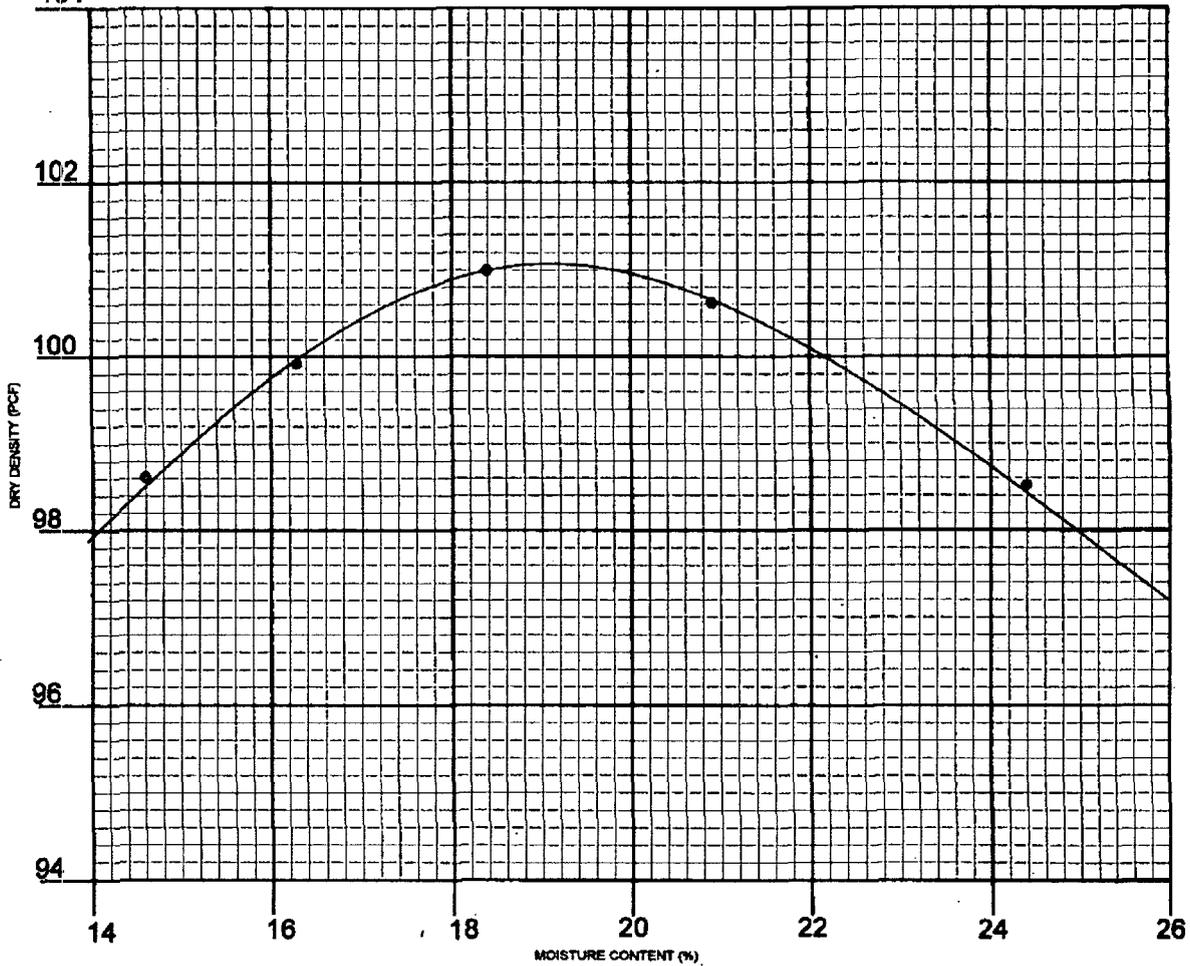
SOIL CLASSIFICATION: _____ TEST METHOD: ASTM: D 698

DRY WEIGHT LB/CU. FT. 101.1 MOISTURE CONTENT % 19.0

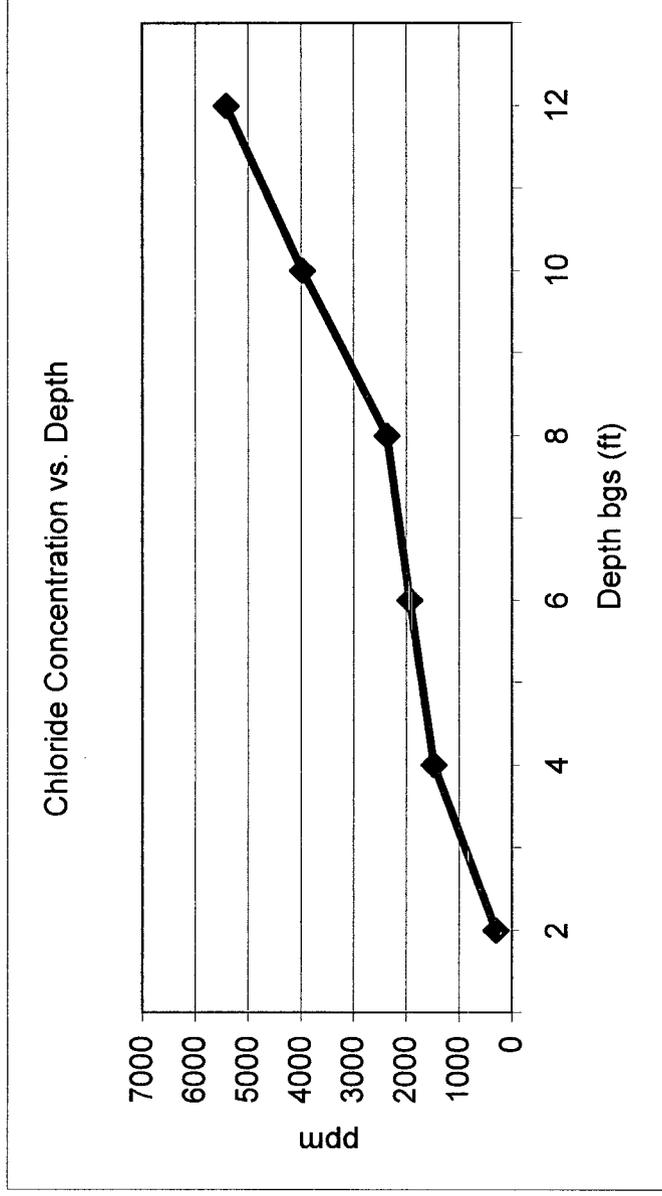
CHLORIDE CONCENTRATION CURVE

Backhoe samples 5 ft. south of the junction (source)

Depth bgs (ft)	[Cl ⁻] ppm
2	297
4	1476
6	1934
8	2367
10	3972
12	5414

Groundwater = 55 ft.

LOCATION	DEPTH	mg/kg
4-wall comp.	n/a	456
bottom comp.	12'	1,168
backfill comp.	n/a	504
background	6"	151
vertical delineation at 5 ft. south of junction (source)	2'	297
	4'	1,476
	6'	1,934
	8'	2,367
	10'	3,972
	12'	5,414
