**RICE OPERATING COMPANY  
JUNCTION BOX DISCLOSURE\* REPORT**

SWD SYSTEM	JUNCTION	UNIT	SECTION	TOWNSHIP	RANGE	COUNTY	BOX DIMENSIONS - FEET		
							Length 5 ft.	Width 5 ft.	Depth 3 ft.
Blinebry-Drinkard (BD)	Jct. N-17 (2 boxes)	N	17	21S	37E	Lea	eliminated

# BD Jct. N-17

Unit 'N', Sec. 17, T21S, R37E

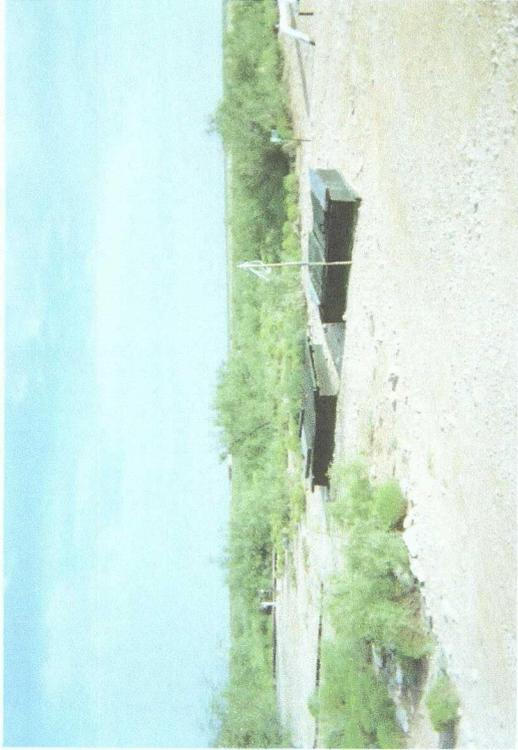
9/13/2010

Site prior to delineation

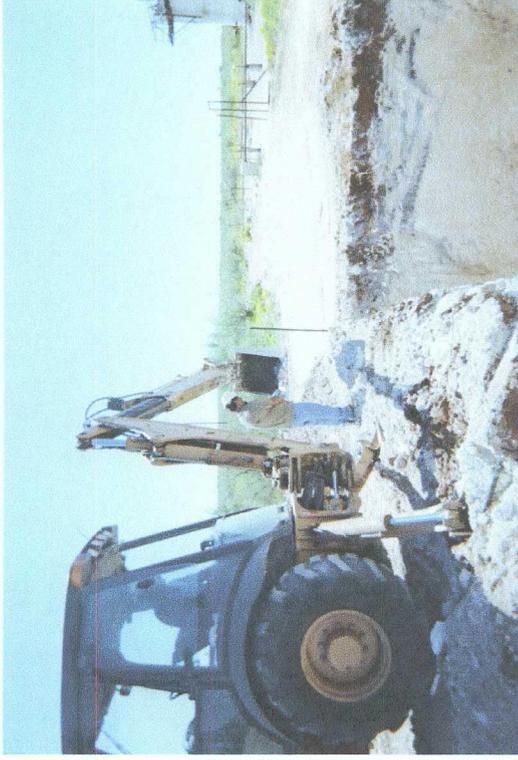
9/29/2010

Collecting final sample

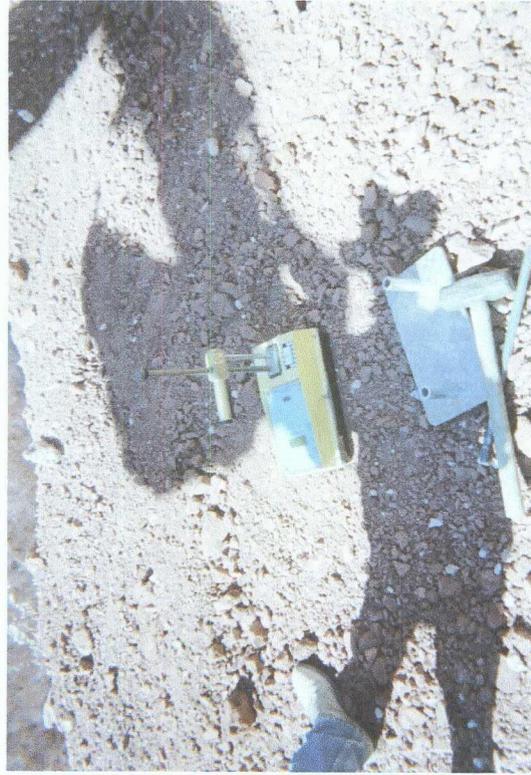
10/14/2010

Compaction test

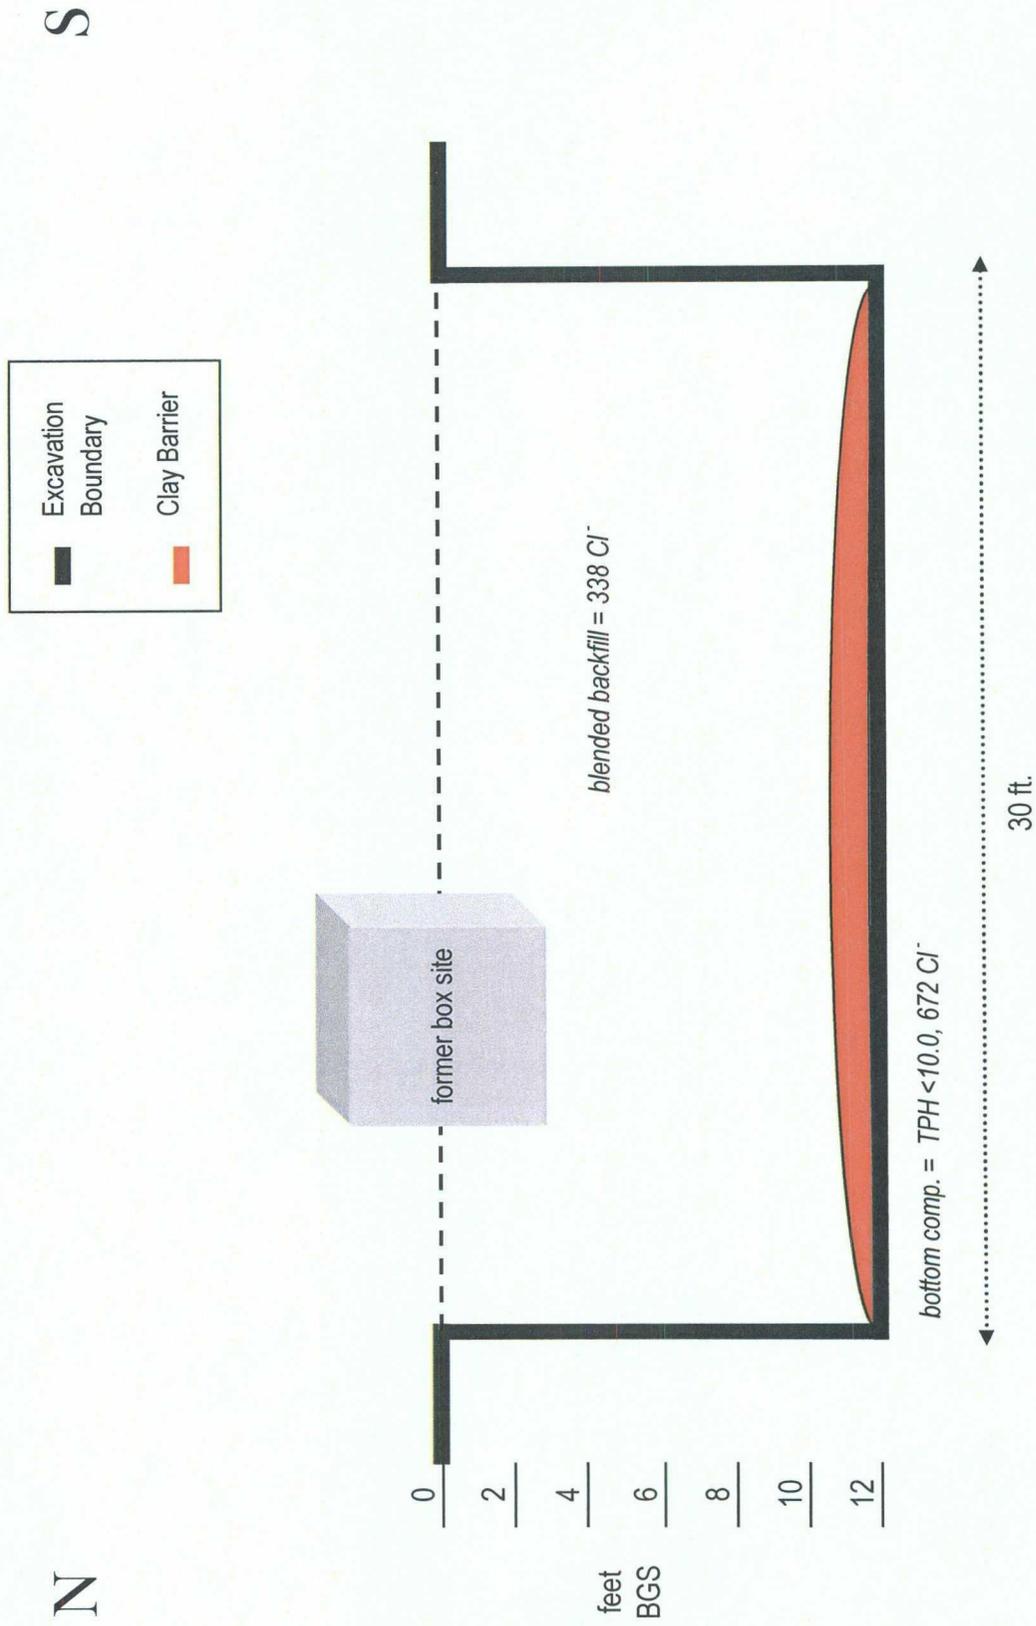
### Excavation Cross-Section

The excavated soil was blended on site and representative composite samples were collected from the blended backfill, the bottom of the excavation, and the excavation walls. The representative samples were sent to a commercial laboratory for analysis of chloride and TPH. At 12-11 ft. BGS, a 1-ft. thick clay layer was installed and compaction test performed on 10/14/2010. 288 yards of the blended backfill was hauled to a NMOCD approved facility. The remaining blended backfill was blended with clean imported soil and a representative sample was collected and sent to a commercial laboratory for analysis of chloride, which confirmed low concentrations. The remaining excavation was backfilled with the blended backfill with clean imported soil to ground surface and contoured to the surrounding area. An identification marker was placed at the site of the former junction boxes to mark the presence of clay below. On 10/15/2010, the site was seeded with a blend of native vegetation and is expected to return to a productive capacity at a normal rate. NMOCD was notified of potential groundwater impact on 3/02/2011.

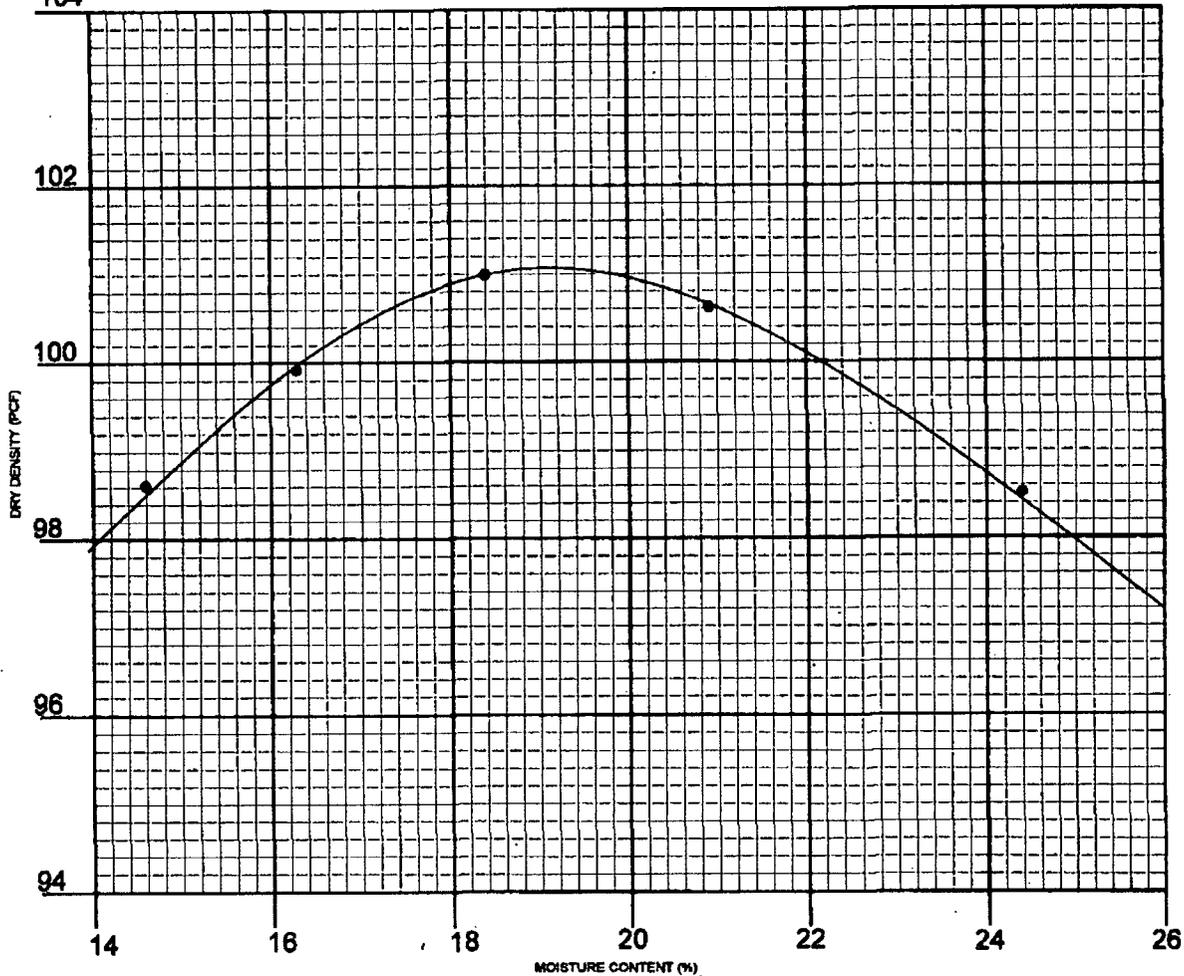
SOIL DESCRIPTION: Wallach Red Clay

DRY WEIGHT LB/CU. FT. 101.1 MOISTURE CONTENT % 19.0

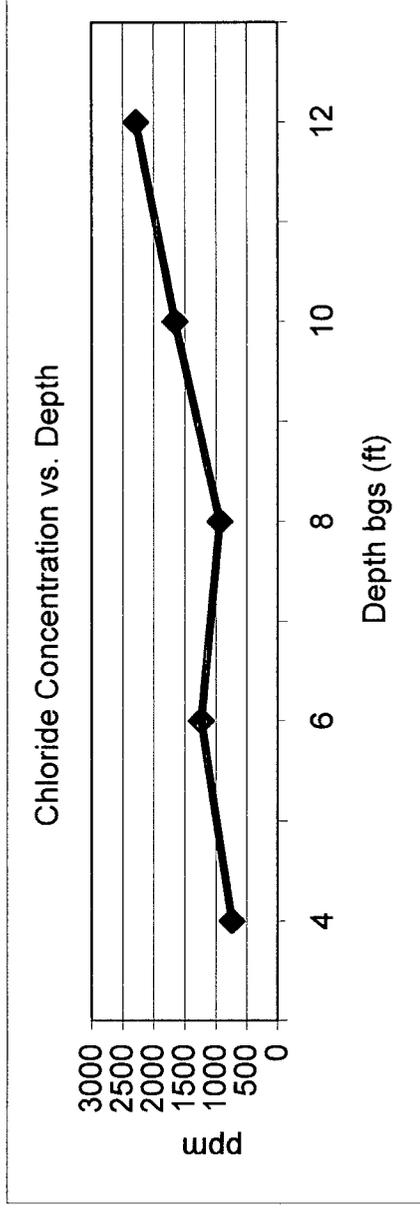
CHLORIDE CONCENTRATION CURVE

Backhoe samples 10 ft. north of junction (source)

Depth bgs (ft)	[Cl] ppm
4	742
6	1235
8	935
10	1658
12	2285

Groundwater = 72 ft
