CLOSURE

**RICE OPERATING COMPANY
JUNCTION BOX FINAL REPORT**

BD O-6 EOL

Unit O, Section 6, T22S, R38E

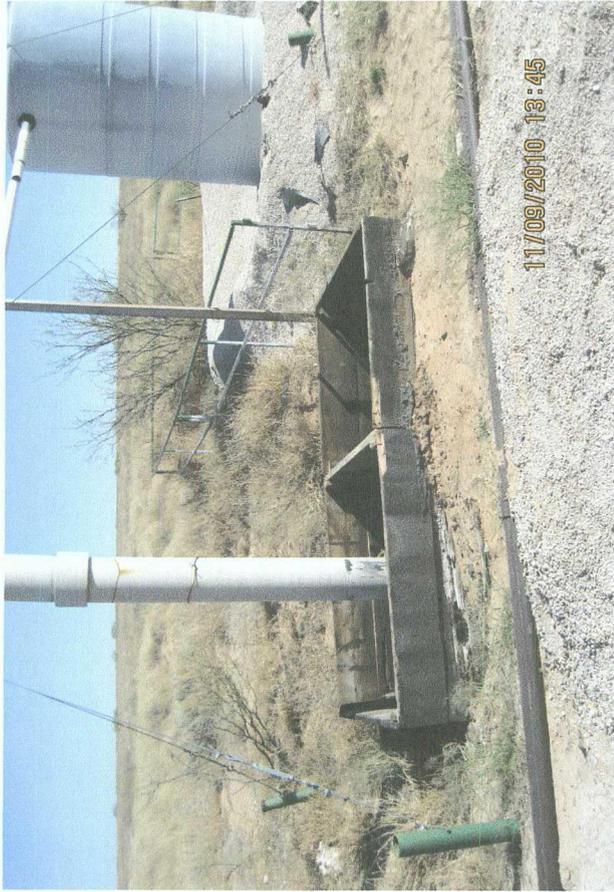
11/09/2010

Site prior to excavation

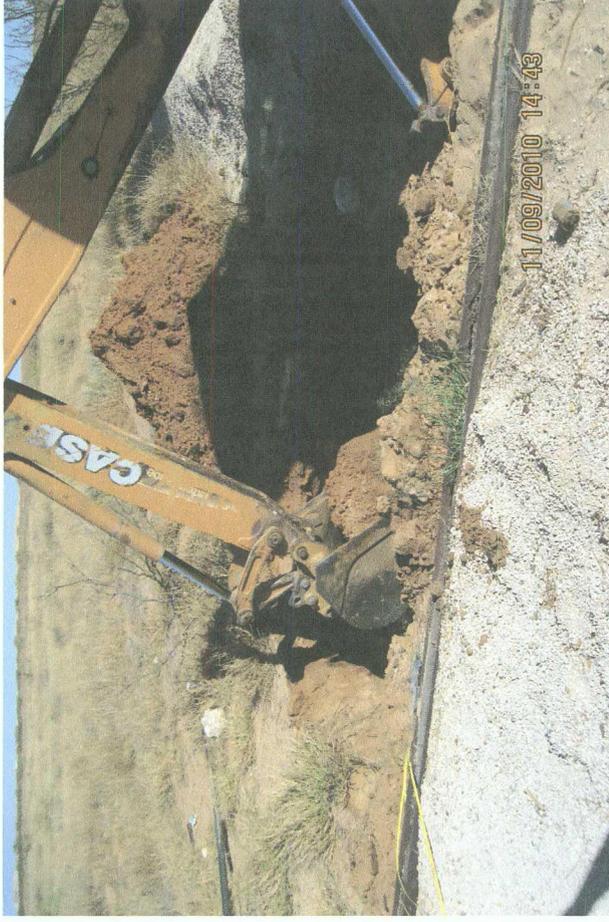
11/09/2010

Delineation trench being excavated

General Description of Remedial Action: This junction was addressed during the pipeline replacement/upgrade program. After the former junction box was removed, an investigation was conducted using a backhoe to collect soil samples at regular intervals creating a 7X2X10-ft. deep excavation. Chloride field tests performed on each sample yielded concentrations that did relent with depth. Organic vapors were measured using a PID, which yielded low concentrations. The deepest sample, 10 ft. BGS, was sent to a commercial laboratory for analysis of chloride and TPH, which confirmed low concentrations of each. The excavated soil was returned to the excavation to ground surface and contoured to the surrounding area. On 11/17/2010, the site was seeded with a blend of native vegetation and is expected to return to a productive capacity at a normal rate. A new water tight junction box built 190 ft. south west.

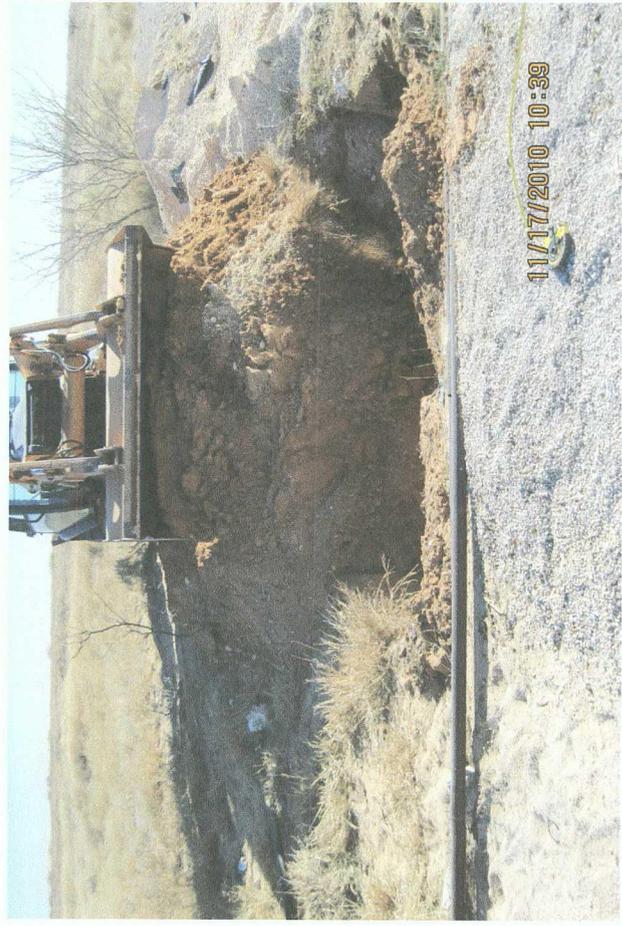
11/17/2010

Backfilling excavation

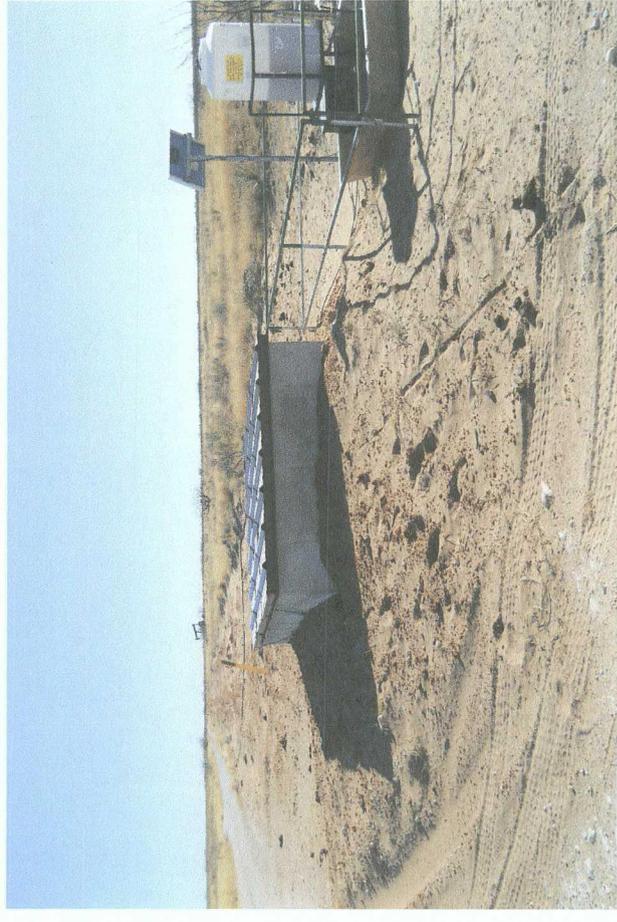
2/28/2011

New water tight junction box

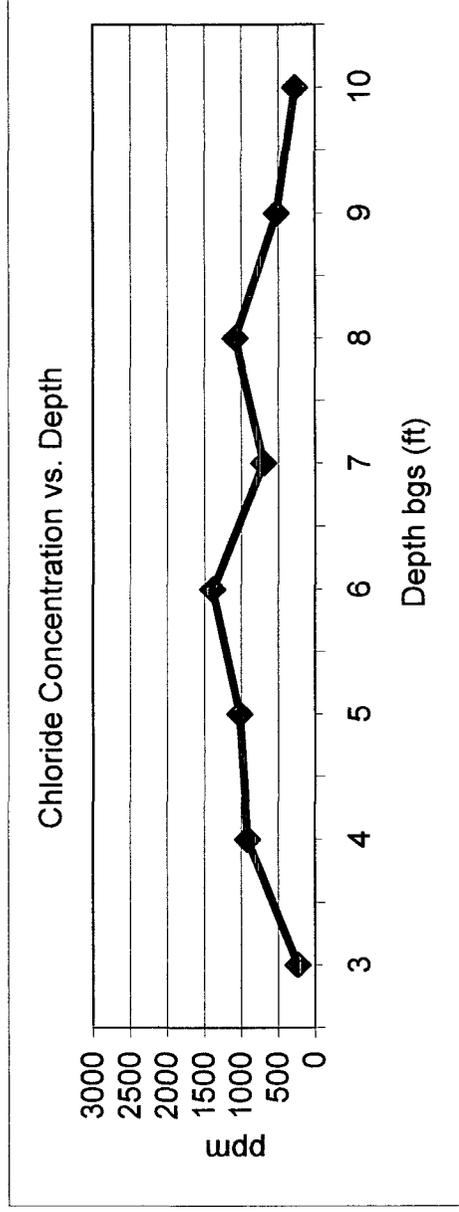
CHLORIDE CONCENTRATION CURVE

Backhoe samples at the junction (source)

Depth bgs (ft)	[Cl ⁻] ppm
3	232
4	914
5	1023
6	1385
7	699
8	1085
9	520
10	273

Groundwater = 55 ft.

LOCATION	DEPTH	mg/kg
background	6"	85
vertical delineation at junction (source)	3'	232
	4'	914
	5'	1023
	6'	1385
	7'	699
	8'	1085
	9'	520
	10'	273
