BD Jct. K-9

CLOSURE

**RICE OPERATING COMPANY
JUNCTION BOX FINAL REPORT**

SWD SYSTEM	JUNCTION	UNIT	SECTION	TOWNSHIP	RANGE	COUNTY	BOX DIMENSIONS - FEET		
							Length 6'	Width 5'	Depth 5'
Blinebry-Drinkard (BD)	Jct. K-9	K	9	21S	37E	Lea	eliminated

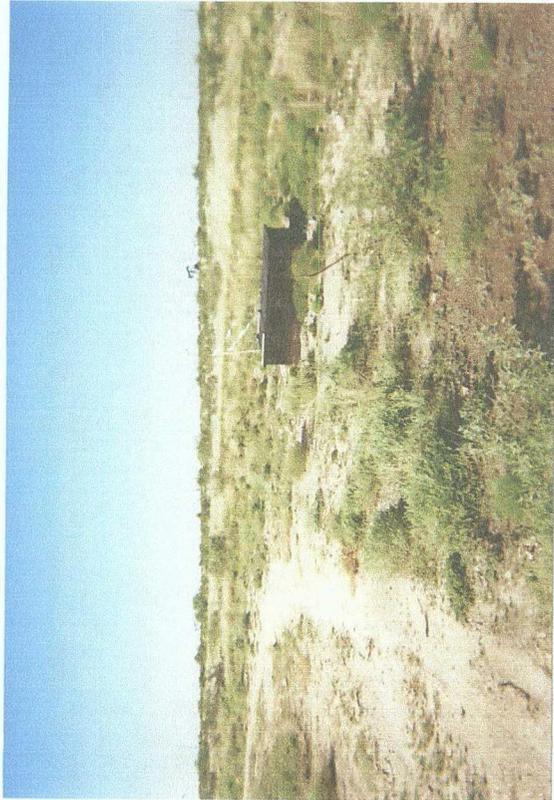
8/23/2010

Site prior to delineation

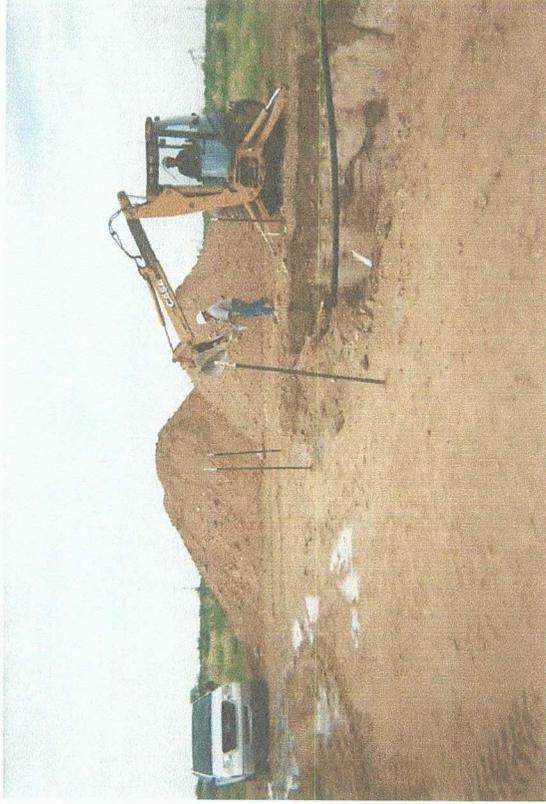
8/23/2010

Delineation trench being excavated

General Description of Remedial Action: This junction and line were eliminated during the pipeline replacement/upgrade program. After the former box was removed, an investigation was conducted using a backhoe to collect soil samples at regular intervals producing a 20x15x14-ft deep excavation. Chloride field tests were performed on each sample yielded relatively low concentrations. Organic vapors were measured using a PID, which yielded relatively low concentrations. The excavated soil was blended on site and representative samples were collected from the blended backfill, the bottom of the excavation, and excavation walls. The representative samples were sent to a commercial laboratory for analysis of chloride and TPH. 108 yards of the blended backfill was hauled to an NMOCD approved facility. The remaining backfill was blended with clean imported soil and a representative sample was collected and sent to a commercial laboratory for analysis of chloride. The blended backfill with clean imported soil was returned to the excavation to 5 ft. below ground surface (BGS). At 5 ft. BGS, a 20 ml plastic liner was installed with a six inch pad of blow sand above and below the liner. The remaining excavation was backfilled with the blended backfill with clean imported soil to 1 ft. BGS. At 1 ft. BGS, clean imported soil was used as a top cap to ground surface and contoured to the surrounding area. An identification marker was placed on the surface at the former junction box site to mark the presence of a plastic liner below. On 9/20/2010, the site was seeded with a blend of native vegetation and is expected to return to a productive capacity at a normal rate.

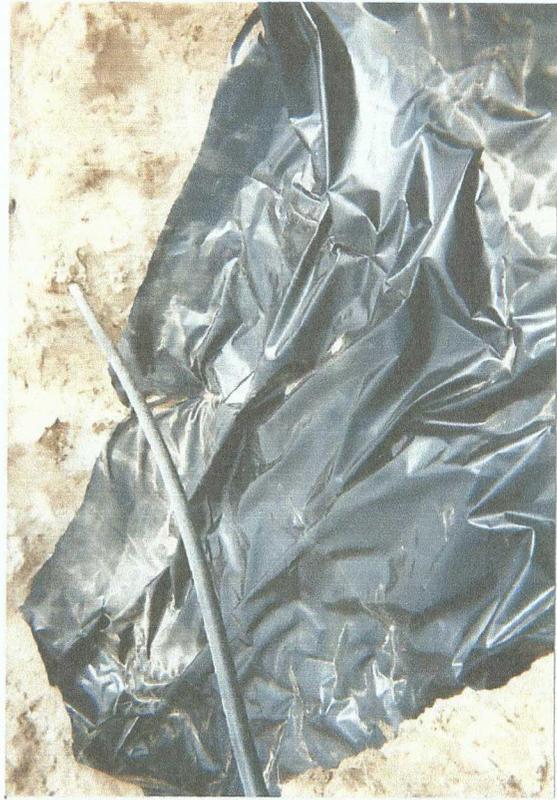
9/17/2010

Installing plastic liner

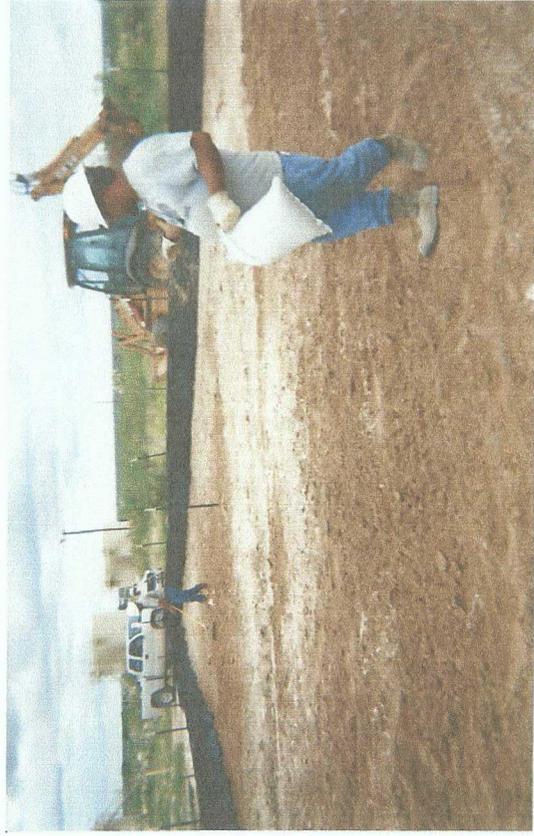
9/20/2010

Seeding site

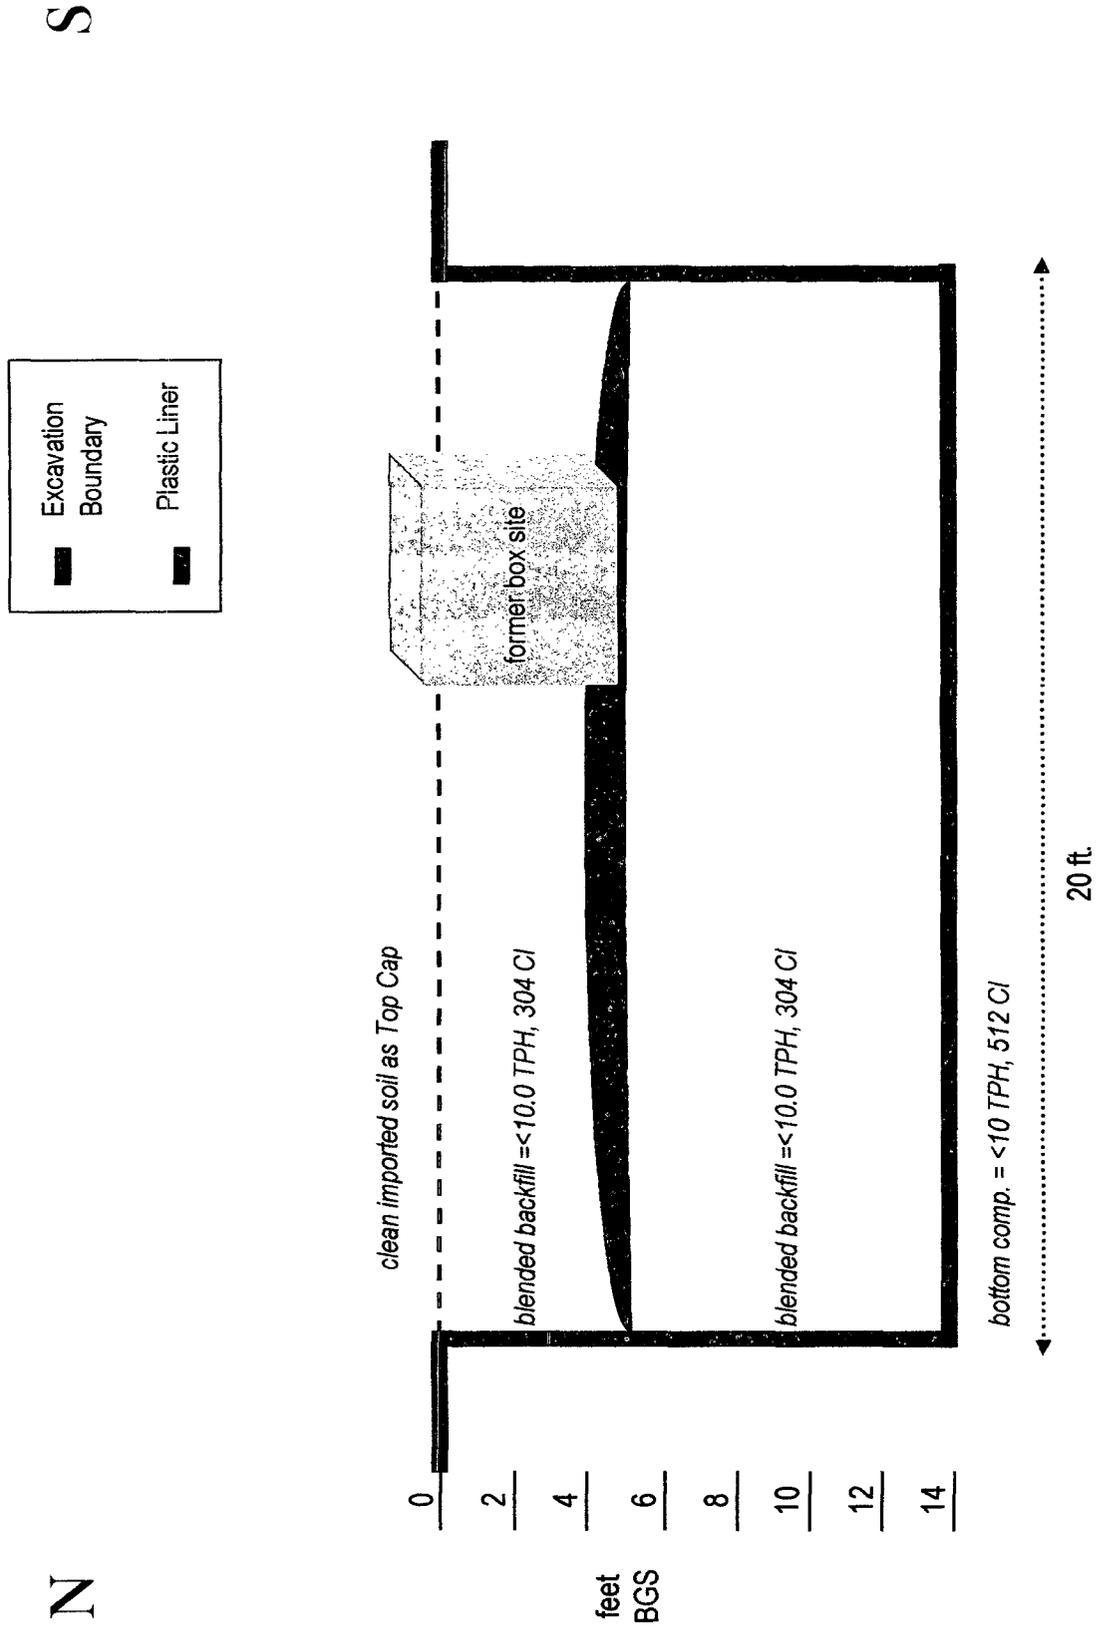
Excavation Cross-Section

Soil Excavated 155.6 cubic yards Excavation Length 20 Width 15 Depth 14 feet

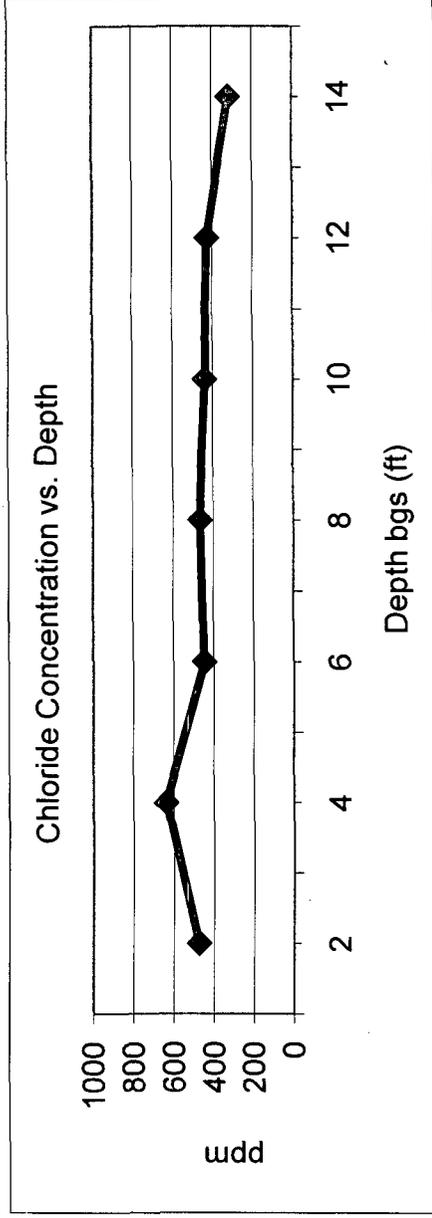
CHLORIDE CONCENTRATION CURVE

Backhoe samples at 15 ft. north of junction (source)

Depth bgs (ft)	Cl ⁻ ppm
2	475
4	638
6	447
8	467
10	441
12	427
14	318

Groundwater = 53 ft

LOCATION	DEPTH	mg/kg
4-wall comp.	n/a	665
bottom comp.	14'	345
backfill comp.	n/a	574
background	6"	29
vertical delineation at 15 ft. north of the junction (source)	2'	475
	4'	638
	6'	447
	8'	467
	10'	441
	12'	427
	14'	318
