BD Jct. K-30

CLOSURE

RICE OPERATING COMPANY
JUNCTION BOX FINAL REPORT

Unit K, Section 30, T22S, R38E

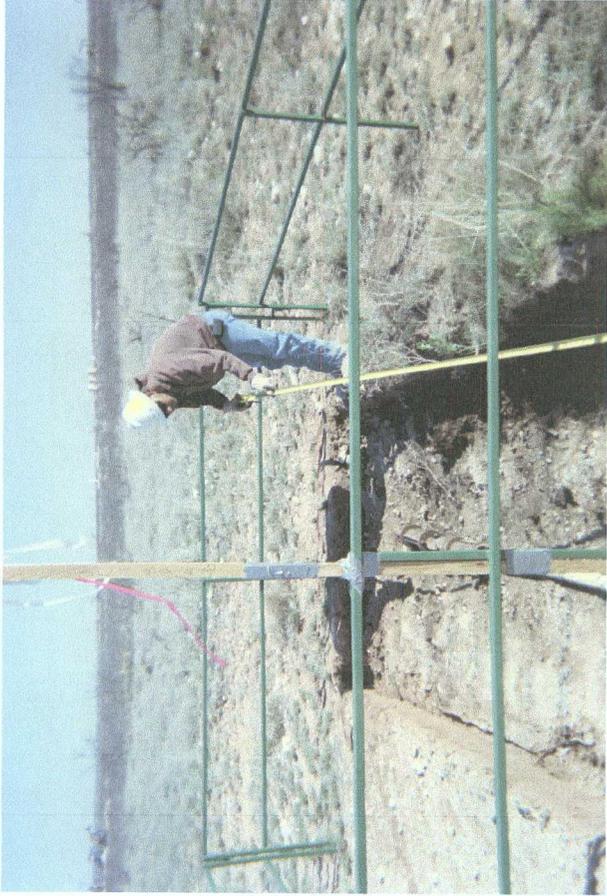
4/08/2010

Site prior to excavating

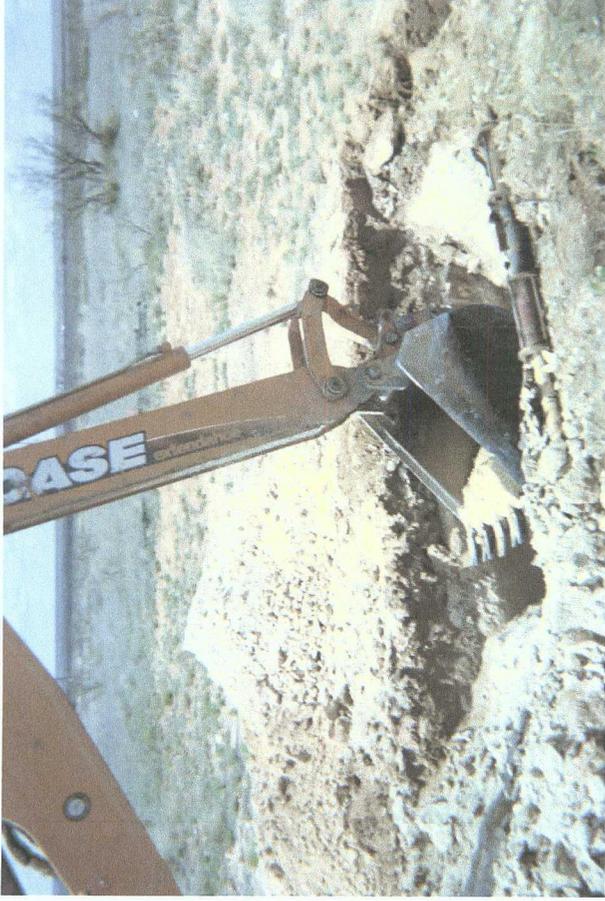
4/12/2010

Delineation trench being excavated
