BD D-12 EOL

CLOSURE

**RICE OPERATING COMPANY
JUNCTION BOX FINAL REPORT**

SWD SYSTEM	JUNCTION	UNIT	SECTION	TOWNSHIP	RANGE	COUNTY	BOX DIMENSIONS - FEET		
							Length 5 ft.	Width 4ft.	Depth 3 ft.
BLINEBRY- DRINKARD BD	D-12 EOL	D	12	22S	37E	Lea	new water tight box 127 ft. north east

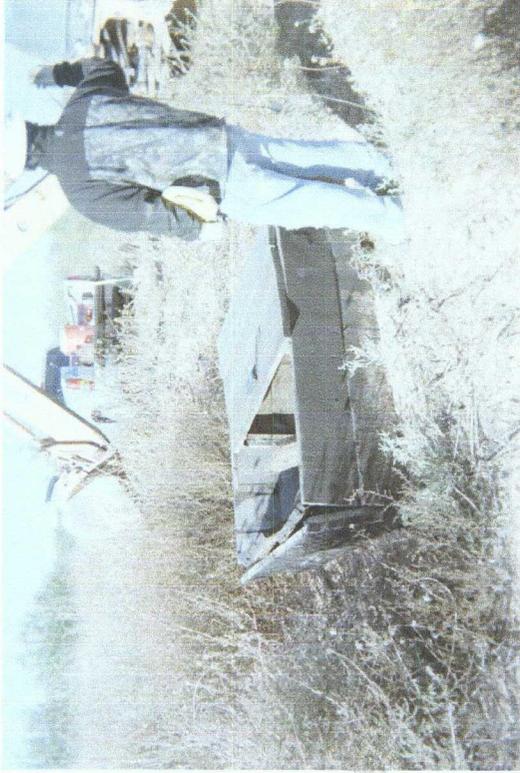
SITE PRIOR TO DELINEATION

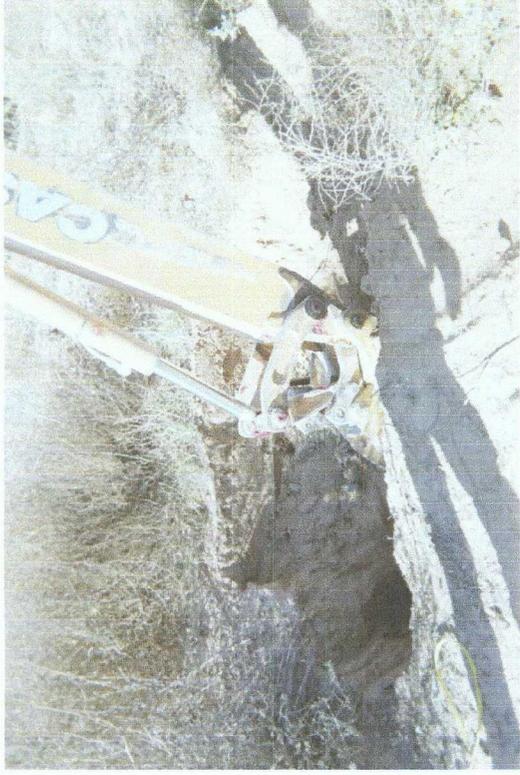
DELINEATION TRENCH

General Description of Remedial Action: This junction was eliminated during the pipeline replacement/upgrade program. After the former junction box was removed, an investigation was conducted using a backhoe to collect samples at regular intervals producing a 5X3X6-ft.-deep excavation. Chloride field tests were performed on each sample yielded low concentrations similar to that of the background sample. Organic vapors were measured using a PID, which yielded low concentrations. The deepest sample, 6 ft. BGS, was sent to a commercial laboratory for analysis of chloride and TPH, which confirmed low concentrations of each. On 10/28/2010, the site was seeded with a blend of native vegetation and is expected to return to a productive capacity at a normal rate. A new water tight box was built 127 ft. north east of former junction box.

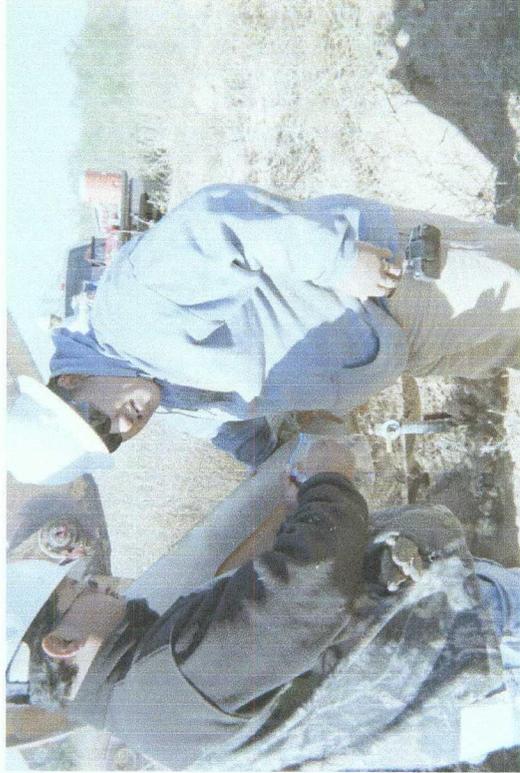
COLLECTING SAMPLE

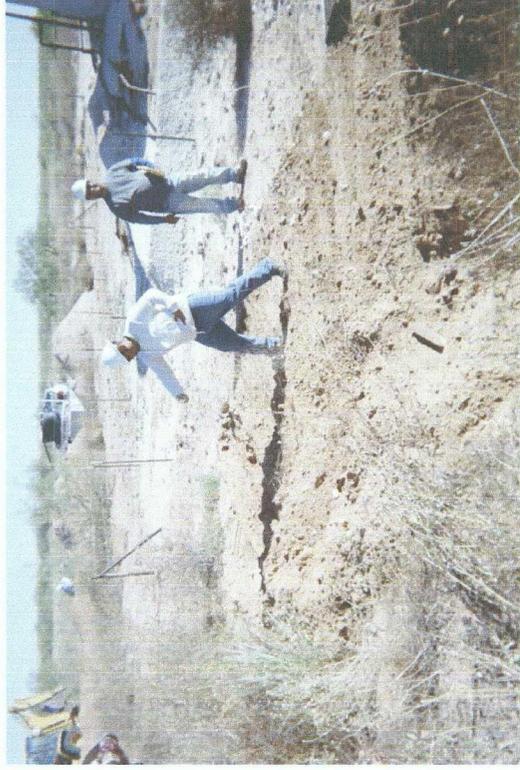
SEEDING SITE

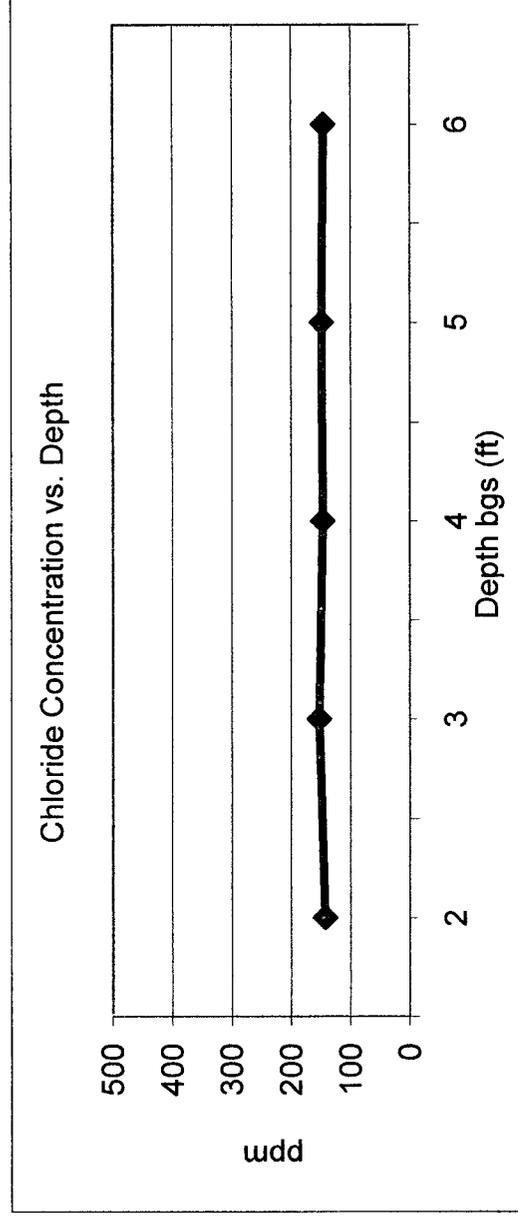
CHLORIDE CONCENTRATION CURVE

Delineation of Source

Depth bgs (ft)	[Cl ⁻] ppm
2	143
3	153
4	147
5	149
6	146

Groundwater = 59 ft

CHLORIDE FIELD TESTS		
LOCATION	DEPTH	mg/kg
BACKGROUND	6"	149
Vertical Delineation of the Junction (source)	2'	143
	3'	153
	4'	147
	5'	149
	6'	146
