BD Jct. H-2

CLOSURE

**RICE OPERATING COMPANY
JUNCTION BOX FINAL REPORT**

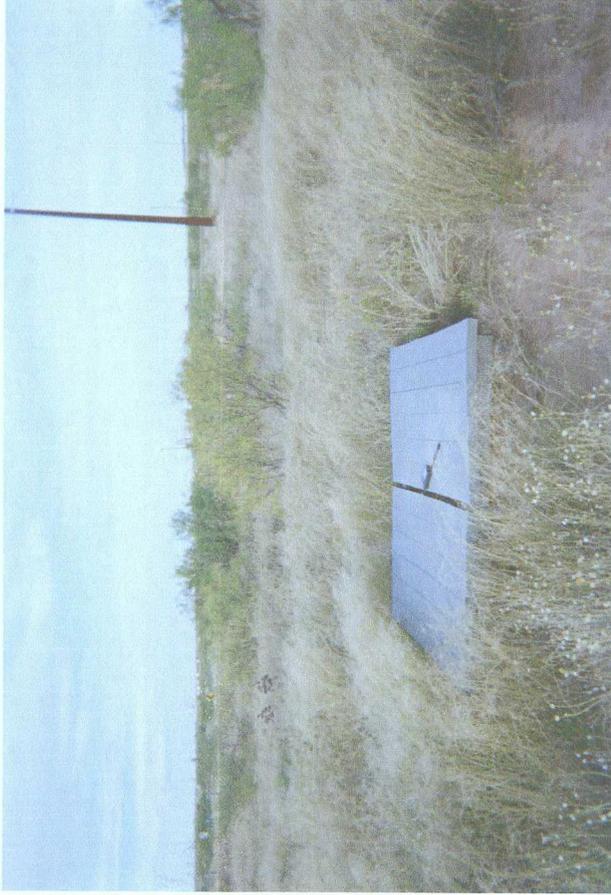
Site prior to excavation

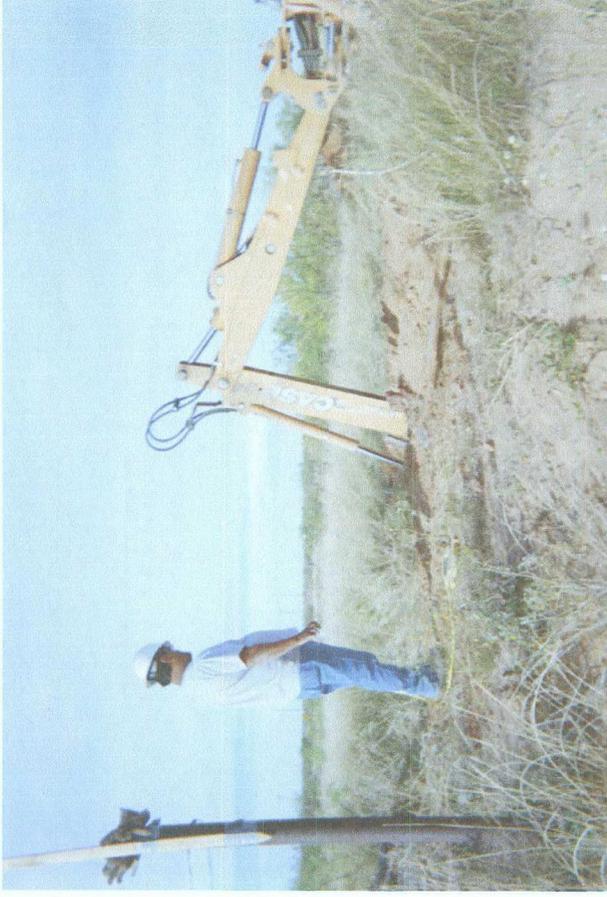
Delineation trench being excavated

General Description of Remedial Action: This junction was addressed during the pipeline replacement/upgrade program. After the former junction was removed, an investigation was conducted using a backhoe to collect soil samples at regular intervals creating a 6X2X12-ft. deep excavation. Chloride field tests were performed on each sample yielded chloride concentration similar to that of the background sample.

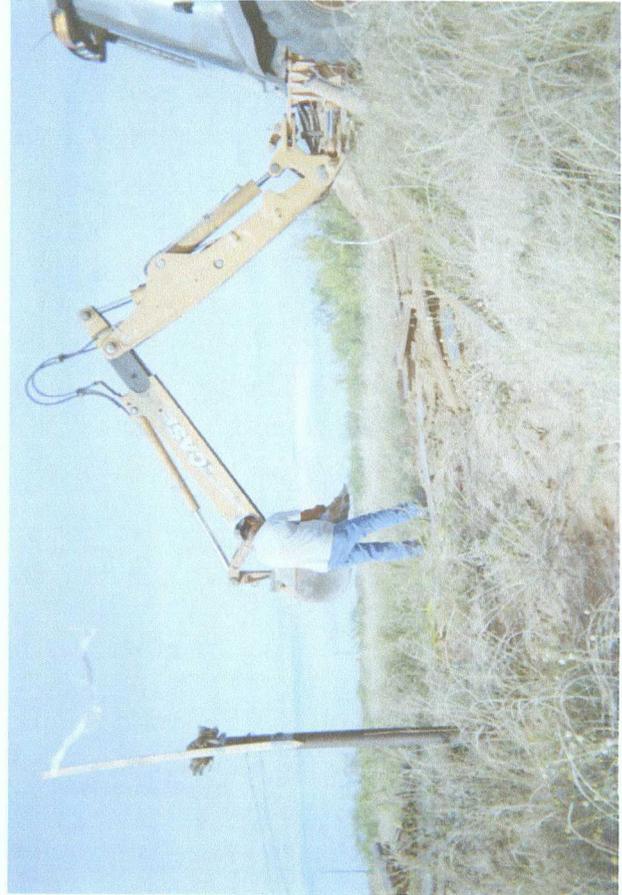
Collecting sample

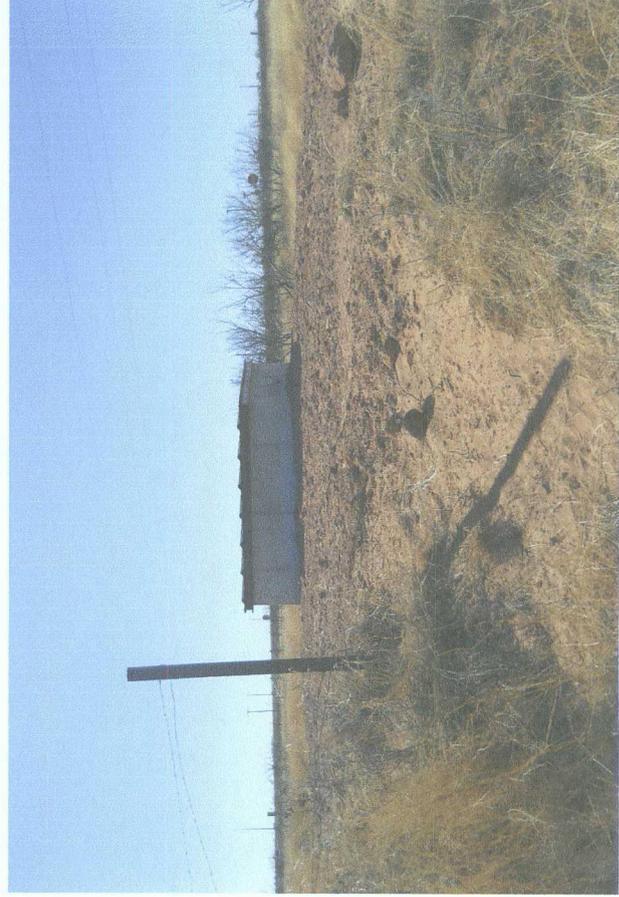
New water tight junction box

Organic vapors, were measured using a PID, yielded low concentrations. The deepest sample, 12 ft. BGS, was sent to a commercial laboratory for analysis of chloride and TPH, which confirmed low concentrations of each. The excavated soil was returned to the excavation to 5 ft. below ground surface (BGS). A new water tight junction box was built in the same location.

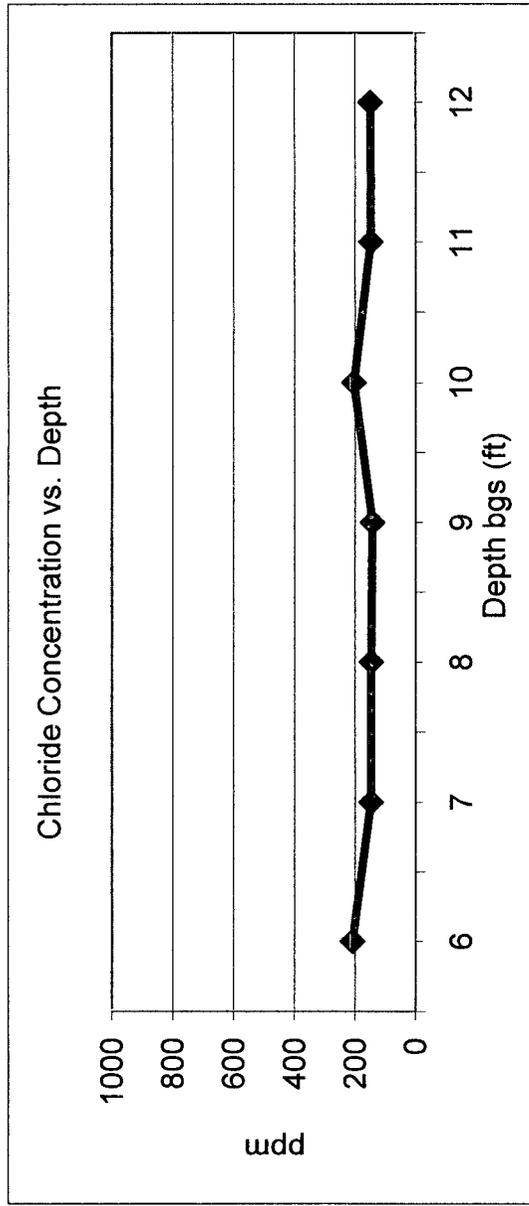
BD H-2 JCT

Delineation of Source

Depth bgs (ft)	[Cl ⁻] ppm
6	209
7	148
8	147
9	143
10	204
11	148
12	150

Groundwater = 54 ft
