**BD F-5 EOL**  
**2010**

**CLOSURE**

RICE OPERATING COMPANY  
JUNCTION BOX FINAL REPORT

SWD SYSTEM	JUNCTION	UNIT	SECTION	TOWNSHIP	RANGE	COUNTY	BOX DIMENSIONS - FEET		
							Length	Width	Depth
Blinebry-Drinkard (BD)	F-5 EOL	F	5	22S	37E	Lea	water tight box built in same place

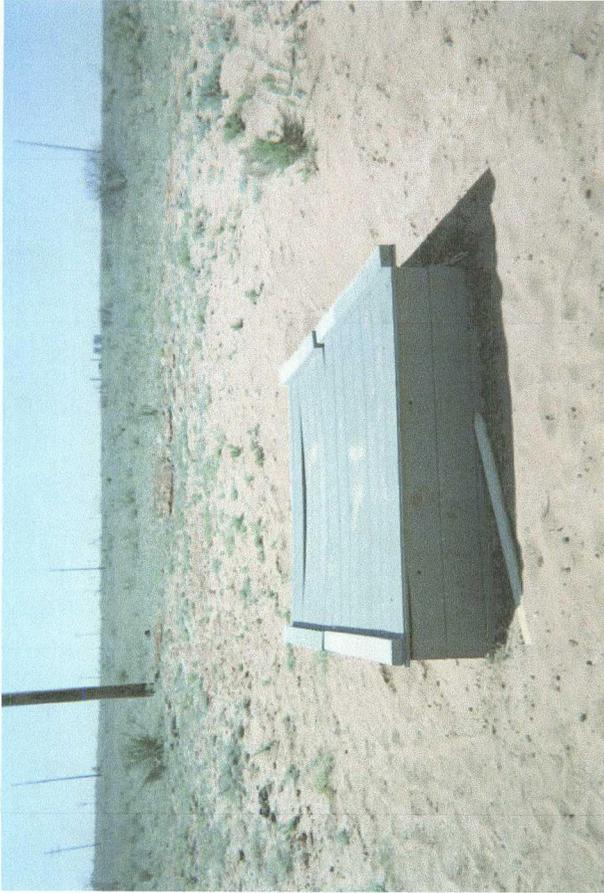
Site prior to excavation

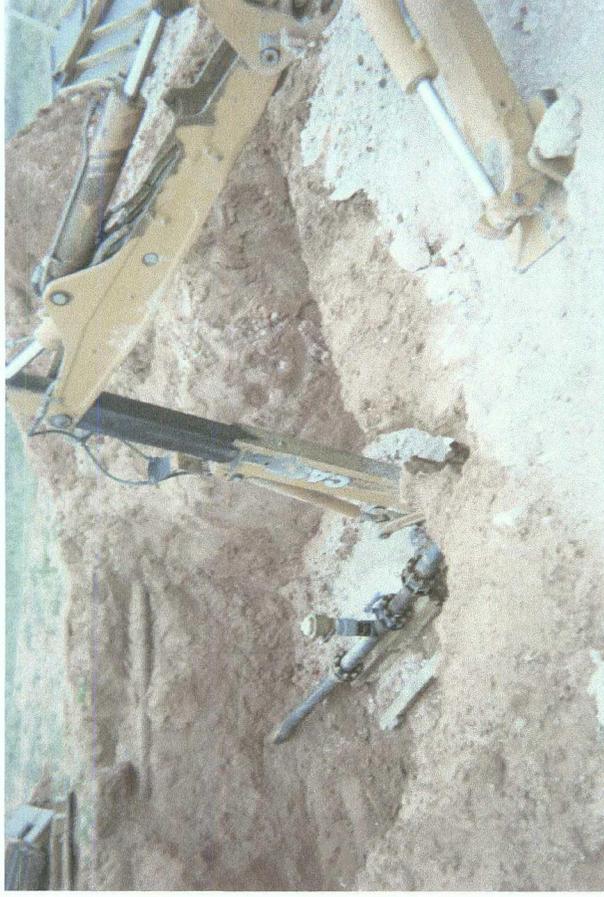
Delineation trench being excavated

**General Description of Remedial Action:** This junction box was addressed during the pipeline replacement/upgrade program. After the former junction box was removed, an investigation was conducted using a backhoe to collect soil samples at regular intervals creating a 7x3x12-ft. deep excavation. Chloride field tests performed on each sample yielded low concentrations similar to that of the background. Organic vapors were measured using a PID which also yielded low concentrations. The deepest sample, 12 ft. BGS was sent to a commercial laboratory for analysis of chloride and TPH, which confirmed low concentrations. The excavated soil was returned to the excavation to 7 ft. bgs. A new water tight junction box was built in the same location as the former box.

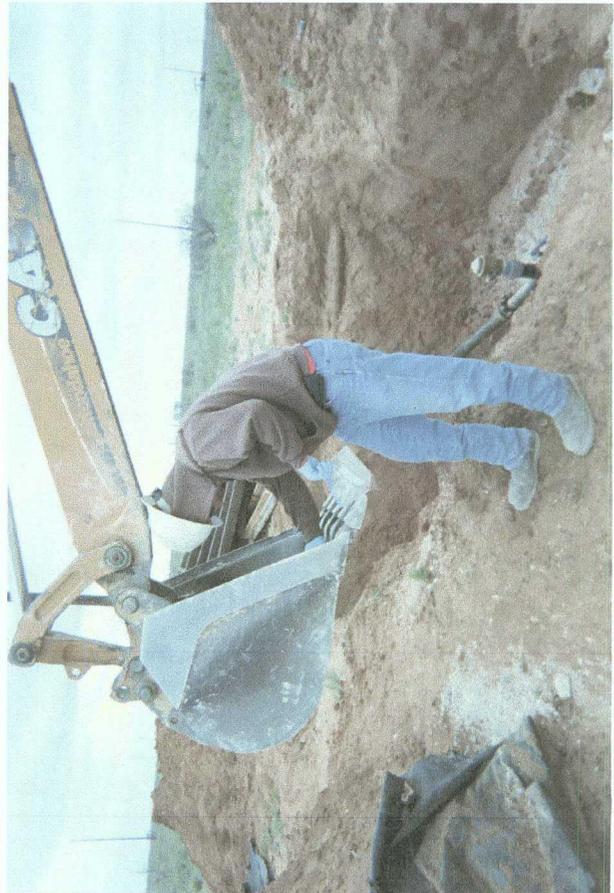
Sample being taken

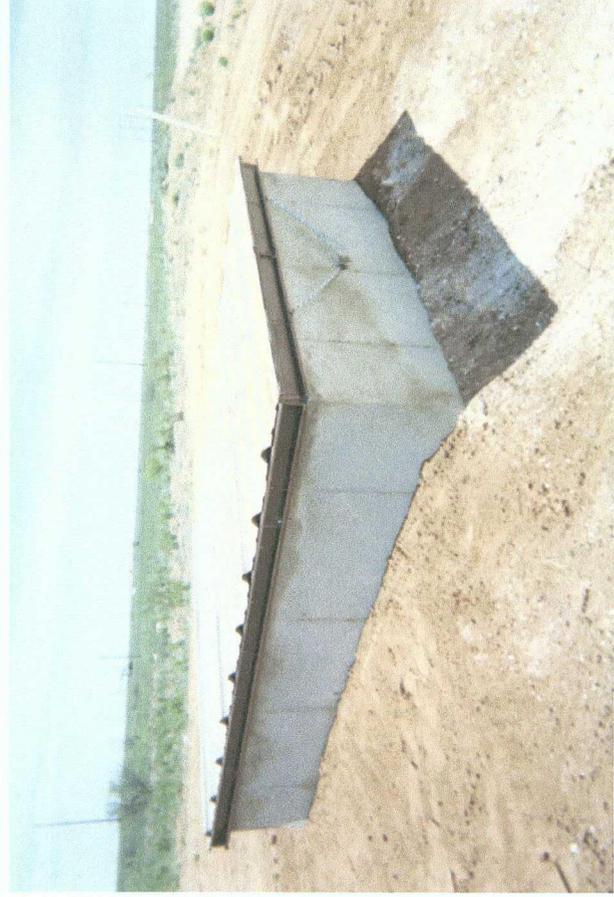
New water tight junction box

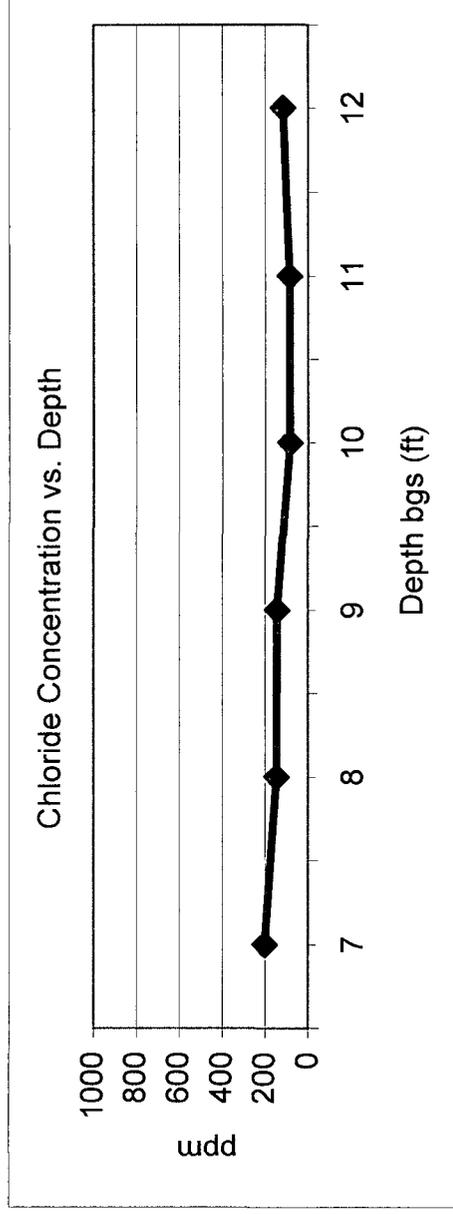
# CHLORIDE CONCENTRATION CURVE

Backhoe samples at the junction (source)

Depth bgs (ft)	[Cl] ppm
7	203
8	148
9	144
10	85
11	86
12	117

Groundwater = 82 ft
