1R425-102

**Vacuum J-33 EOL**

**RICE OPERATING COMPANY  
JUNCTION BOX FINAL REPORT**

Unit J, Section 33, T17S, R35E

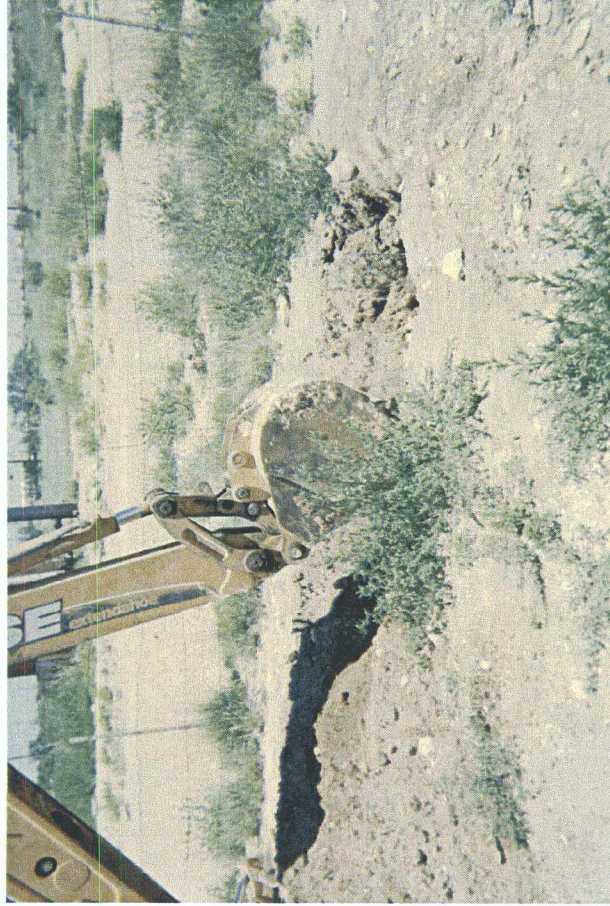
7/19/2010

Digging initial delineation trench

**General Description of Remedial Action:** This junction box was addressed during the Vacuum SWD System abandonment. An investigation was conducted at the former junction box using a backhoe to collect soil samples at regular intervals creating a 15x15x12-ft. deep excavation. Chloride field tests were performed on each sample which yielded relatively low concentrations. Organic vapors were measured using a PID, which yielded low concentrations. The excavated soil was blended on site and representative samples were collected from the blended backfill, the bottom of the excavation, and excavation walls. The representative samples were sent to a commercial laboratory for analysis of chloride and TPH. The blended backfill was returned to the excavation and contoured to the surrounding area. On 9/10/2010, the site was seeded with a blend of native vegetation and is expected to return to a productive capacity at a normal rate.

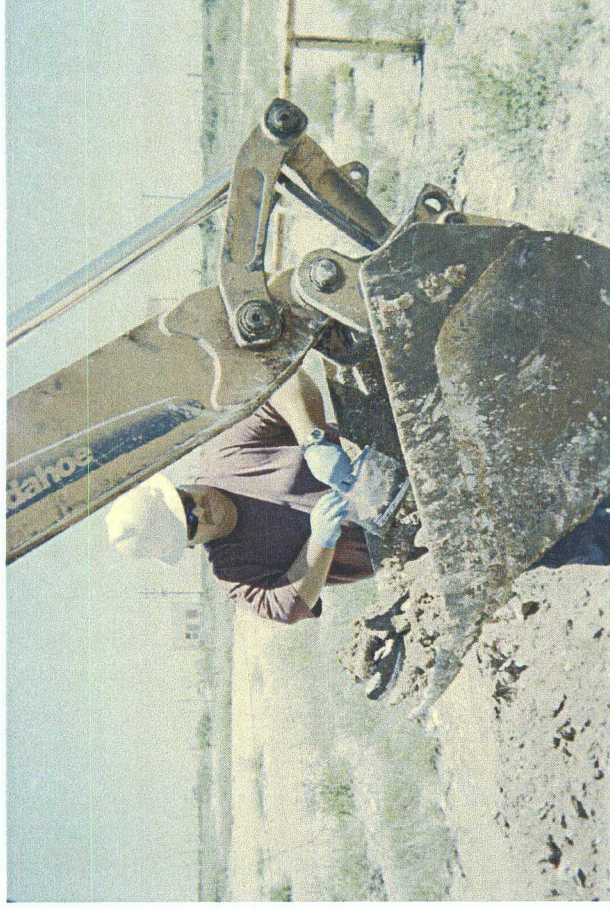
7/19/2010

Collecting sample
